MINERALS PROGRAM INSPECTION REPORT

MINE NAME: Destiny Pit	MINE/PROSPECTING ID#: M-2009-056	MINERAL: Gold, Sand & Gravel	COUNTY: Park
INSPECTION TYPE: Surety-Related Inspection	INSPECTOR(S): Michael A. Cunningham	INSP. DATE: December 8, 2017	INSP. TIME: 10:00
OPERATOR: Gold Tamers, LLC	OPERATOR REPRESENTATIVE: Caleb Bolander, Matt Donnelly	TYPE OF OPERATION: 110(2) - Hard Rock Limited Impact

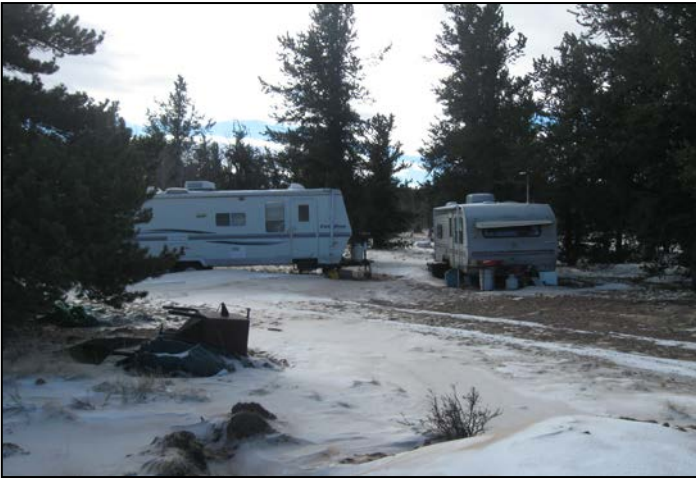
PROBLEM/POSSIBLE VIOLATION: Problem: Land has been affected outside of the approved permit boundary. This is a problem at this time pursuant to C.R.S. 34-32-116(7)(h) for failure to protect areas outside of the affected land from slides or damages occurring during the mining operation.

The Division observed three trailers and a portable restroom located immediately outside of the southeast corner of the permit boundary. The structures are located on BLM property, but are currently outside of the approved permit boundary. The trailers have been parked on the grass and no pads were constructed in order to place the trailers in their current location. This matter has been cited as a problem and will require

1. Trailers located outside of the permit boundary.

CORRECTIVE ACTIONS: The Operator shall remove the trailers and the portable restroom which are located outside of the permit boundary. The facilities shall be removed entirely from the site. Alternately, the Operator may relocate the facilities to the interior of the permit boundary, with the necessary BLM approvals. Proof of compliance may be in the form of photographs.

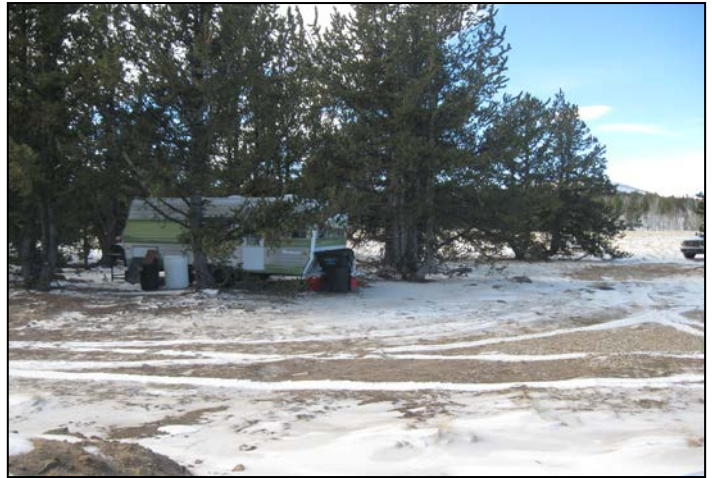
2. Trailer located outside of the permit boundary.

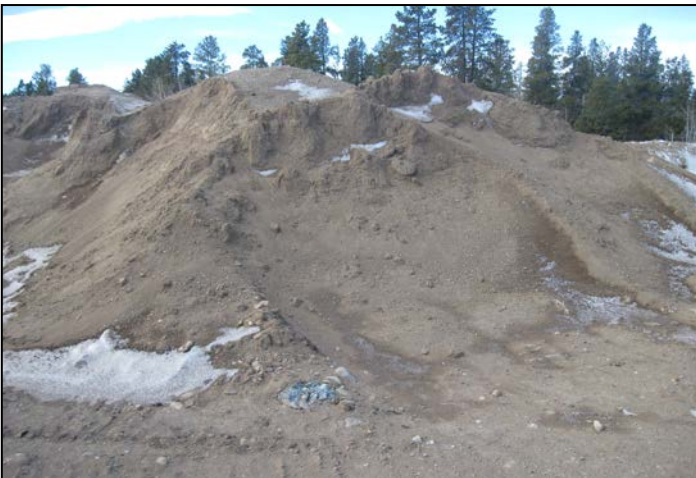
The Operator has salvaged and screened topsoil, which has been stockpiled towards the center of the pit. The Division and the Operator discussed relocating the topsoil stockpile to the perimeter of the pit, so as to avoid disturbance from ongoing operations. The Operator is reminded the Reclamation Permit requires topsoil stockpiles to be stabilized through revegetation with the prescribed seed mix.

3. Screened topsoil stockpile.

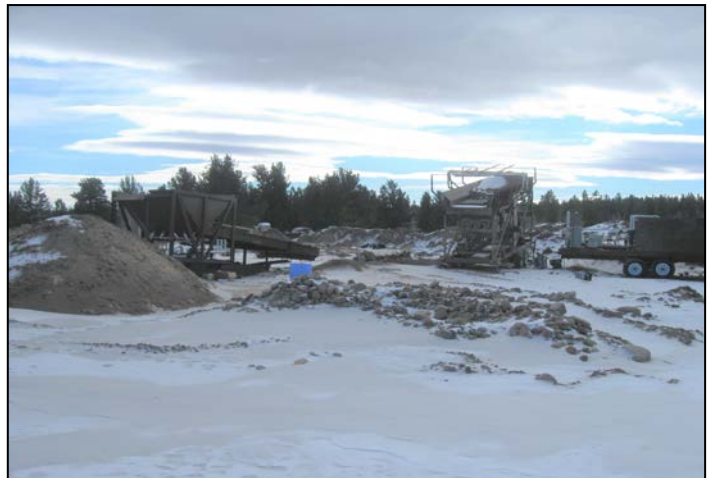
A gold recovery plant has been set up towards the south end of the permit area. The gold plant consists of a grizzly with a belt feeder, a trommel screen, conveyors, a sluice box and sand screw. Water from the wash plant is recirculated in a horseshoe shaped pit which is approximately 6 ft. deep. The recirculation pit is lined to prevent the loss of water. A second area of disturbance was located north of the wash plant and consisted of a pit approximately 20 ft deep with side walls at 1H:1V. Overburden has been stockpiled along the eastern and norther permit boundaries.

4. Wash plant for gold recovery.
