MINERALS PROGRAM INSPECTION REPORT
PHONE: (303) 866-3567

| MINE NAME: 15 Road Gravel Pit | MINE/PROSPECTING ID#: M-2002-114 | MINERAL: Sand and gravel | COUNTY: Mesa |
| INSPECTION TYPE: Monitoring | INSPECTOR(S): Amy C. Yeldell | INSP. DATE: January 25, 2018 | INSP. TIME: 13:15 |

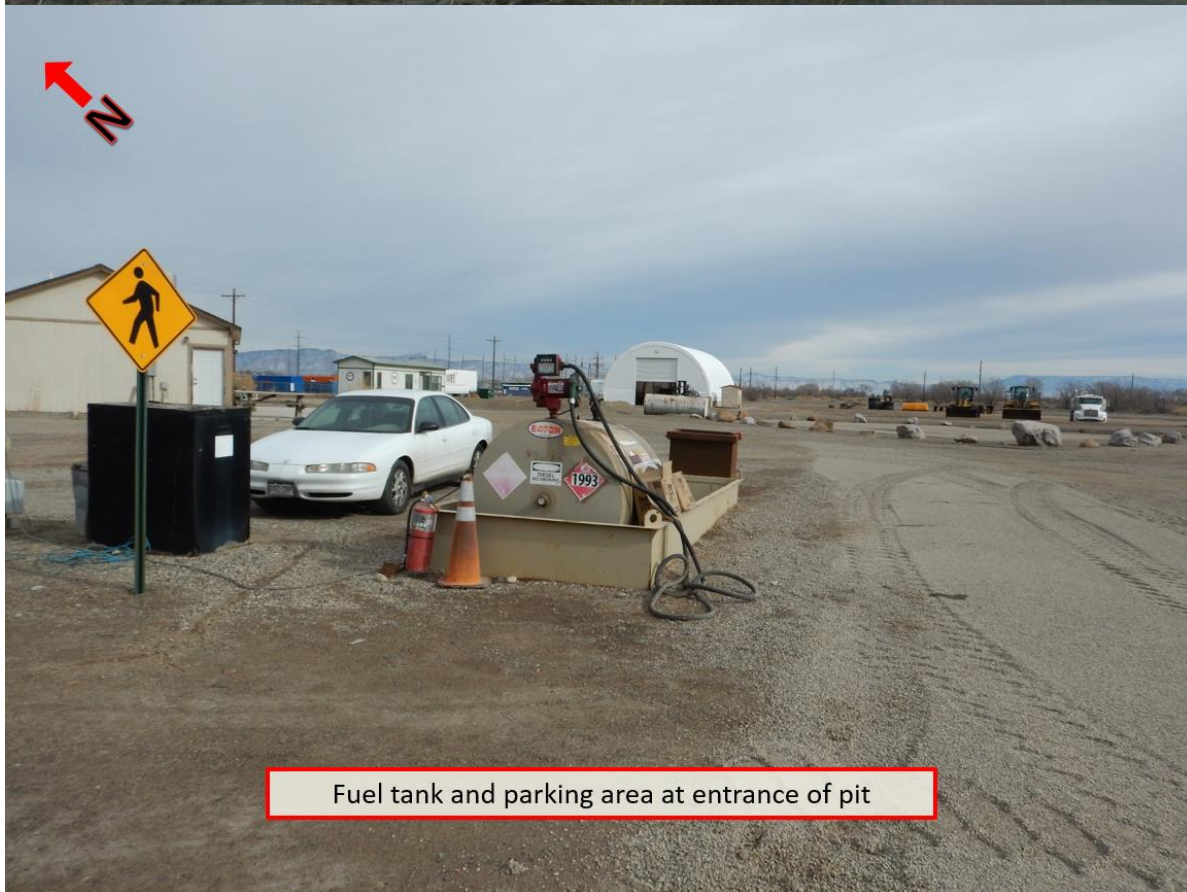
This pit was active at the time of the inspection. During the inspection a portable crusher was being fed and new ground was being excavated. The wash plant and asphalt plant were in the laydown yard and slated to be mobilized in the near future. Additional equipment and stockpiled material is stored in phase 5. This includes several very large piles of recycled asphalt. A scale and scale house is located along the haul road near the pit entrance. Three fuel tanks were observed throughout the site. All were stored properly within secondary containments.

Fuel tank and parking area at entrance of pit

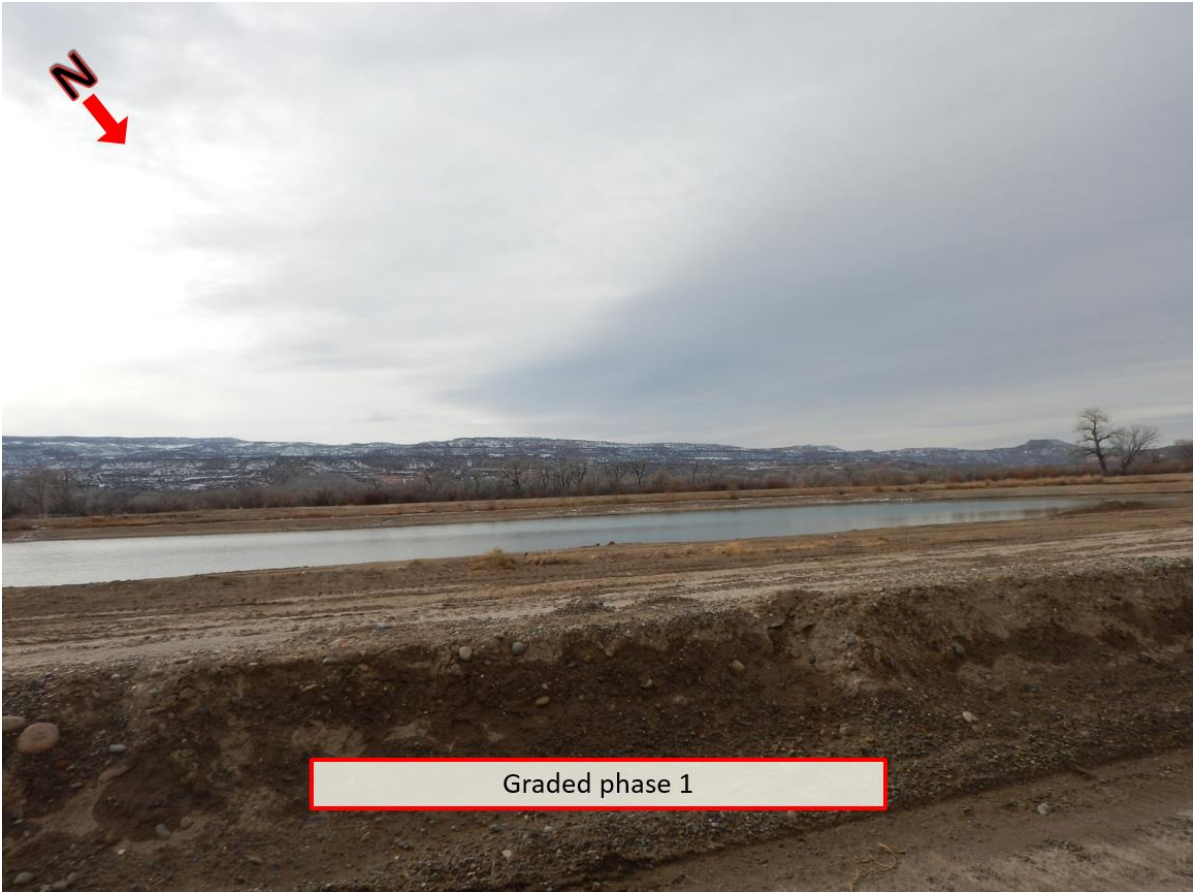
Phase 1 mining has been completed. The slopes have all been graded and the lake is filling with water. Once the water level is determined the banks will be seeded down to the water's edge.

Graded phase 1

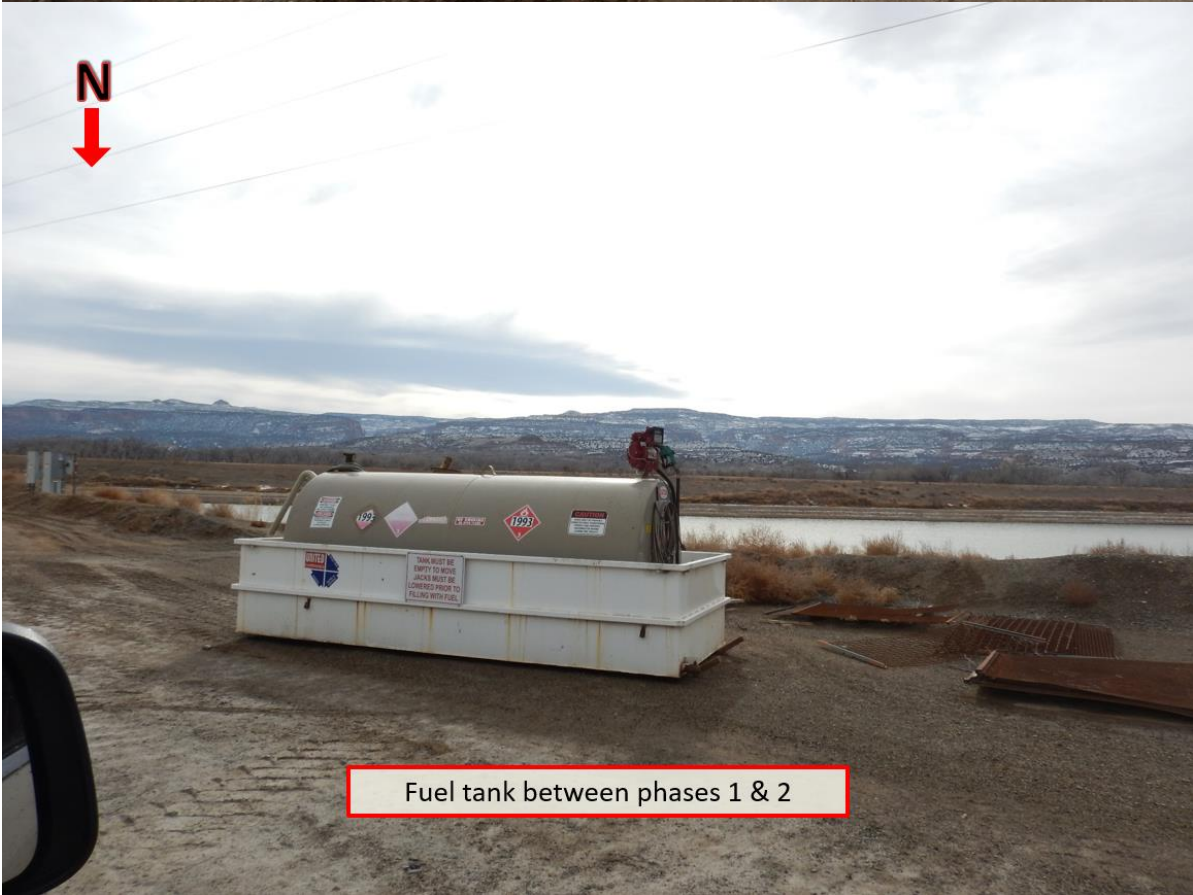
Fuel tank between phases 1 & 2

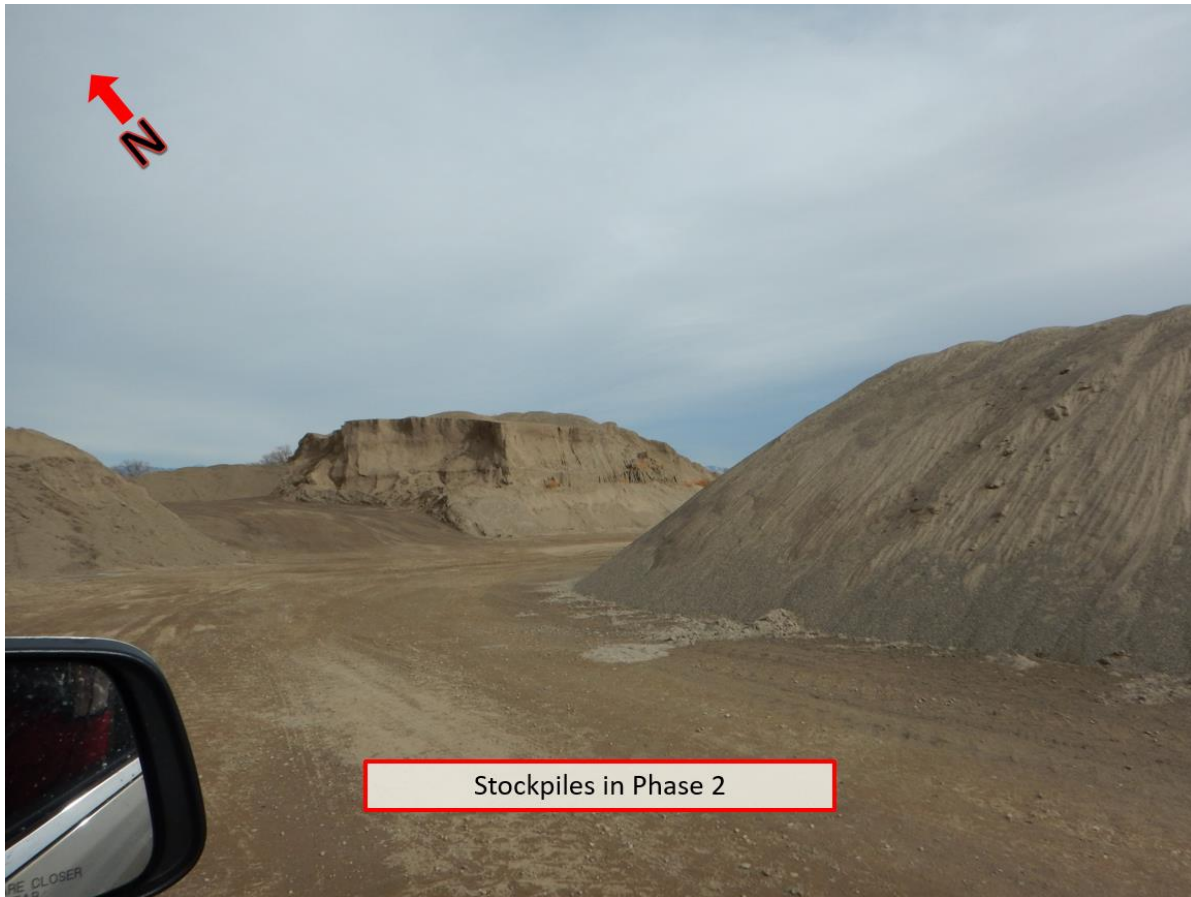
Phase 2 mining has also been completed. The outer perimeter banks have been graded. The highwall adjacent phase 3 and the stockpiles is at approximately a 1:1 slope and requires future grading. Mr. Burkey was unsure if the stockpiles area in phase 2 would be mined at a future date. To date no seeding has occurred within phase 2.

Stockpiles in Phase 2

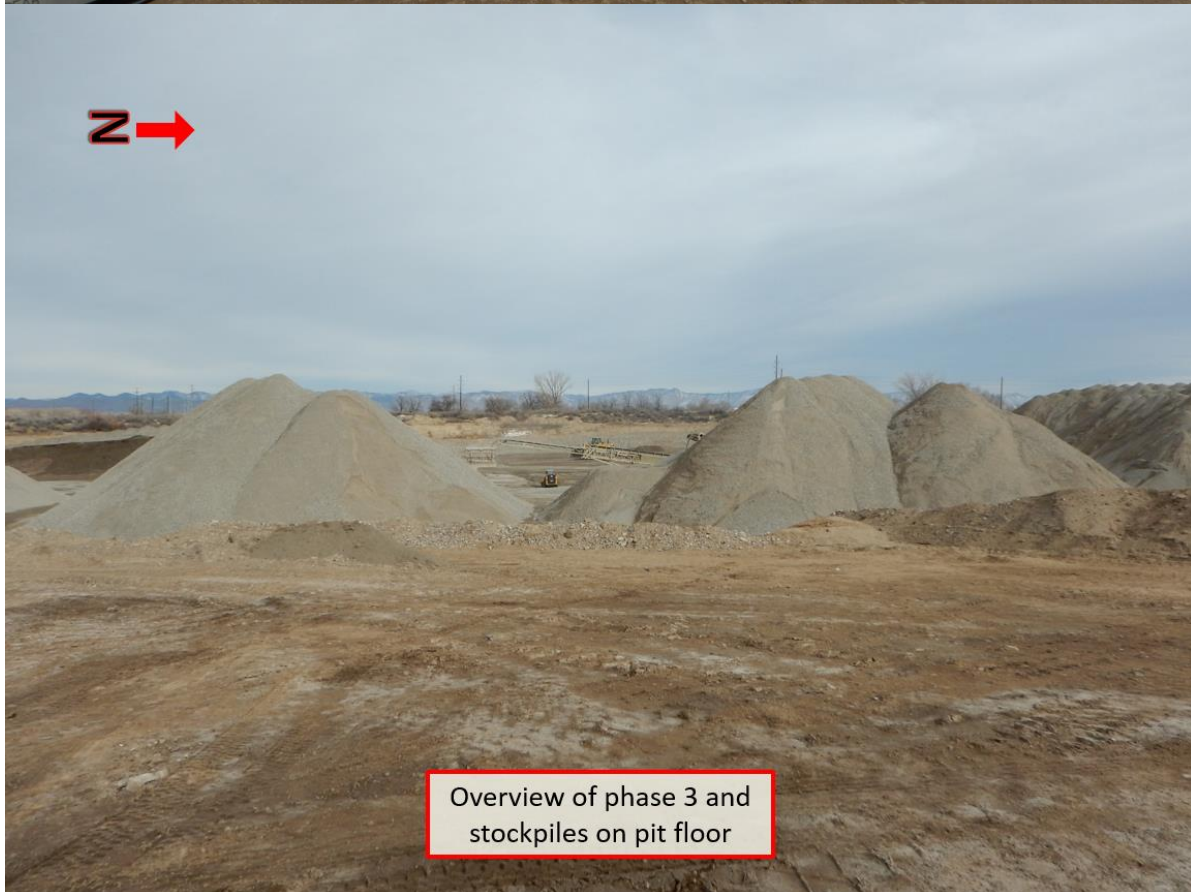
Phase 3 is where active mining is occurring. The crusher is staged in the bottom of the pit and mining is moving towards the north. The excavated pit is approximately 30 feet deep with vertical highwalls along the active face. Based on site observations compared to the mining maps the operation appears to be reaching the limits of phase 3.

Overview of phase 3 and
stockpiles on pit floor
