MINERALS PROGRAM INSPECTION REPORT
PHONE: (303) 866-3567

MINE NAME: Cresson Project	MINE/PROSPECTING ID#: M-1980-244	MINERAL: Gold	COUNTY: Teller
INSPECTION TYPE: Monitoring	INSPECTOR(S): Timothy A. Cazier	INSP. DATE: July 27, 2017	INSP. TIME: 9:15
OPERATOR: Cripple Creek & Victor Gold Mining Company	OPERATOR REPRESENTATIVE: Clara Steward	TYPE OF OPERATION: 112d-3 - Designated Mining Operation	
REASON FOR INSPECTION: Normal I&E Program	BOND CALCULATION TYPE: None	BOND AMOUNT: \$207,828,540.00	
DATE OF COMPLAINT: NA	POST INSP. CONTACTS: None	JOINT INSP. AGENCY: None	
WEATHER: Clear	INSPECTOR'S SIGNATURE:

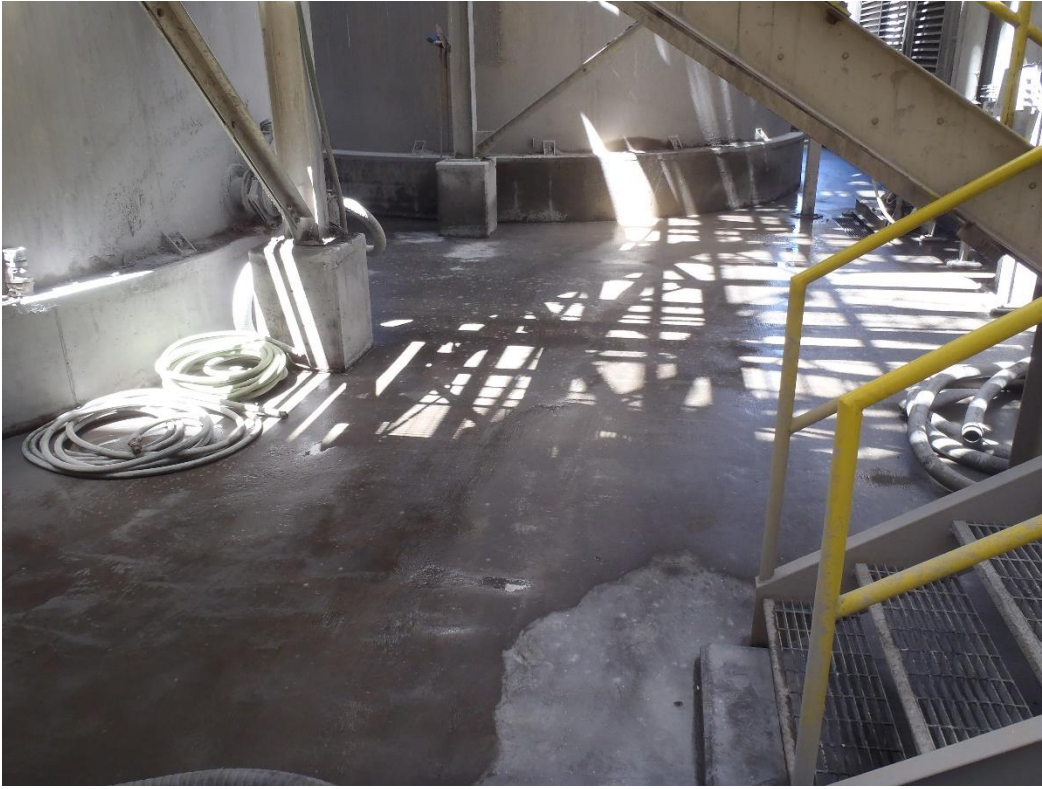
High Grade Mill: The Division was accompanied by Dylan Noble at the HGM to perform an exterior walk-around inspection. The focus was to observe the status of secondary containment on both the west side (vat leach area) and the east side. No significant reduction in secondary containment was observed in either the vat leach area (**Photo 1**) or the east side (**Photo 2**).

Photo 1. Secondary containment observed in vat leach area (no significant volume used).

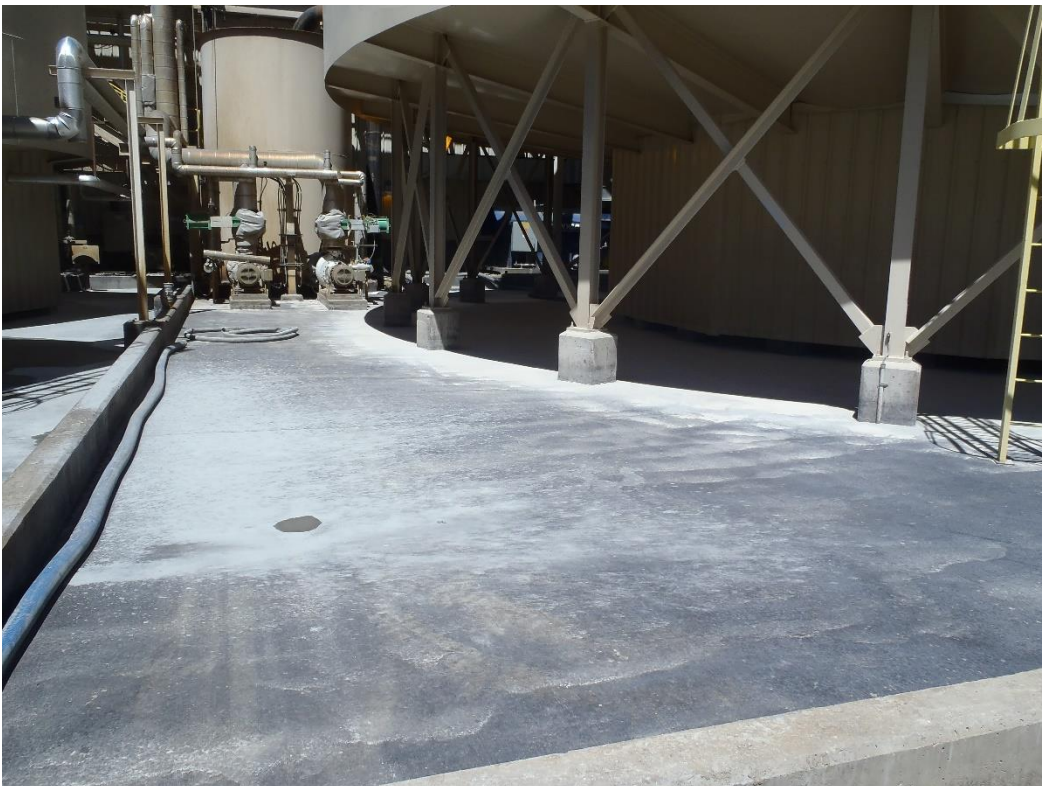
Photo 2. Typical available secondary containment on east side of HGM.

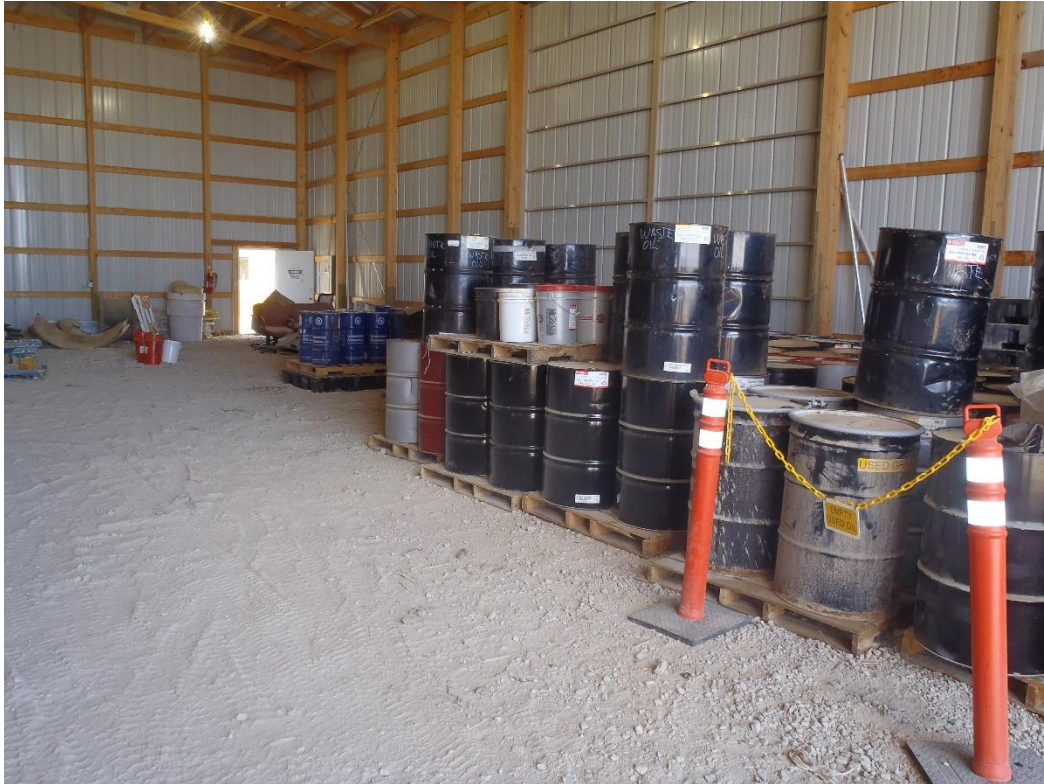
The mill satellite warehouse was inspected. This area is used primarily for oil storage. All containers were on pallets (**Photo 3**), some of those with secondary containment capacity (**Photo 4**). The Division recommends all pallets with non-empty containers of fresh or used oil be placed on pallets with secondary containment.

Photo 3. Drum storage on pallets in mill satellite warehouse.

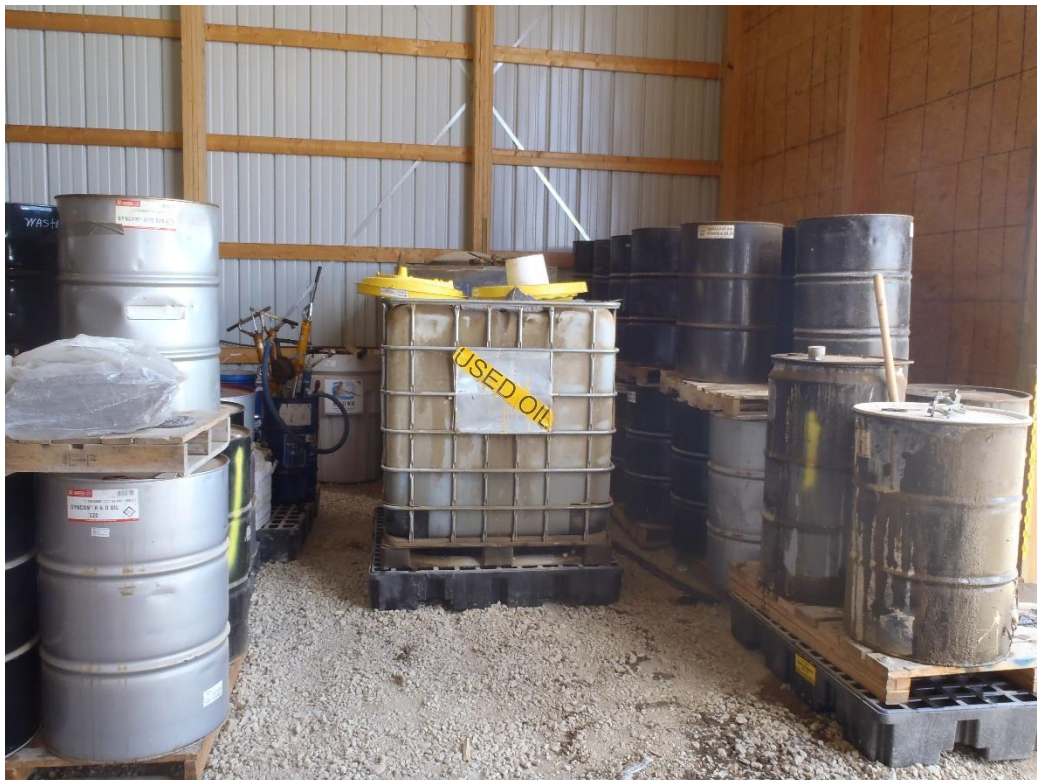
Photo 4. Used oil storage on pallets with secondary containment in mill satellite warehouse.

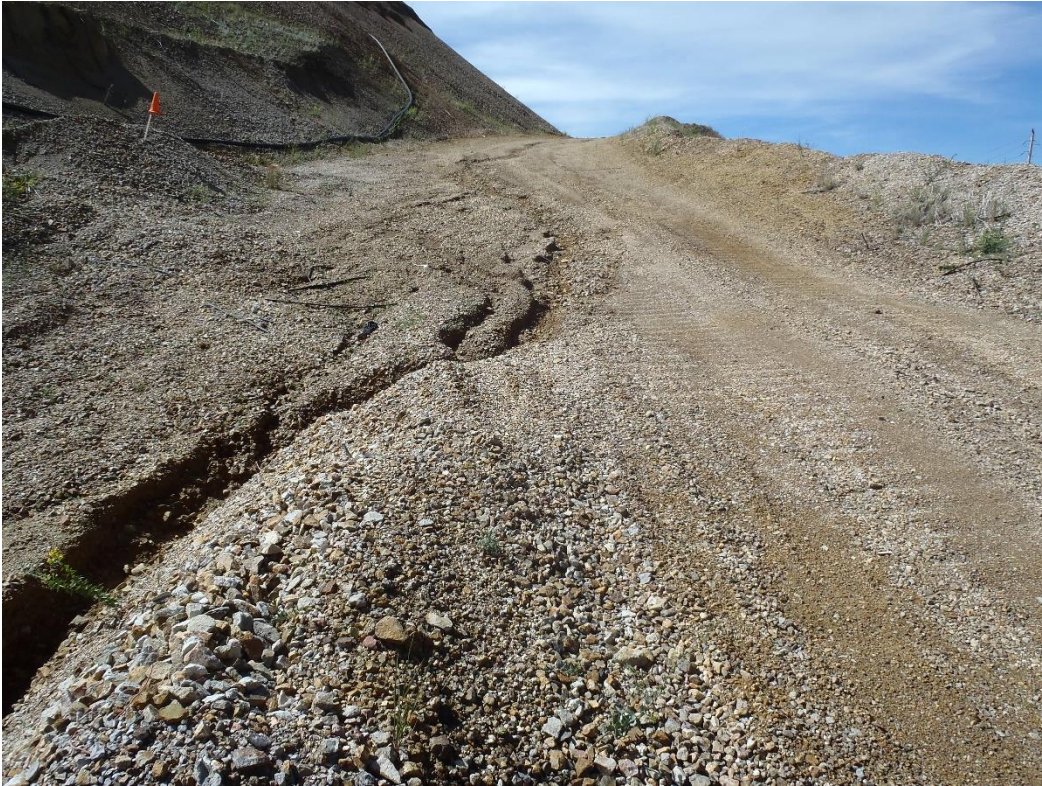
AGVLF: The Division was accompanied by Ms. Steward to inspect the area near the northwest toe of the AGVLF where the Division had observed an area of concern relating to stormwater control where the access road crosses the edge of liner during the October 27, 2016 inspection (*UTM coordinates: Zone 13 S, 485856.96 m E, 4286300.68 m N*). Ms. Steward indicated the mine site had received 8.06 inches of precipitation since July 1, 2017 through the day before this inspection (i.e., 7/26). The repairs made to the drainage controls appeared to be adequate and functioning as intended (**Photos 5 and 6**).

Photo 5. Functioning drainage repairs on northwest toe of the AGVLF (looking upgradient).

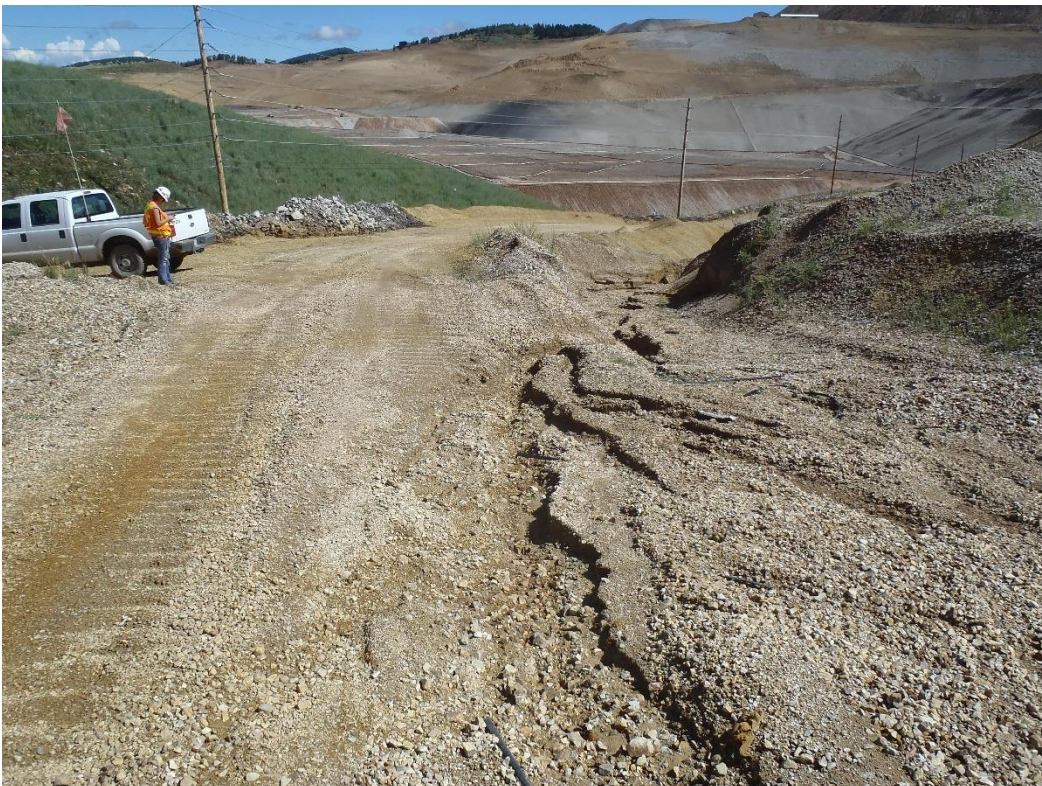
Photo 6. Functioning drainage repairs on northwest toe of the AGVLF (looking downgradient)..

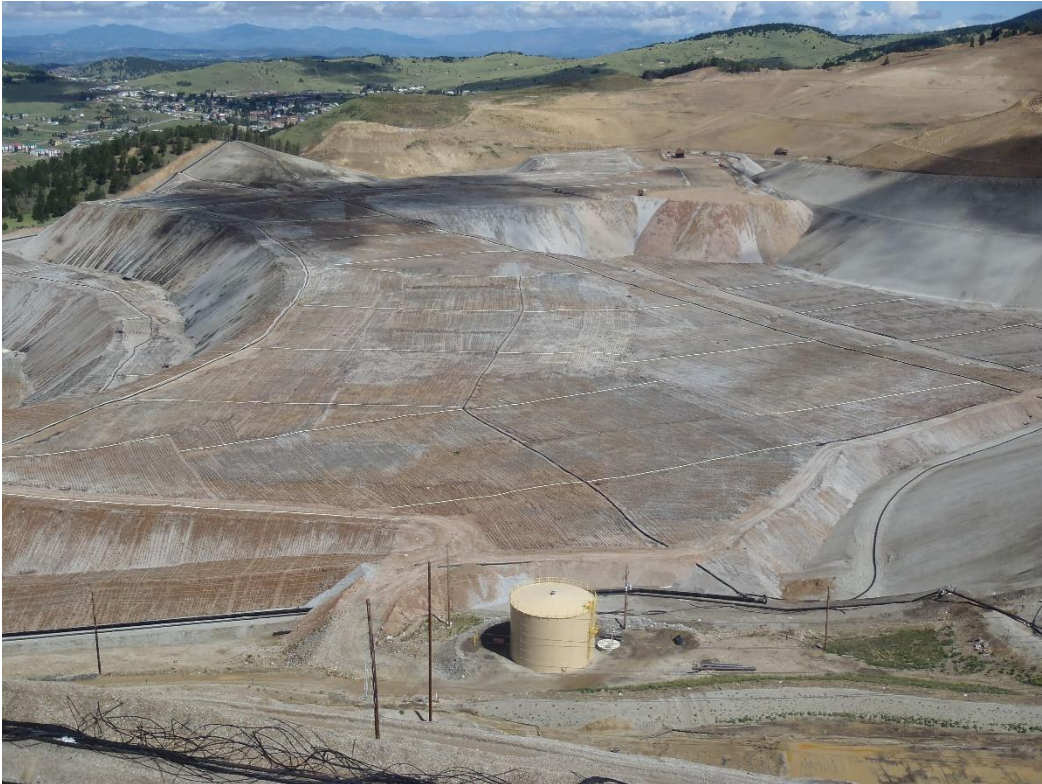
Squaw Gulch Valley Leach Facility: The Division was accompanied by Ms. Steward to observe the surface for ponded solution and general slope stability concerns (**Photo 7**). No ponded solution or slope concerns were observed.

Photo 7. No ponded solution or slope concerns observed on SGVLF (looking NW).

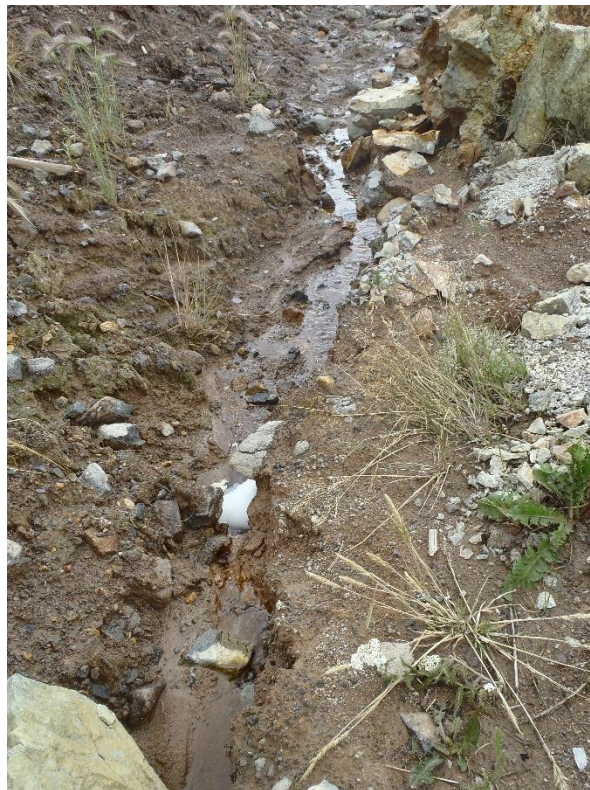
ECOSA seep: A seep at the toe of the south end of the ECOSA was first observed during the Division's June 15, 2017 inspection. Subsequent review of aerial photos taken on March 30, 2017 suggest the seep may have been active at that time.

During this inspection, the Division was accompanied by Ms. Steward to the seep area where other CC&V representatives were available to discuss the seep and how the mine was approaching characterization and mitigation. The flow was estimated to be on the order of a gallon per minute and appeared to be confined to the ditch formed by the toe berm along the base of the ECOSA (**Photo 8**). Portions of this ditch were covered with boulders making it difficult to determine exactly where the seep initiated and where flow in the ditch stopped (**Photo 9**). Large mammal footprints were observed near where the seep first appears from under the boulders on the south end (**Photo 10**). A large volume of the seep water was observed pooled (**Photo 11** and

A CC&V representative collected samples of the seep water for laboratory analyses. The Division received the results of the laboratory analyses on August 22, 2017 via email. Several analytes exceeded the Table Value Standards of the Water Quality Control Division's Rule 41 for groundwater (see **Attachment A**). The Division and CC&V representatives met in the Division's office on November 28, 2017 to discuss details for monitoring and mitigating impacts as necessary. During this November meeting, it was agreed that CC&V would submit a technical revision (TR) to the permit to install infiltration drains and a monitoring plan for the seep. As of the date of this report, the Division has not received the request for this required TR. The Division expects to receive this TR request within 60 days (**April 8, 2018**) of the signature date of this report and installation of the necessary monitoring wells during the second quarter of 2018 with the goal of monitoring seepage impacts during the summer of 2018.

Photo 8. ECOSA seep in toe berm ditch (looking SW/upgradient).

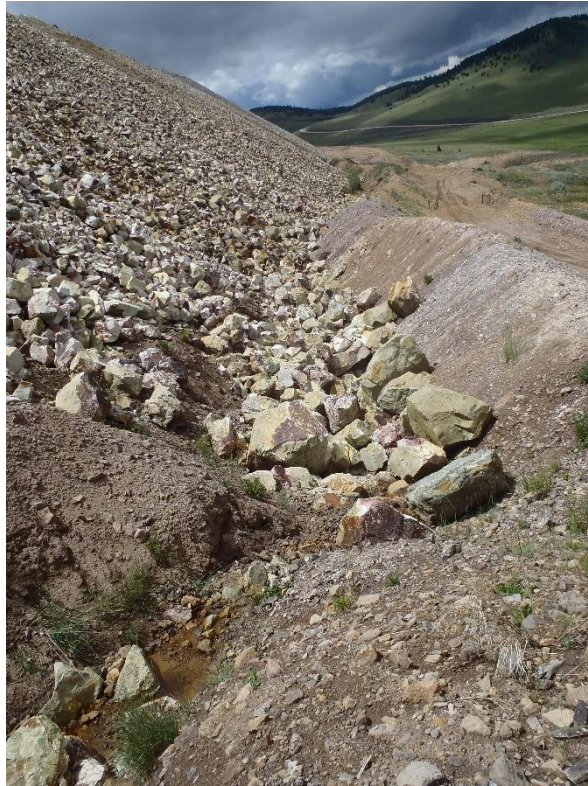
Photo 9. ECOSA toe berm ditch covered with boulders, seep flow not observable (looking NE/downgradient).

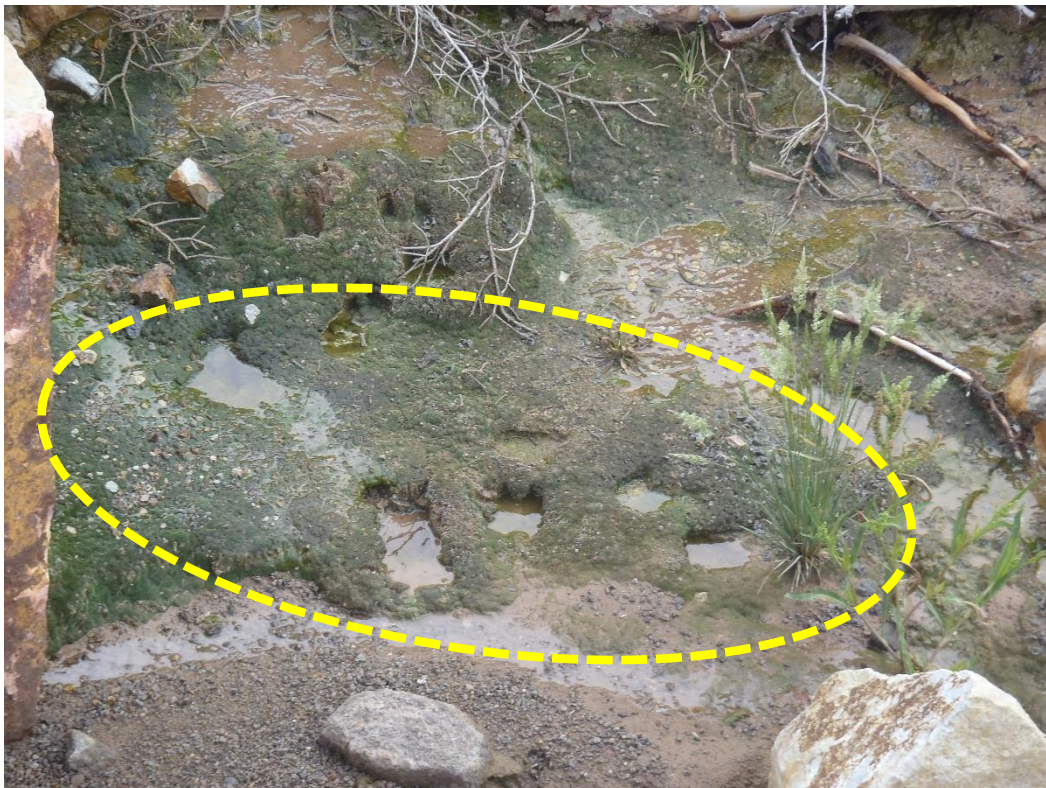
Photo 10. Large mammal footprints within the area affected by the ECOSA seep.

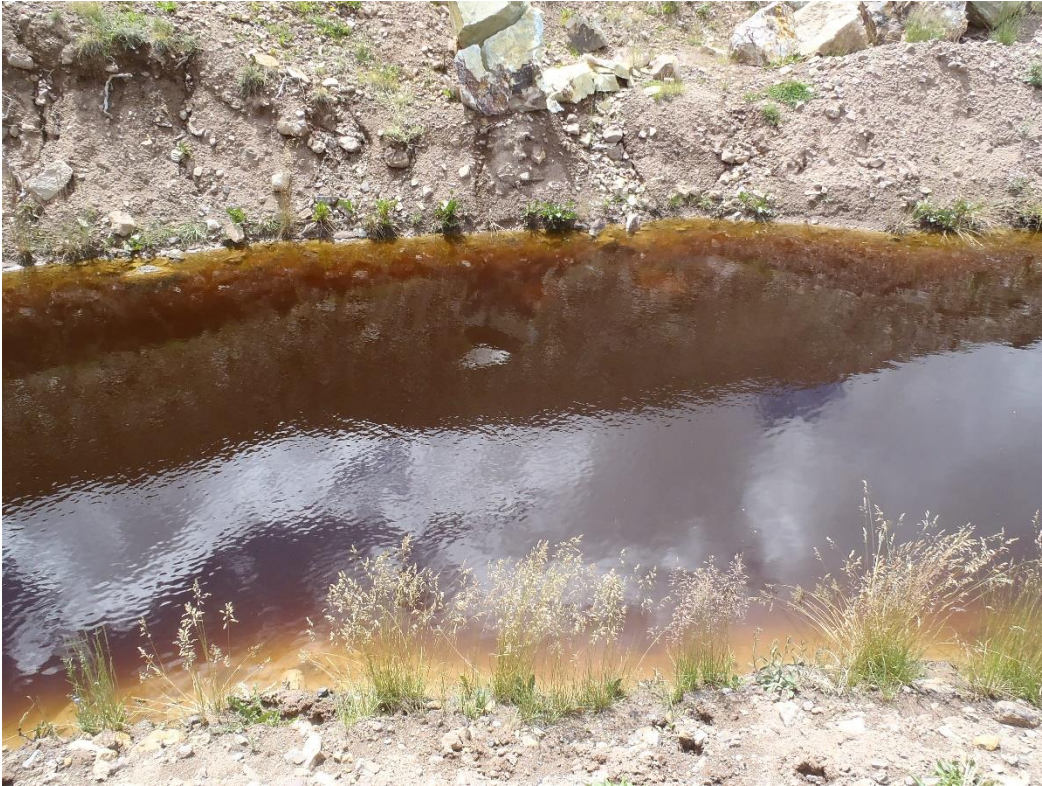
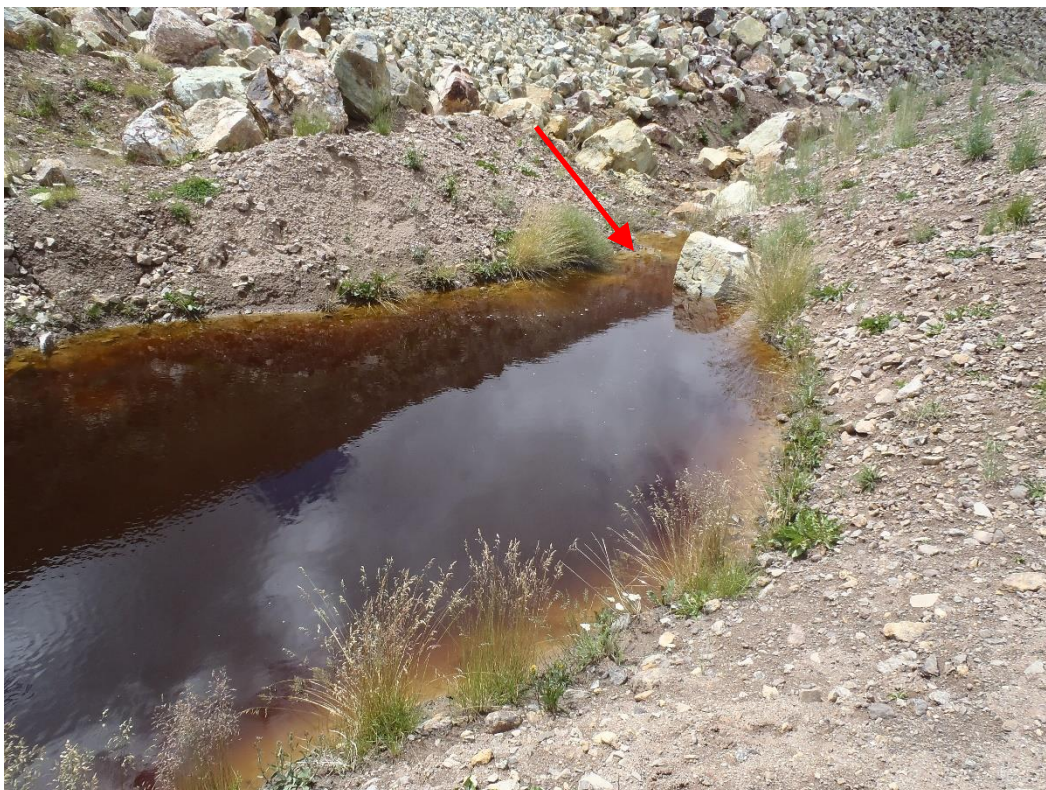
12) in a relatively flat segment of the toe berm ditch. This pool was also observed to have flow exiting it towards the north end (**Photo 13**). The Division was accompanied by Ms. Steward to a segment of the toe ditch past the boulder coverage. No flow was observed here suggesting the seep infiltrated somewhere under this segment. The March 30, 2017 aerial inspection report indicated some of the seepage may have been expressed on the toe berm road. Although the road was muddy from recent rains, it did not appear to have seepage from the toe ditch as a contributor (**Photo 14**).

Photo 11. Pooled ECOSA seep water (1 of 2).

Photo 12. Pooled ECOSA seep water (2 of 2, showing overflow outlet).

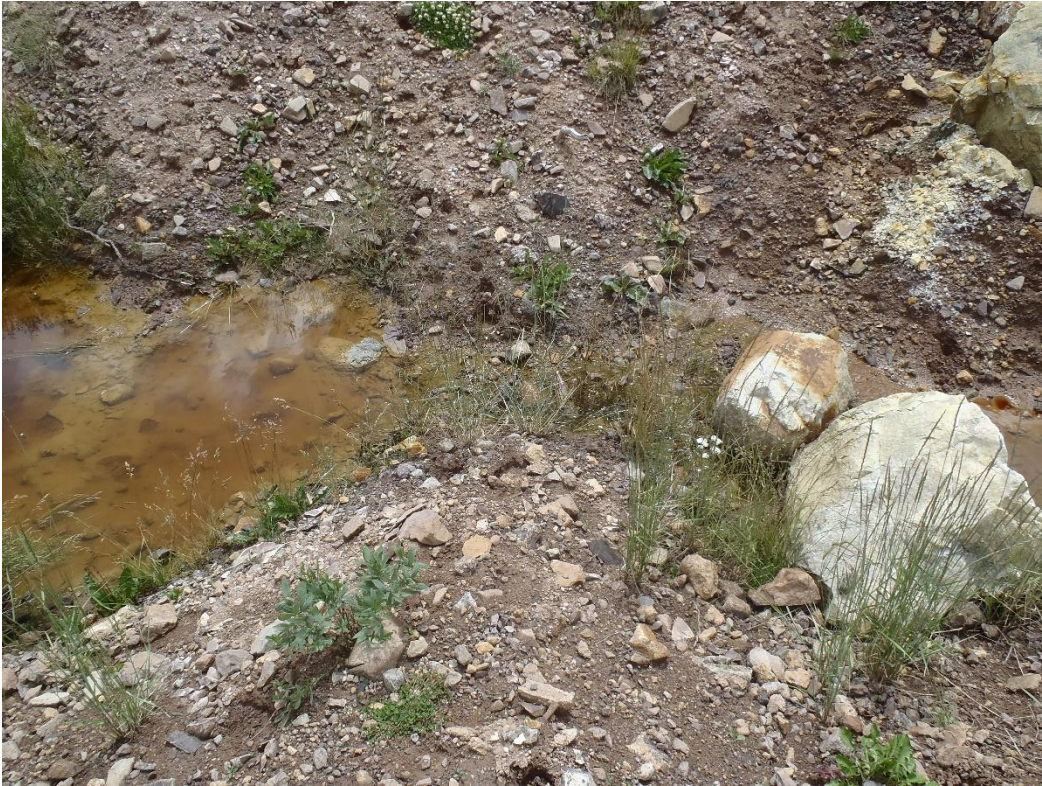
Photo 13. Pooled ECOSA seep water overflow outlet.

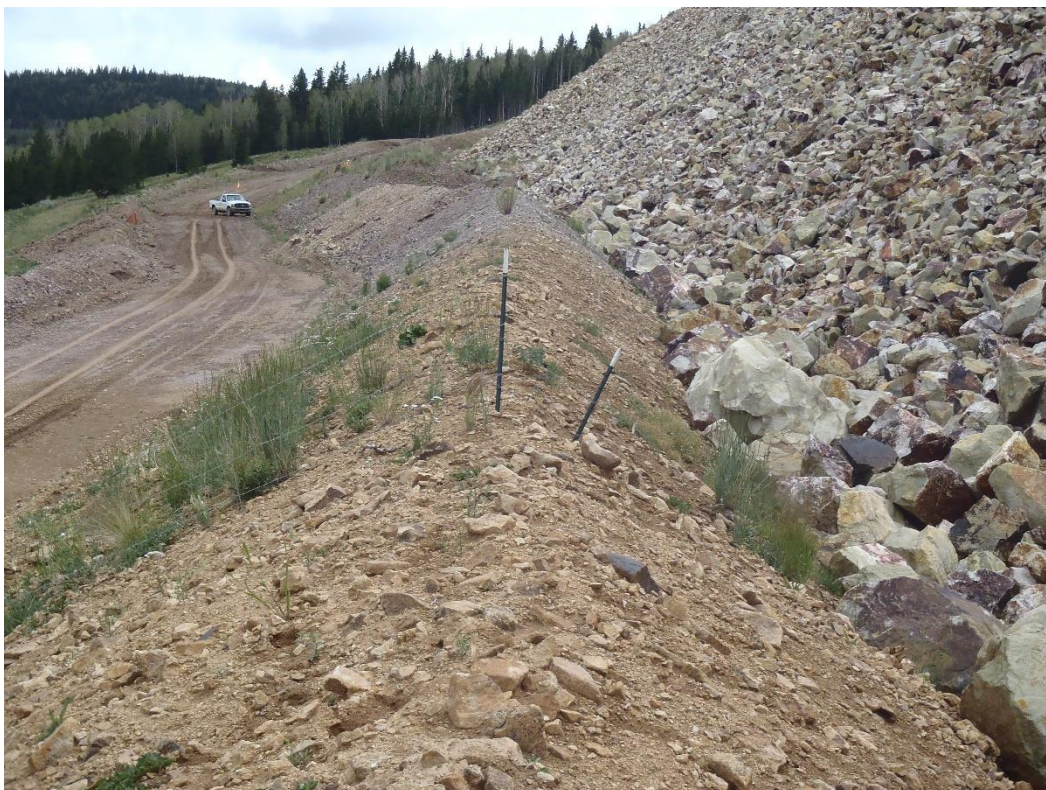
Photo 14. Toe berm ditch (looking SW, truck is near ECOSA seep pool).

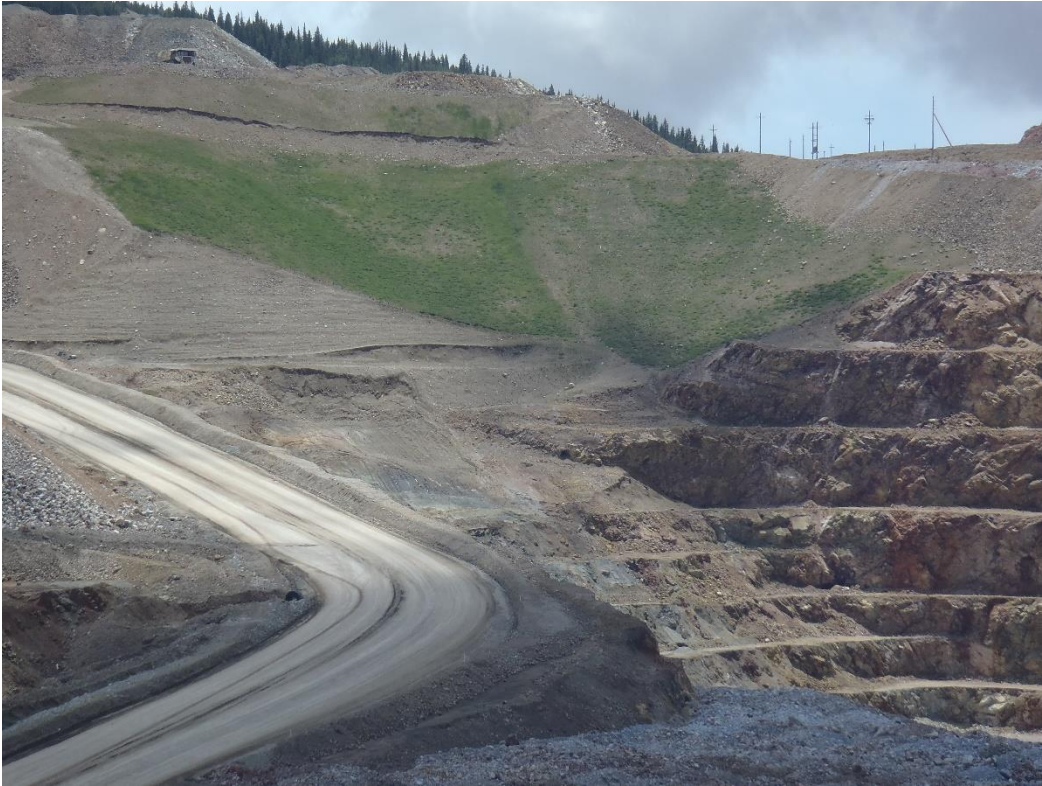
WHEX (Zoon area) and Altman backfill: During a review of Google Earth images of the site, the Division noted significant rill and gulley erosion on the reclaimed area on the south end of the WHEX pit, known to site personnel as the Zoon area. The purpose of inspecting the Zoon area and the Altman Backfill reclamation area was to assess these areas in terms of erosional stability. The Zoon area accessibility was limited for safety reasons as the toe of the area is at the crest of the WHEX highwall (**Photo 15**). It is a steep slope and from the uphill perspective, no erosion features could be seen (**Photo 16**).

Photo 15. Zoon reclamation area (looking SW from WHEX pit).

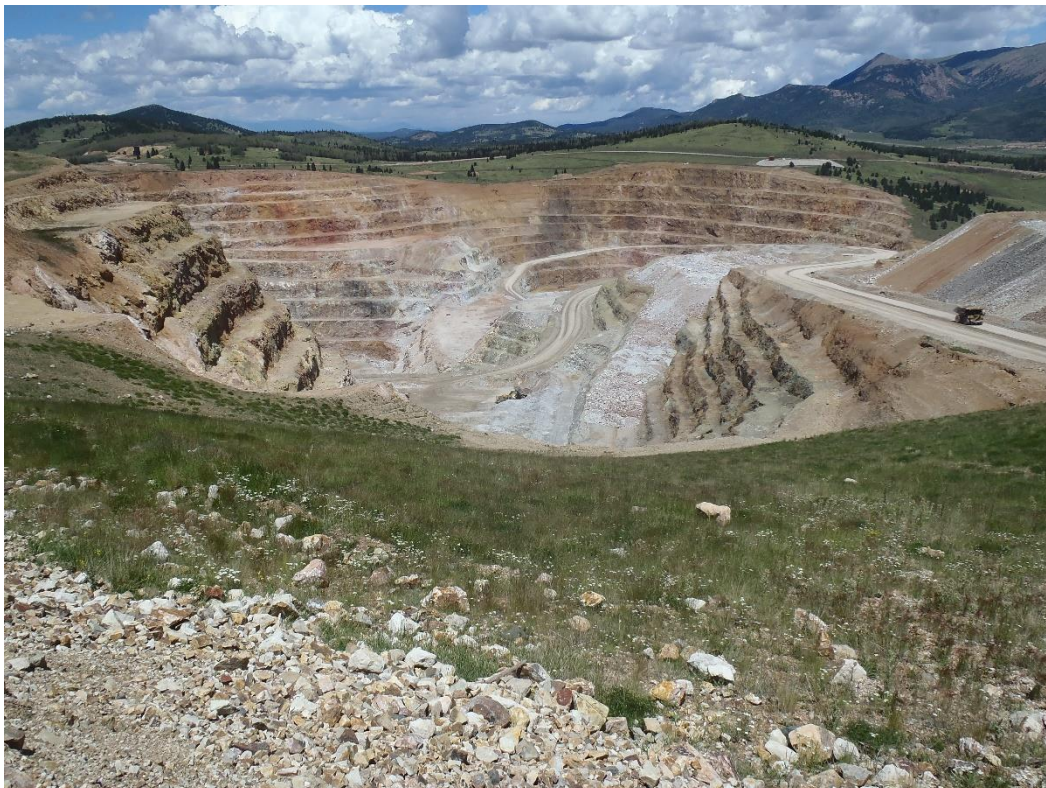
Photo 16. Zoon reclamation area (looking NE from above WHEX pit).

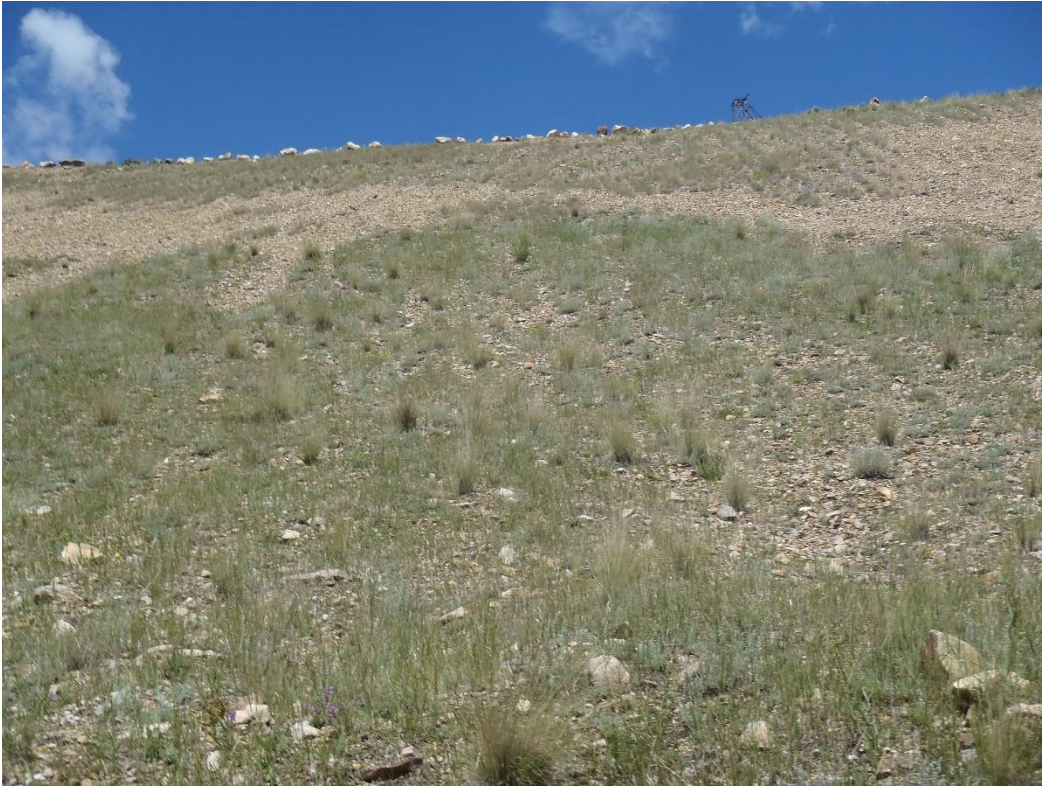
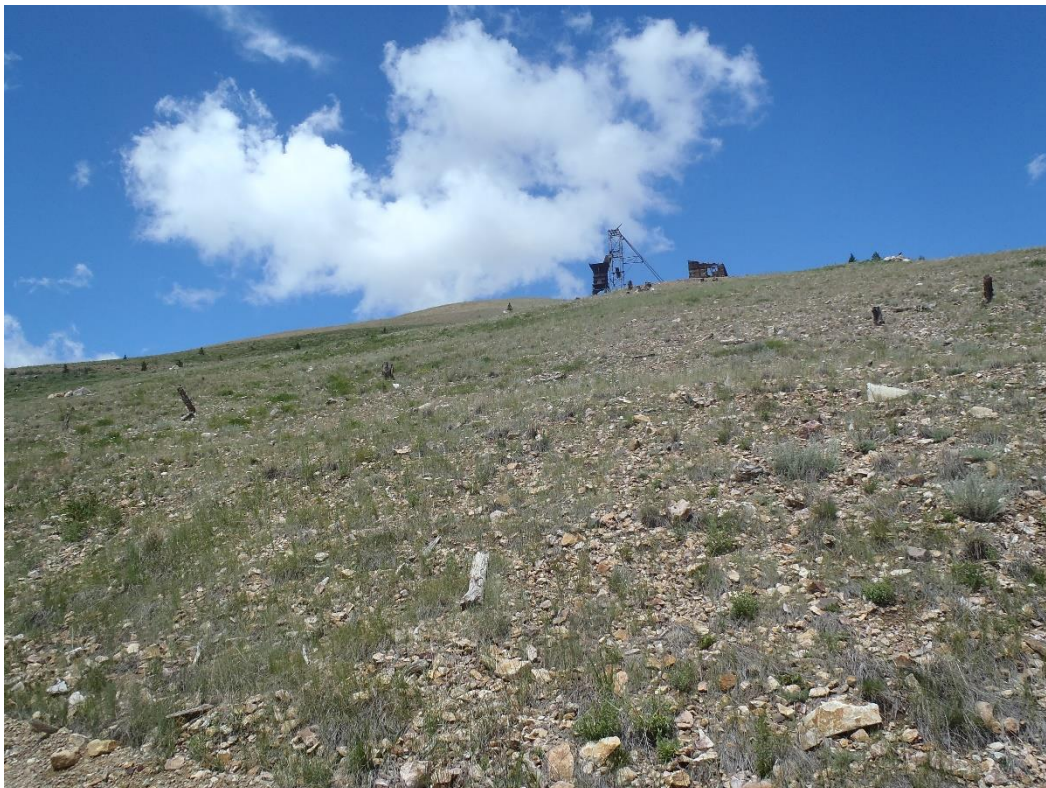
The inspection of the Altman backfill area indicated no significant evidence of erosion (**Photos 17 and 18**). The Division will continue to monitor this and other reclamation areas.

Photo 17. Altman backfill reclamation (1 of 2).

Photo 18. Altman backfill reclamation (2 of 2).
