***RE: Cole Gravel Pit, Permit No. M-2004-020, Unresolved Problem(s) Noted in a Past Inspection Report***

**MINERALS PROGRAM INSPECTION REPORT****PHONE: (303) 866-3567**

<b>MINE NAME:</b> Cole Gravel Pit	<b>MINE/PROSPECTING ID#:</b> M-2004-020	<b>MINERAL:</b> Sand and gravel	<b>COUNTY:</b> Mesa
<b>INSPECTION TYPE:</b> Monitoring	<b>INSPECTOR(S):</b> Stephanie J. Mitchell	<b>INSP. DATE:</b> April 19, 2017	<b>INSP. TIME:</b> 13:00
<b>OPERATOR:</b> M.A. Concrete Construction, Inc.	<b>OPERATOR REPRESENTATIVE:</b> Martin Azcarraga	<b>TYPE OF OPERATION:</b> 112c - Construction Regular Operation

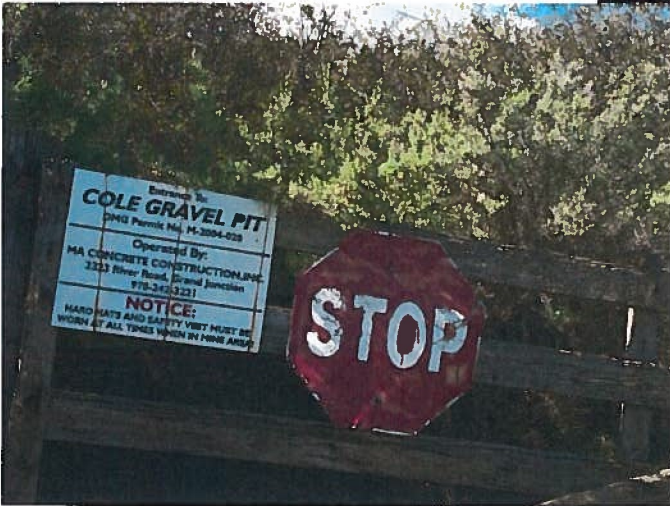
The Mine Identification sign was at the entrance to the mine site in compliance per Rule 3.1.12 (2) and permit boundary markers and fencing were in correct locations.

Mine ID Sign

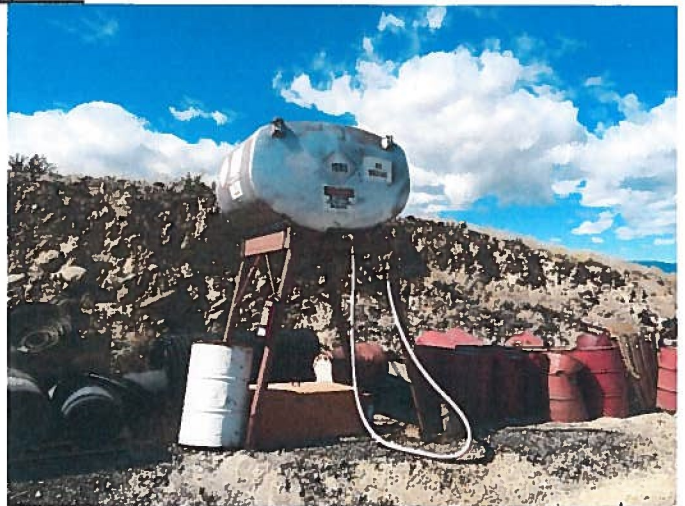
**PROBLEM/POSSIBLE VIOLATION:** Problem: Improper storage and containment of fuels and/or other hazardous materials was present on site.

**There are two fuel tanks on site. One tank is double walled with adequate secondary containment. The second fuel tank needs to be protected by secondary containment. This is noted as a problem at the beginning of this inspection report.**

Fuel Storage with no secondary containment- PROBLEM

**CORRECTIVE ACTIONS:** All storage tanks, petroleum and any hazardous materials on site for any period of time shall have appropriate secondary containment. The site will also have to comply with all applicable SPCC requirements. Please supply photo documentation that any fuel or hazardous materials containers are stored properly - including applicable secondary containment structures by the corrective action date. Note that secondary containment structures shall consist of an impermeable containment which could contain all contents of the tanks and various containers (when full) plus 10% of the total capacity. The operator may also provide photo documentation that all containers have been removed from the site on or before the corrective action date.

requirements. Please supply photo documentation that any fuel or hazardous materials containers are stored properly - including applicable secondary containment structures by the corrective action date. Note that secondary containment structures shall consist of an impermeable containment which could contain all contents of the tanks and various containers (when full) plus 10% of the total capacity. The operator may also provide photo documentation that all containers have been removed from the site on or before the corrective action date.

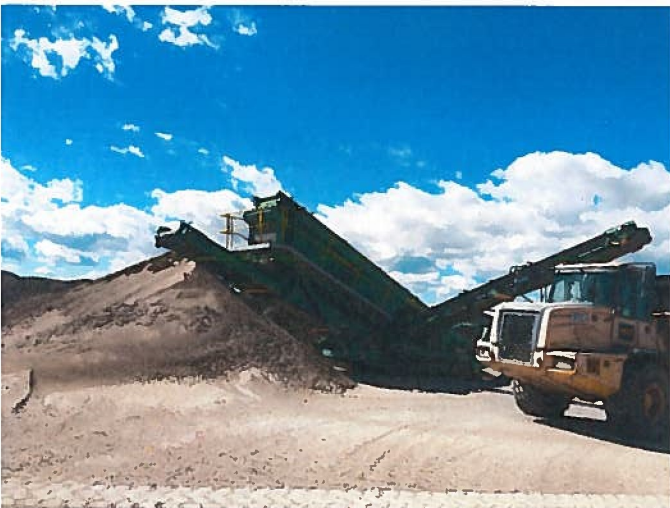
Crushing/ Screen Op

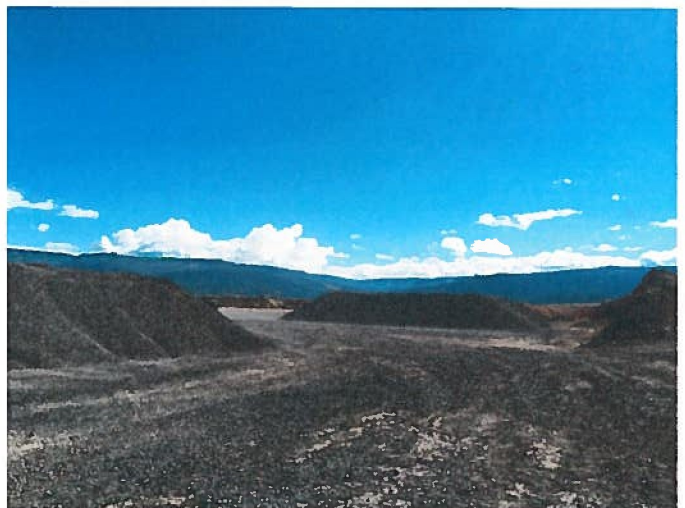
Material Stockpiles

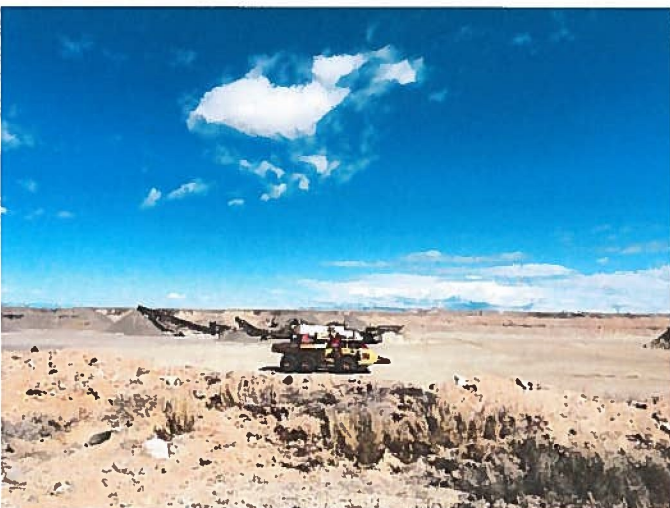
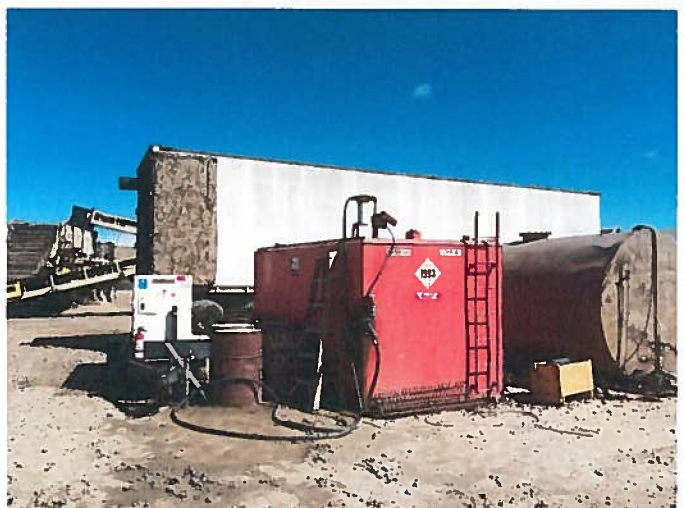
Fuel Storage- Double walled
