**MINERALS PROGRAM INSPECTION REPORT**  
**PHONE: (303) 866-3567**

<b>MINE NAME:</b> Climax Mine	<b>MINE/PROSPECTING ID#:</b> M-1977-493	<b>MINERAL:</b> Molybdenum	<b>COUNTY:</b> Summit
<b>INSPECTION TYPE:</b> Monitoring	<b>INSPECTOR(S):</b> Dustin M. Czaplá	<b>INSP. DATE:</b> February 7, 2018	<b>INSP. TIME:</b> 09:00
<b>OPERATOR:</b> Climax Molybdenum Company	<b>OPERATOR REPRESENTATIVE:</b> Ray Lazuk	<b>TYPE OF OPERATION:</b> 112d-3 - Designated Mining Operation	
<b>REASON FOR INSPECTION:</b> Normal I&E Program	<b>BOND CALCULATION TYPE:</b> None	<b>BOND AMOUNT:</b> \$78,246,088.00	
<b>DATE OF COMPLAINT:</b> NA	<b>POST INSP. CONTACTS:</b> None	<b>JOINT INSP. AGENCY:</b> None	
<b>WEATHER:</b> Clear	<b>INSPECTOR'S SIGNATURE:</b>

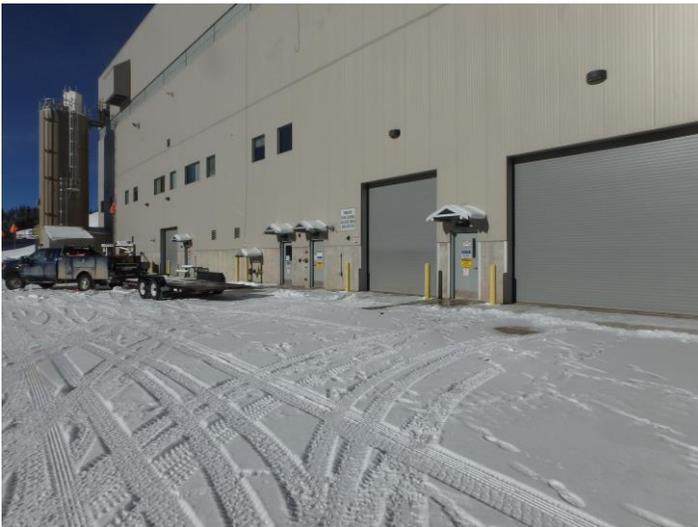
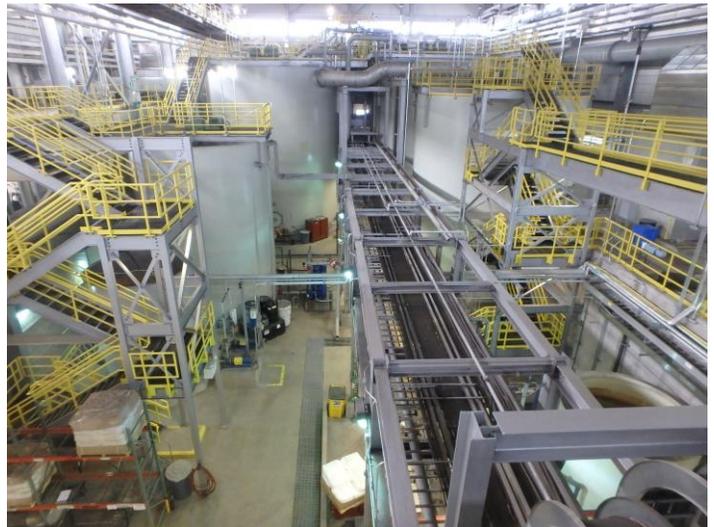
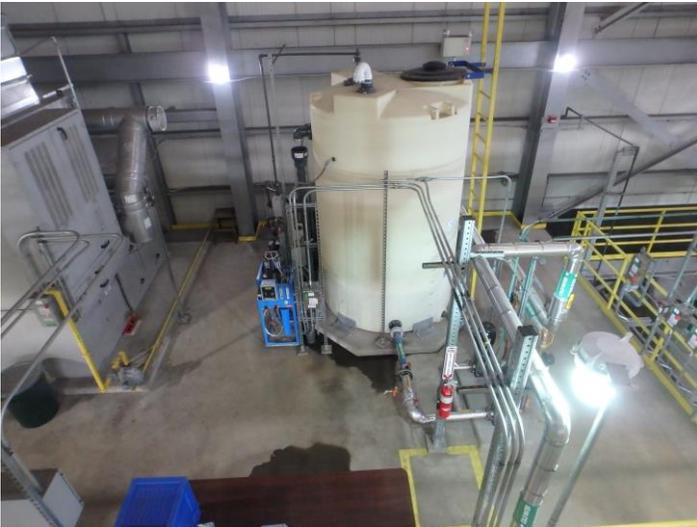
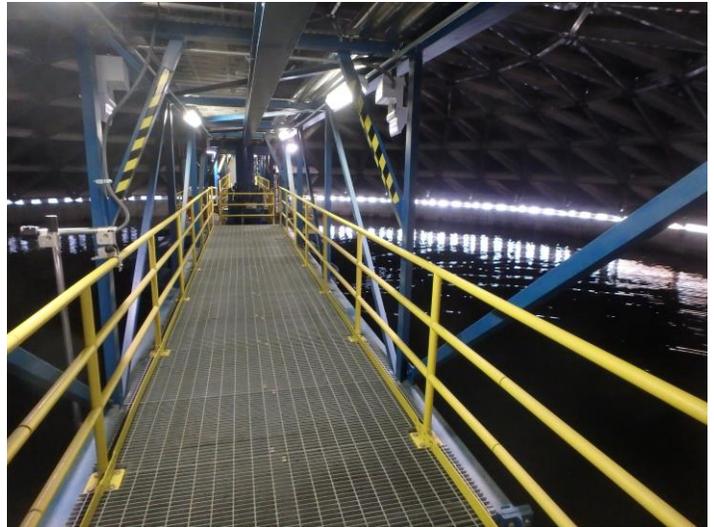
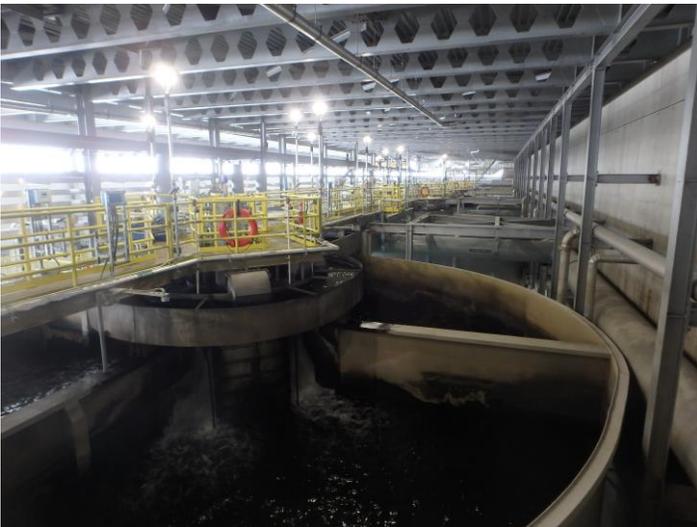
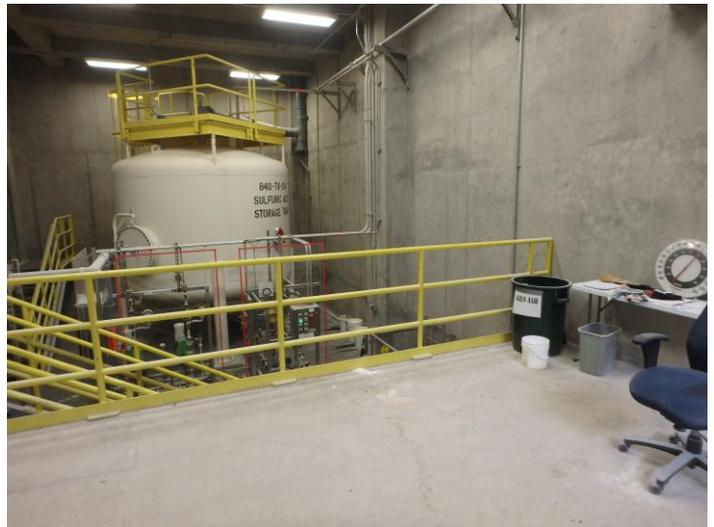
### **Property Discharge Water Treatment Plant (PDWTP)**

The PDWTP is located below 5 Dam and is intended to remove second stage metals, such as manganese, iron, copper and zinc, prior to discharging excess water into Tenmile Creek. It provides final treatment before affected water leaves the property. The plant has been constructed with adequate secondary containment, in the form of concrete sumps, to contain spills that could occur within the plant. There is an "Events Pond", constructed of concrete, downstream to the west of the PDWTP. The "Events Pond" is constructed with a five million gallon capacity intended to temporarily store any water not meeting discharge requirements. Any water reaching the "Events Pond" can be recycled back to the head of the PDWTP. The "Events Pond" was empty during this inspection. Operation of the PDWTP is automated, but also manned around the clock. Emergency generators are in place in case of power outages. Reagents utilized in the PDWTP include lime, flocculant and sulfuric acid. All chemicals and reagents observed in the PDWTP area were properly stored with adequate secondary containment protections. Containers were clearly labeled. The sulfuric acid is stored in an isolated room in a phenolic lined carbon steel tank, located within an epoxy coated concrete containment area, which is isolated from the rest of the plants containment area. The sulfuric acid truck unloading area has adequate secondary containment in the form of a concrete sump. The facility appears very well kept and maintained.

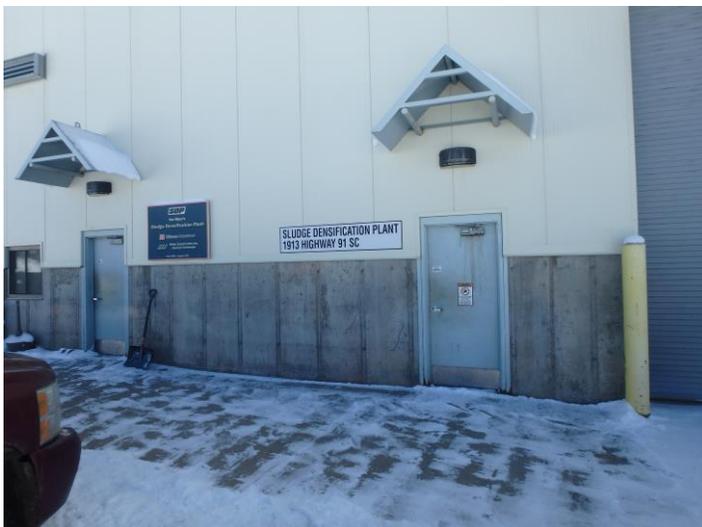
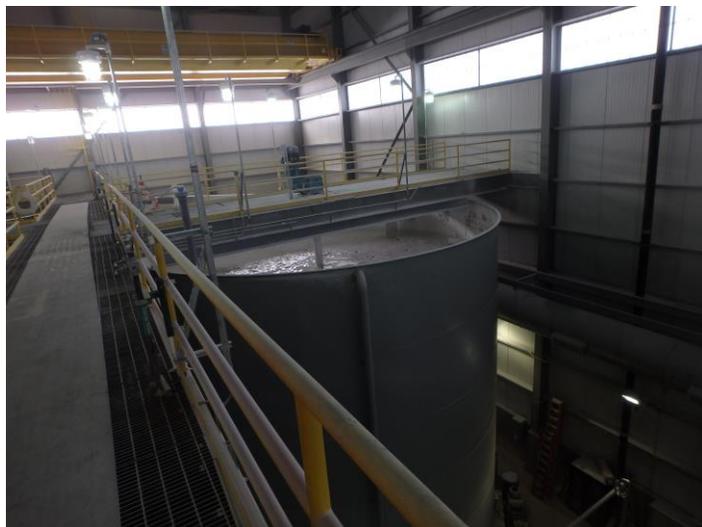
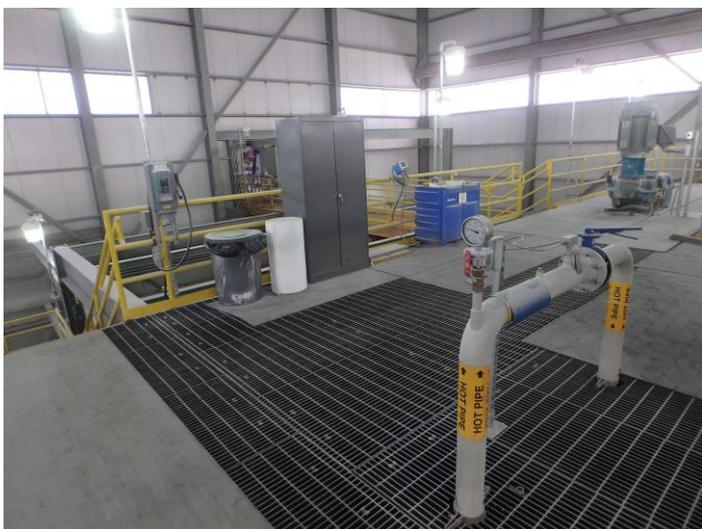
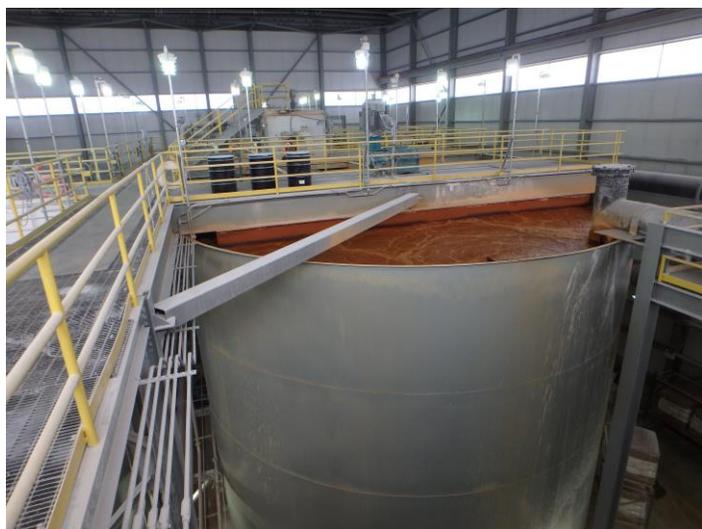
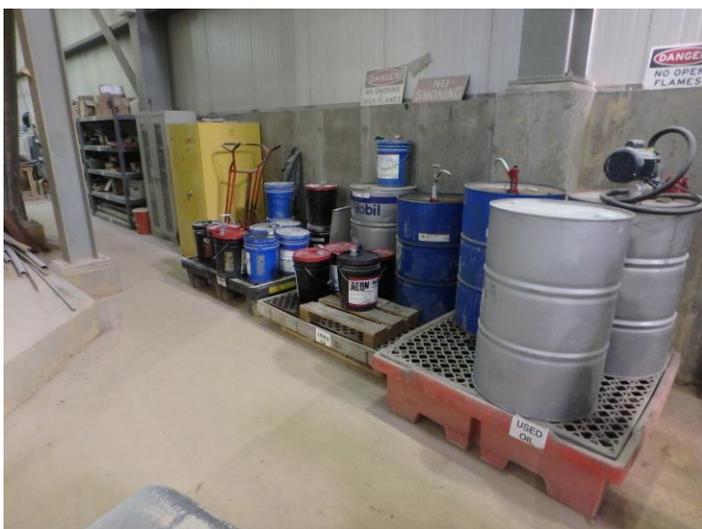
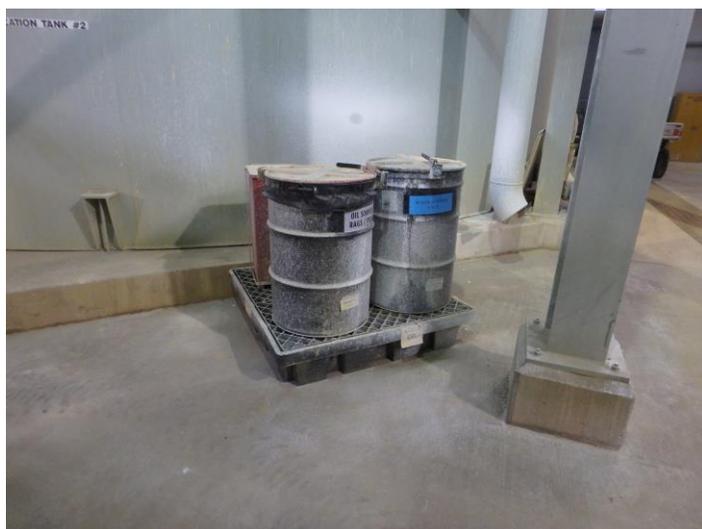
### **Sludge Densification Plant (SDP)**

The SDP is located on the east side of Tenmile Pond. The SDP uses a similar process as the PDWTP to treat water and create sludge for deposit in tailings storage facilities. The plant has been constructed with adequate secondary containment, in the form of concrete sumps, to contain spills that could occur within the plant. Operation of the SDP is automated and emergency generators are in place in case of power outages. Reagents utilized in the SDP include lime and flocculant. All chemicals and reagents observed in the SDP area were properly stored with adequate secondary containment protections. Containers were clearly labeled. The SDP provides first stage treatment for a significant portion of the mines affected waters. When possible, water is recycled through Robinson Lake for use in the mill facility. The facility appears very well kept and maintained.

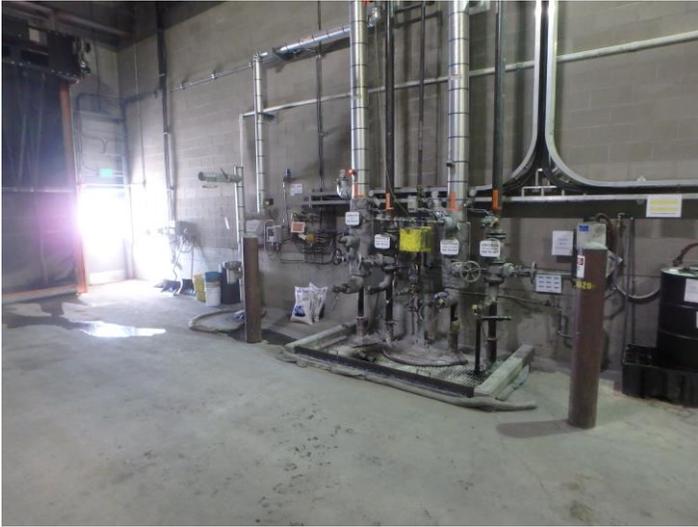
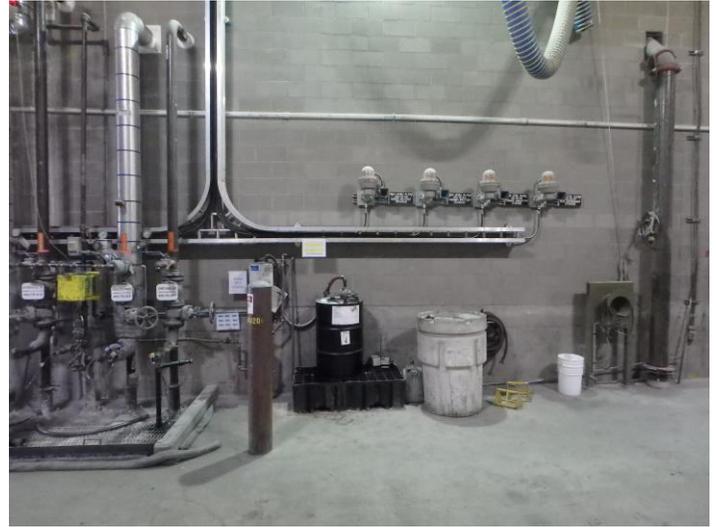
### **Mill Reagent Transfer Area**

The reagent transfer area at the mill facility was inspected. The area is constructed with concrete sump to contain spills. All piping is clearly labeled and appeared to be in good working order. Spill kits are located in the area. Alarms systems are incorporated into the plumbing to alert of problems with the system. The area appears very well kept and maintained.
