MINERALS PROGRAM INSPECTION REPORT
PHONE: (303) 866-3567

MINE NAME: Horvath Pit No 1	MINE/PROSPECTING ID#: M-1977-546	MINERAL: Sand and gravel	COUNTY: La Plata
INSPECTION TYPE: Monitoring	INSPECTOR(S): Lucas J. West	INSP. DATE: February 5, 2018	INSP. TIME: 13:00
OPERATOR: Brice F Lee & Phyllis J Lee	OPERATOR REPRESENTATIVE: Brice Lee	TYPE OF OPERATION: 110c - Construction Limited Impact	
REASON FOR INSPECTION: Normal I&E Program	BOND CALCULATION TYPE: Complete Bond	BOND AMOUNT: \$1,376.00	
DATE OF COMPLAINT: NA	POST INSP. CONTACTS: None	JOINT INSP. AGENCY: None	
WEATHER: Clear	INSPECTOR'S SIGNATURE:

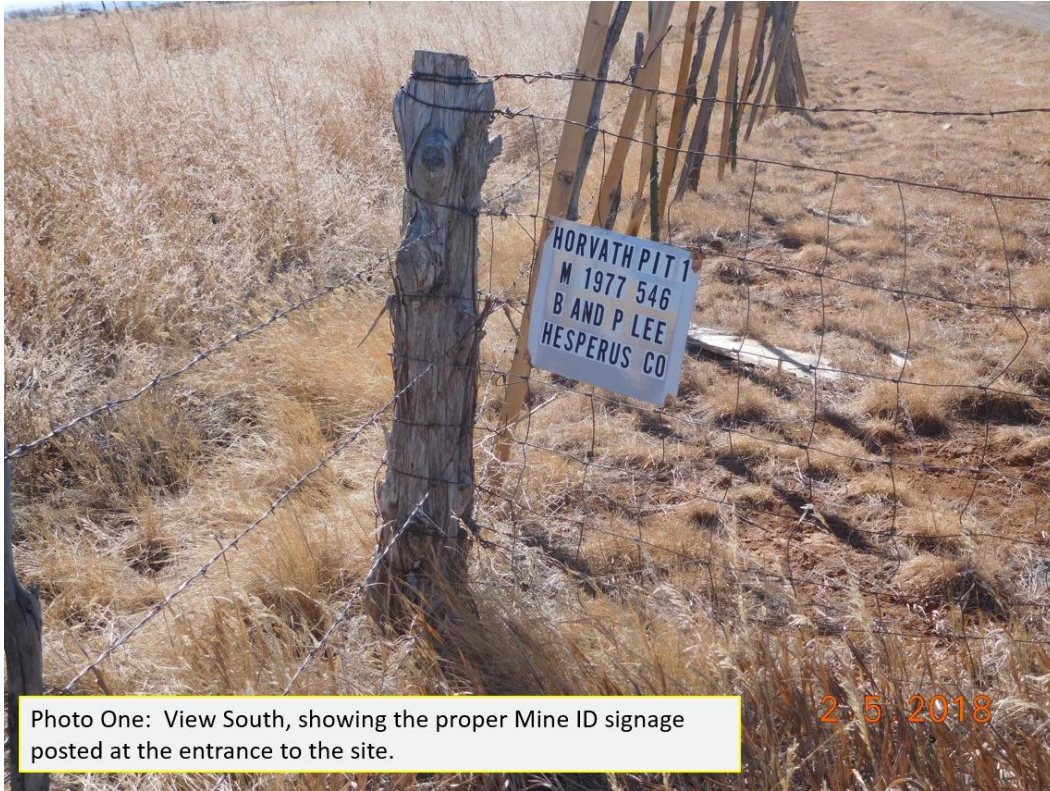
The proper mine identification sign was posted at the entrance to the site as seen in Photo One. The site was not active during the day of the inspection and no mining related equipment was observed on site. Along with the inspector listed on page one of this report, Brice Lee, the Operator for the site was present during the inspection. The site has been fully reclaimed in accordance with the approved reclamation plan and minimal evidence of mining activity remain. Though the site is fully reclaimed, the Operator expressed the desire to retain the permit for potential future use. Three small stockpiles remain on site. An example of the stockpiles can be seen in Photo Two. The Operator periodically hauls a small amount of material from the site to maintain the roads located on his property. The mining area has been graded to a near flat configuration to match the adjacent undisturbed lands. So signs of settling or slumping was observed in the graded area. The entire area has been revegetated, however the vegetation is sparse. This is not uncommon however given the sparse vegetation of the surrounding undisturbed areas and is not considered a problem at this time. The reclaimed area can be seen in Photos Three and Four.

Photo One: View South, showing the proper Mine ID signage posted at the entrance to the site.

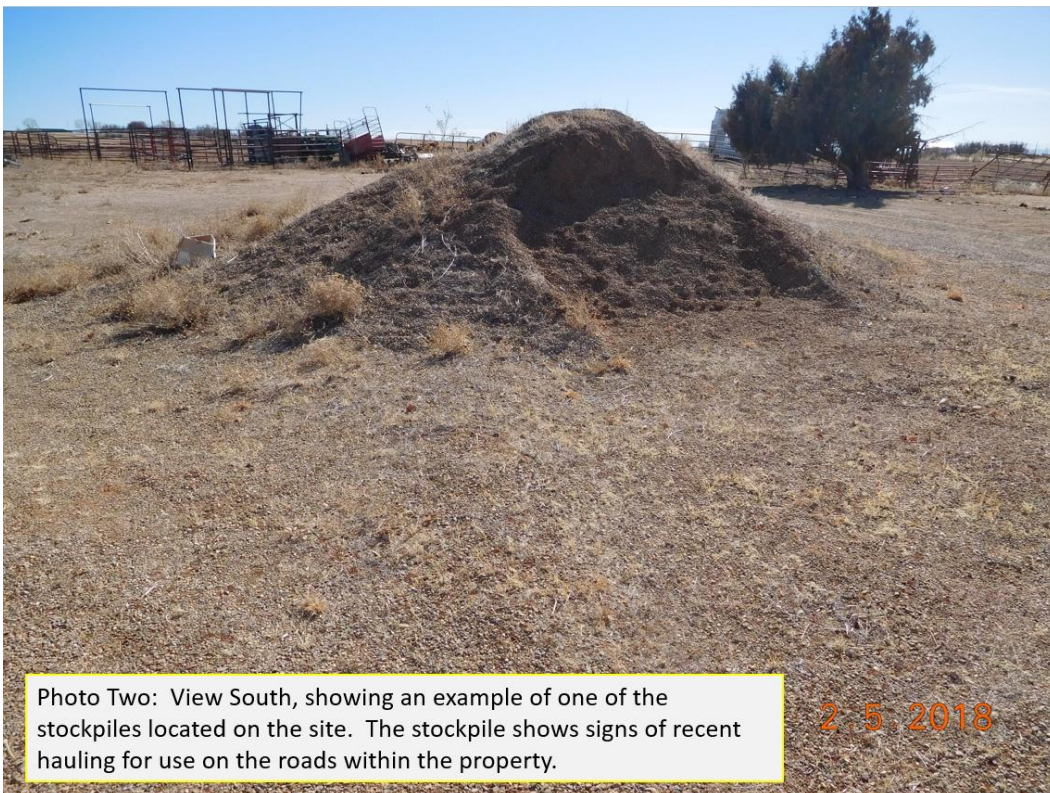
Photo Two: View South, showing an example of one of the stockpiles located on the site. The stockpile shows signs of recent hauling for use on the roads within the property.
