**MINERALS PROGRAM INSPECTION REPORT**  
**PHONE: (303) 866-3567**

| <b>MINE NAME:</b><br>Hess Pit | <b>MINE/PROSPECTING ID#:</b><br>M-1986-033 | <b>MINERAL:</b><br>Sand and gravel | <b>COUNTY:</b><br>La Plata |
| <b>INSPECTION TYPE:</b><br>Monitoring | <b>INSPECTOR(S):</b><br>Lucas J. West | <b>INSP. DATE:</b><br>February 5, 2018 | <b>INSP. TIME:</b><br>14:00 |

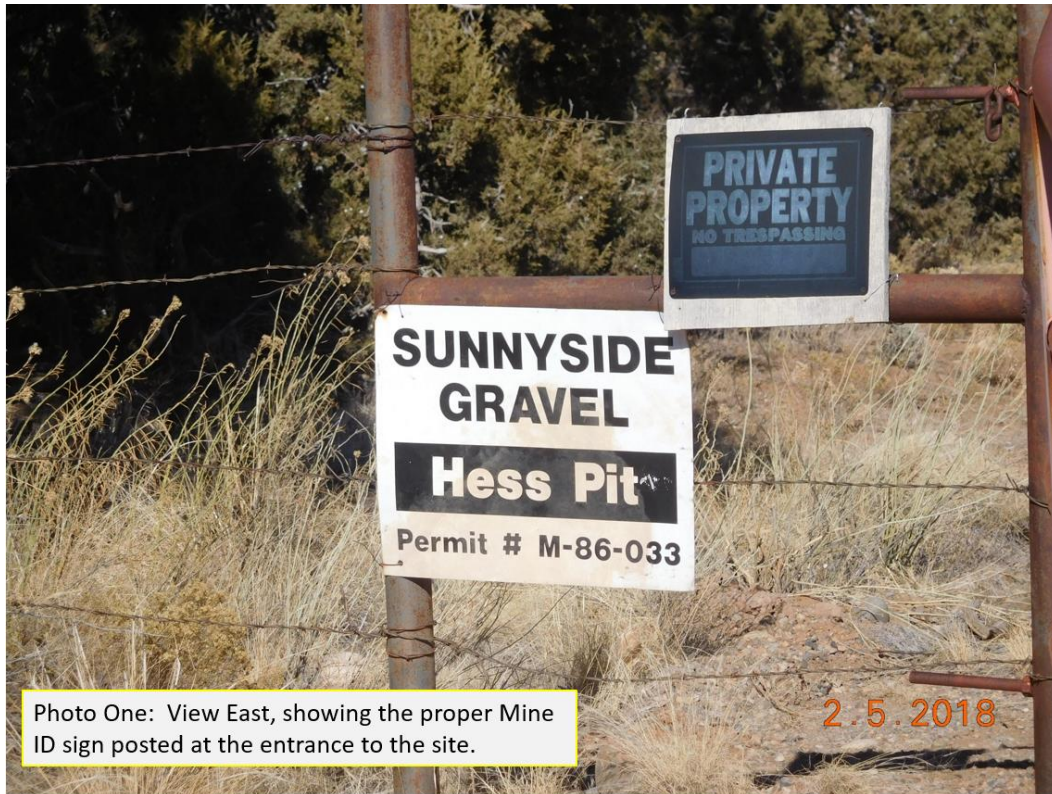
The proper Mine Identification Sign was posted at the entrance to the site as seen in Photo One, and the permit boundaries were also clearly identified. The site was not active during the inspection and no mining related equipment was on site. The active mining area is located in the southern extent of the site and consists of a small highwall with varying slopes. The highwall can be seen in Photo Two, appears to be stable and in good condition. It is being mined in various stages of a 1H:1V and 2H:1V configurations. The base of the highwall is accessed by a ranch road that extends along the edge of the permitted area. Small stockpiles of material are located at the base of the highwall. The stockpiles are small, appear to be stable and in good condition.

Photo One: View East, showing the proper Mine ID sign posted at the entrance to the site.

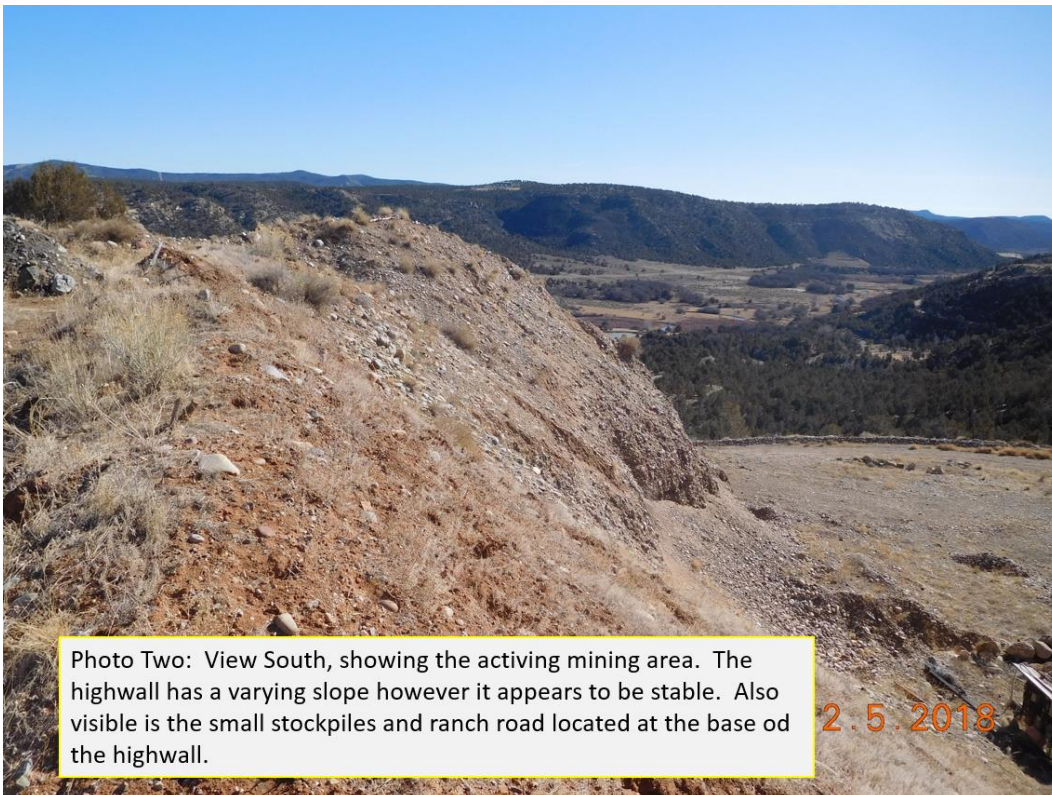
Photo Two: View South, showing the active mining area. The highwall has a varying slope however it appears to be stable. Also visible is the small stockpiles and ranch road located at the base of the highwall.

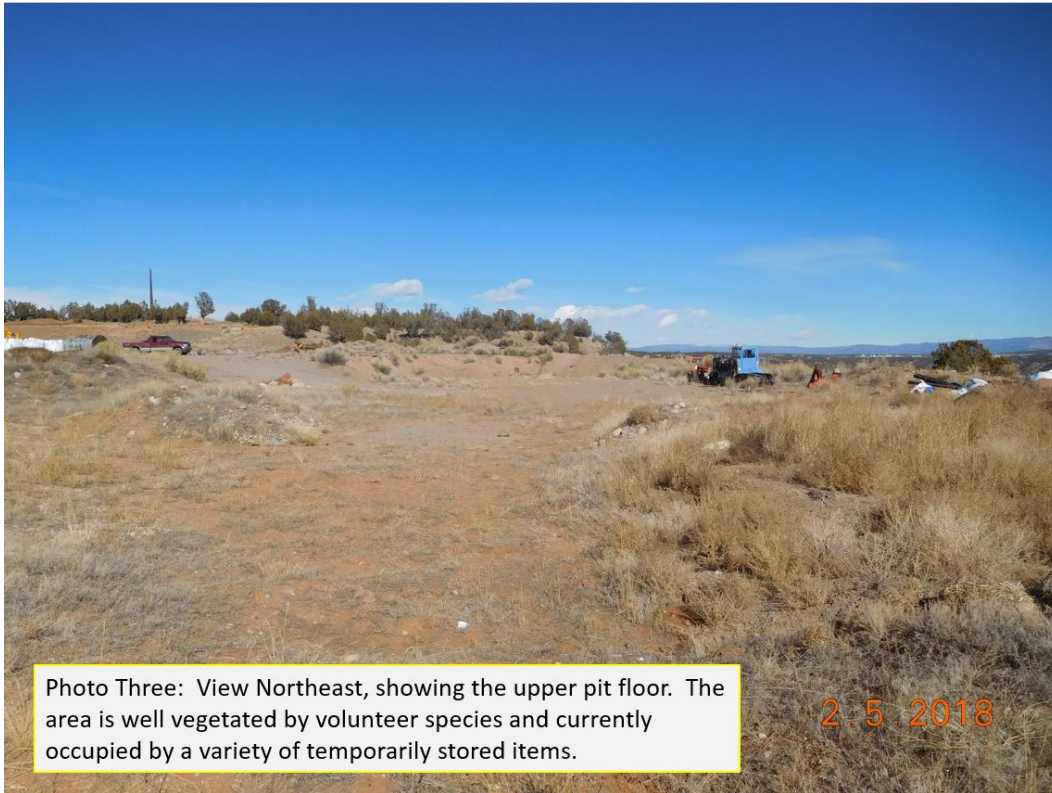
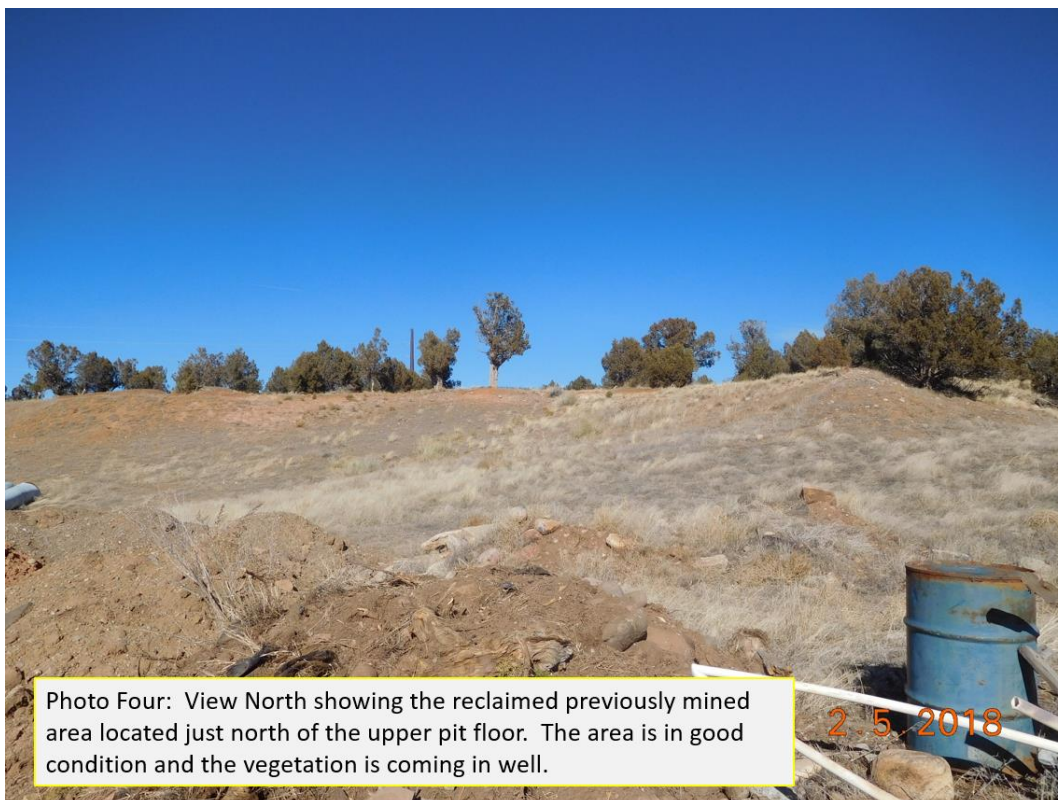
The upper area of the site consists of a large pit floor area, and historically mined upper highwall. The pit floor area can be seen in Photos Three and Four. The area is currently being used to store a variety of construction debris and vegetative slash that has accumulated through the routine maintenance of the ranch. These materials are stored temporarily and discussions with the Operator indicate that the materials are removed annually and either taken to the landfill or recycled when possible. The northern extent of the permitted area consists mainly of a previously mined highwall that has been reclaimed. The reclaimed highwall has been sloped to an approximately #H: 1V configuration and revegetated. The graded areas show no signs of settling slumping or significant erosion. The vegetation is somewhat sparse but is establishing well.
