MINERALS PROGRAM INSPECTION REPORT
PHONE: (303) 866-3567

MINE NAME: Oaklands Ranch	MINE/PROSPECTING ID#: M-1989-092	MINERAL: Gravel	COUNTY: Douglas
INSPECTION TYPE: Monitoring	INSPECTOR(S): Peter S. Hays	INSP. DATE: February 2, 2018	INSP. TIME: 13:00
OPERATOR: Oaklands Ranch	OPERATOR REPRESENTATIVE: David Curtis	TYPE OF OPERATION: 112c - Construction Regular Operation	
REASON FOR INSPECTION: Normal I&E Program	BOND CALCULATION TYPE: Complete Bond	BOND AMOUNT: \$12,000.00	
DATE OF COMPLAINT: NA	POST INSP. CONTACTS: None	JOINT INSP. AGENCY: None	
WEATHER: Clear	INSPECTOR'S SIGNATURE:

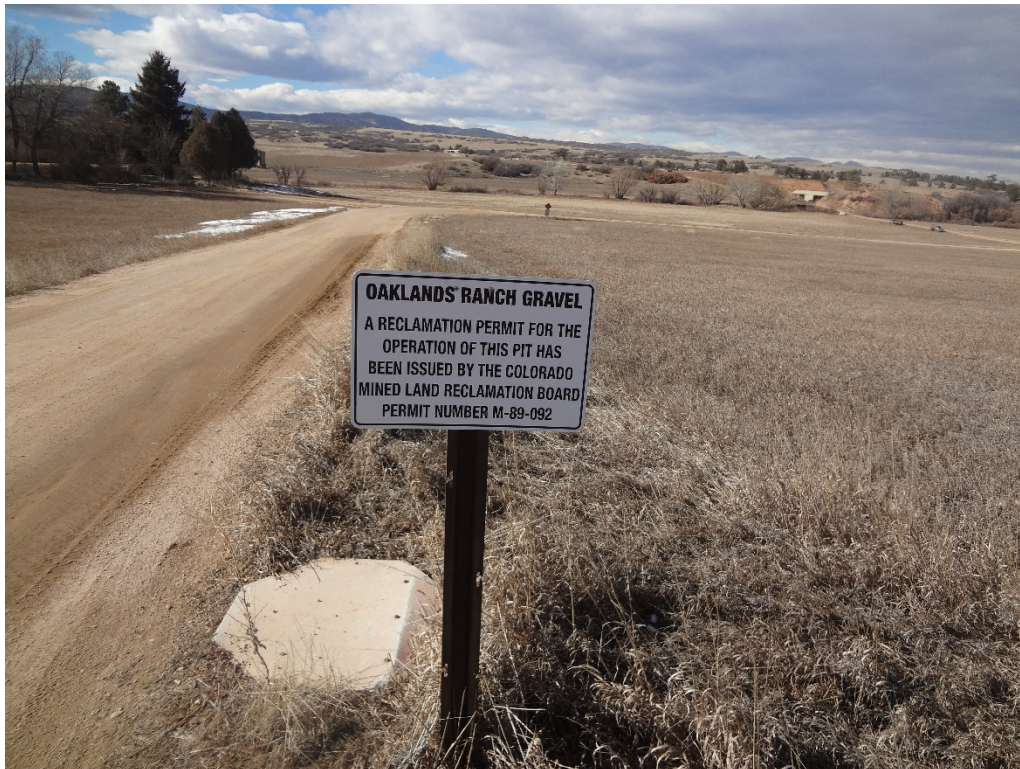
The mine sign and boundary markers were observed as required by Rule 3.1.12. The Division created an inspection map of the current site disturbance using Google Earth Pro after the inspection. Photographs taken during the inspection and the inspection map are attached.

Oaklands Ranch pit mine sign

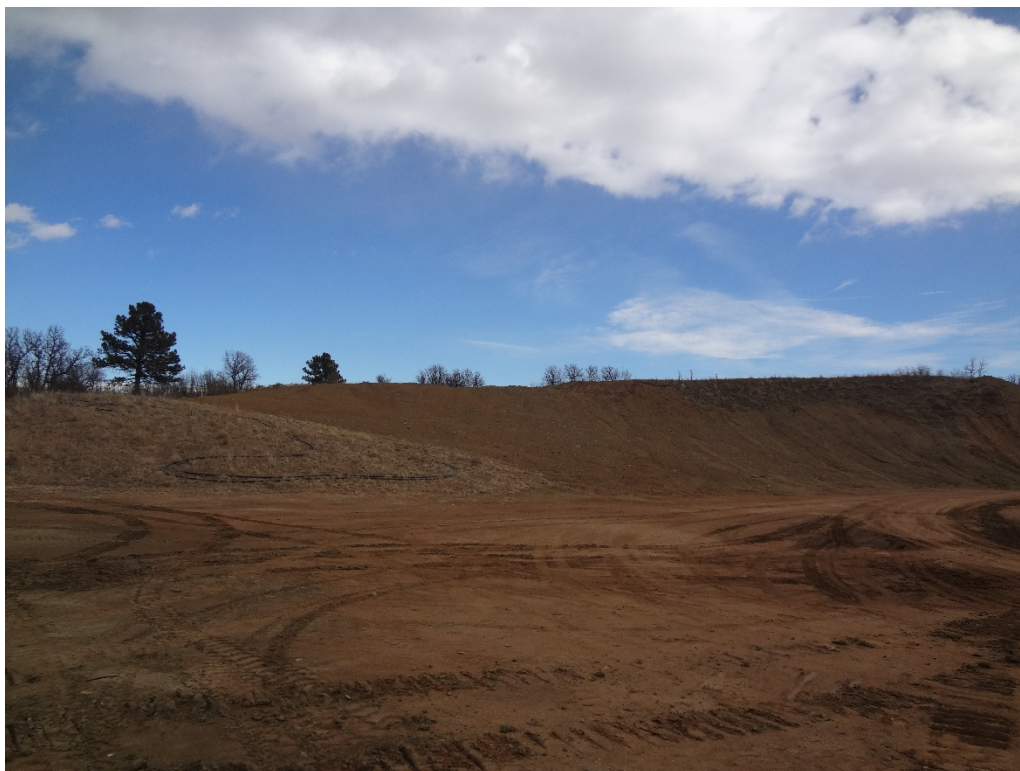
The approved post-mining land use is pastureland. The site is being concurrently reclaimed by the Operator as areas are mined out. The northeast corner of the site has been regraded to a 4H:1V slope, but has not been seeded, an area of the western boundary has been temporarily sloped to a 2H:1V slope and the pit floor excavation has been backfilled with imported inert fill.

View of the regraded slope in the northeast corner of the site

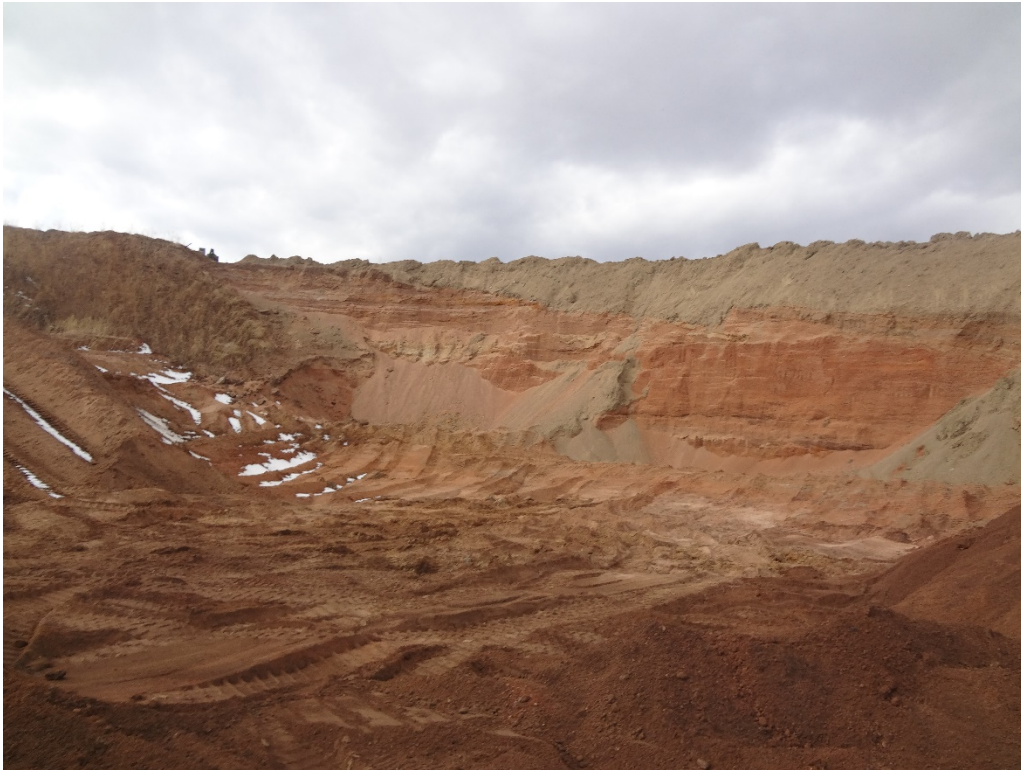
View of the mine highwall in the northwest corner of the site with imported material above the highwall

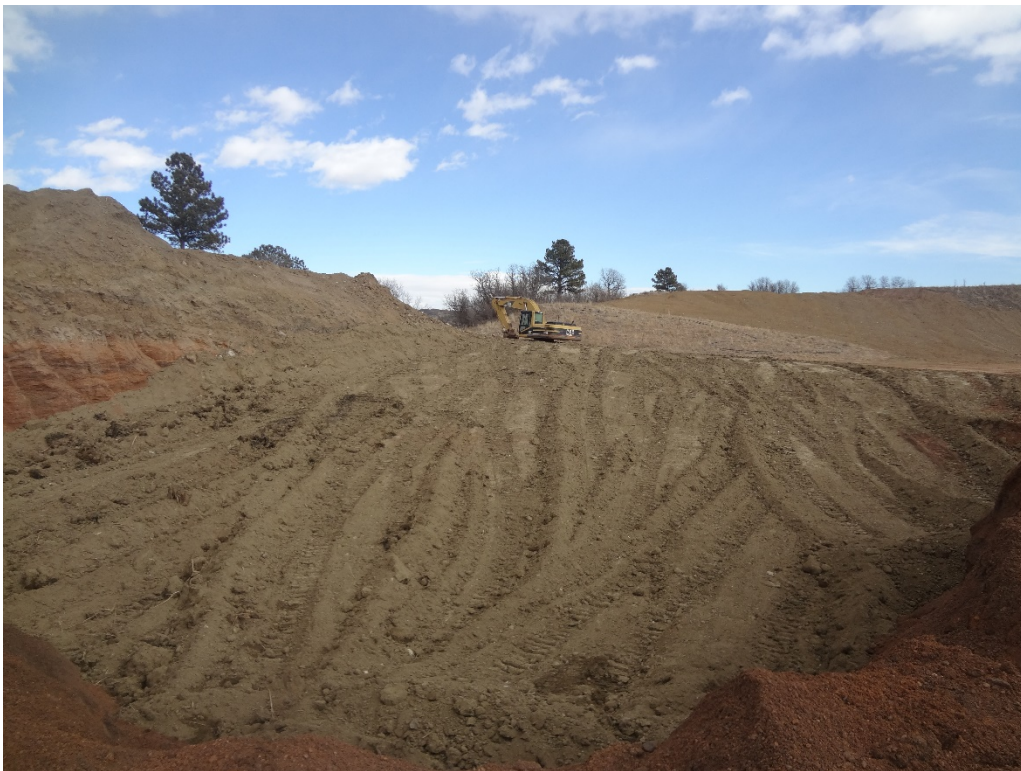
View of the backfilled excavation along the northern boundary of the site

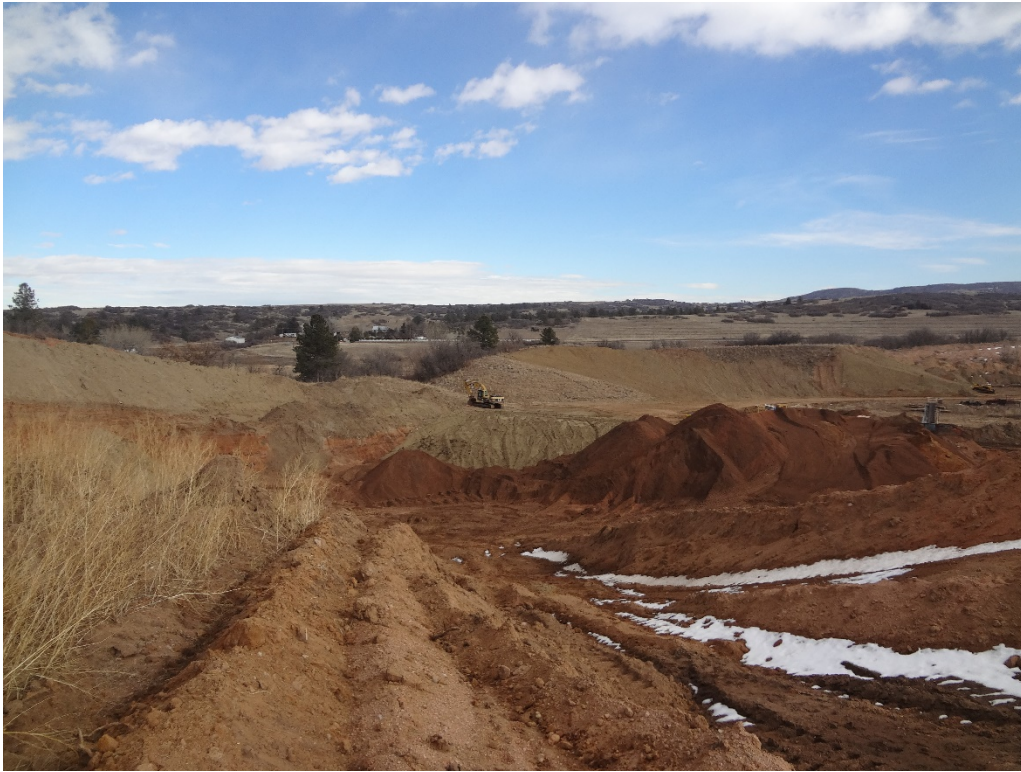
View of the northern portion of the site from the top of access ramp looking east

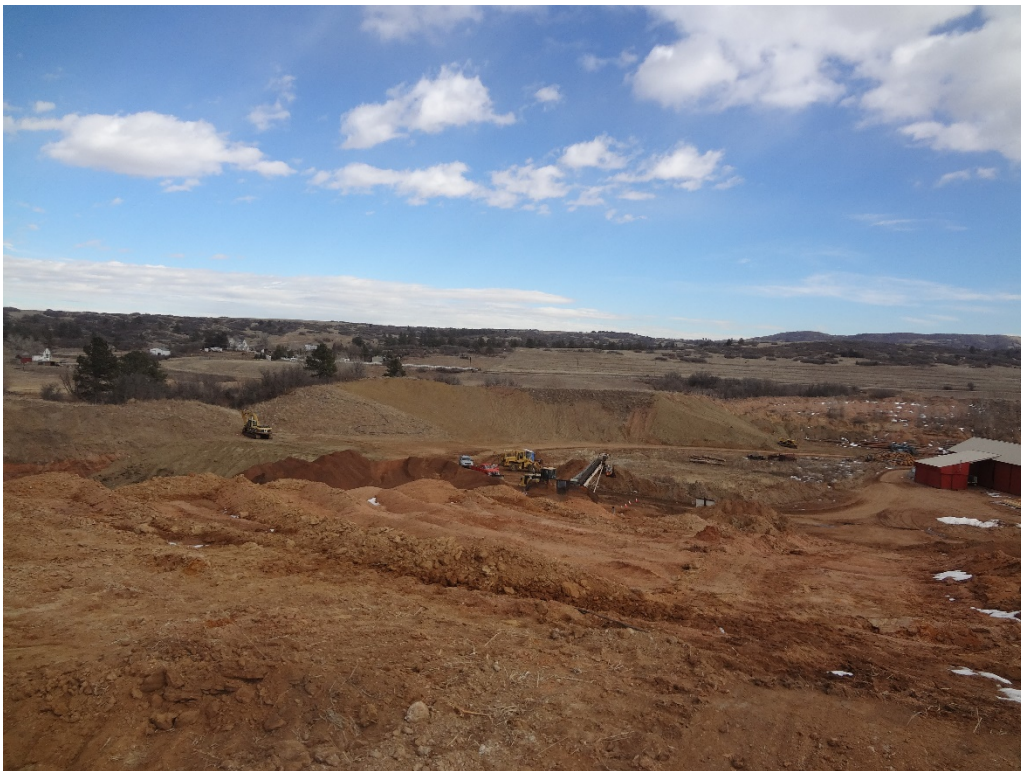
View of the site from the western mining disturbance limit looking northeast

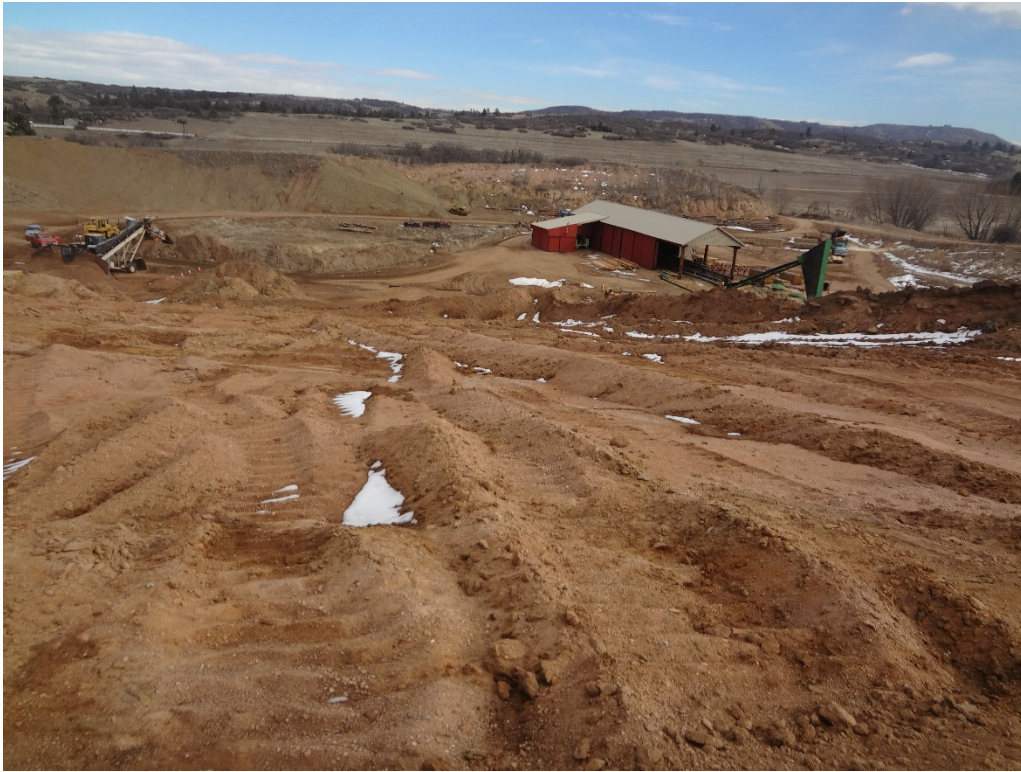
View of the site from the western mining disturbance limit looking east
