MINERALS PROGRAM INSPECTION REPORT
PHONE: (303) 866-3567

MINE NAME: Cresson Project	MINE/PROSPECTING ID#: M-1980-244	MINERAL: Gold	COUNTY: Teller
INSPECTION TYPE: Monitoring	INSPECTOR(S): Timothy A. Cazier	INSP. DATE: October 11, 2017	INSP. TIME: 9:30
OPERATOR: Cripple Creek & Victor Gold Mining Company	OPERATOR REPRESENTATIVE: Jeff Gaul	TYPE OF OPERATION: 112d-3 - Designated Mining Operation	
REASON FOR INSPECTION: Normal I&E Program	BOND CALCULATION TYPE: None	BOND AMOUNT: \$207,991,188.00	
DATE OF COMPLAINT: NA	POST INSP. CONTACTS: None	JOINT INSP. AGENCY: None	
WEATHER: Clear	INSPECTOR'S SIGNATURE:

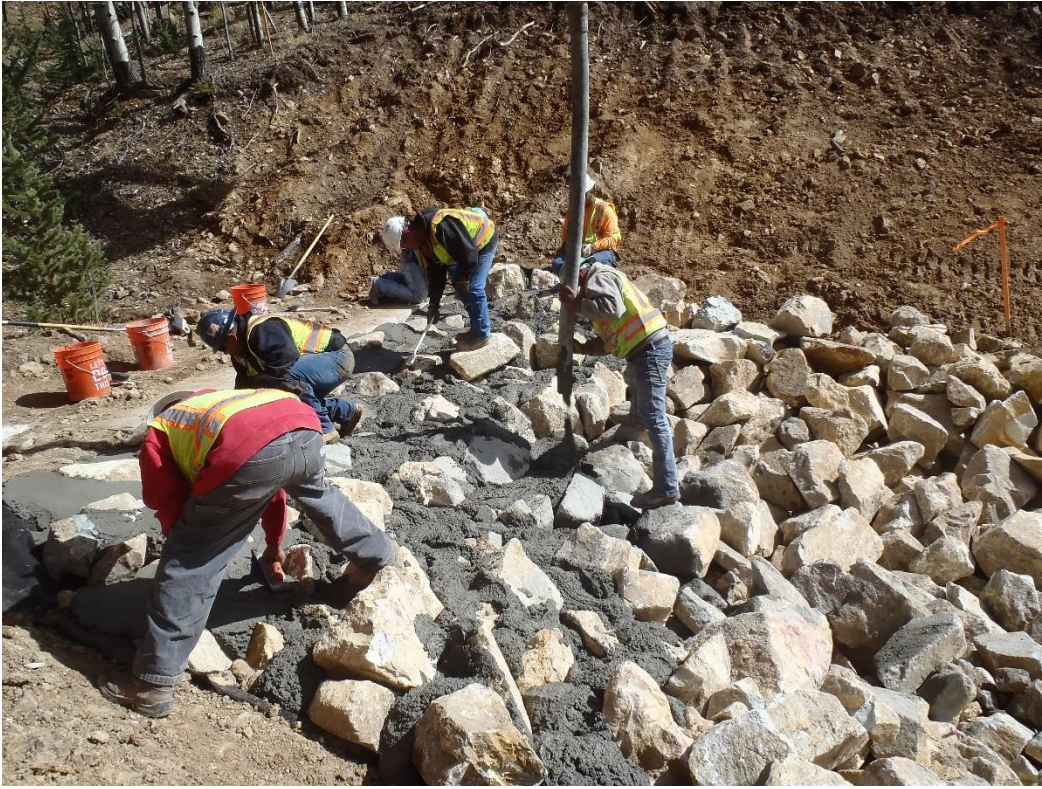
Poverty Gulch Diversion Channel: The development of the Globe Hill Pit is planned to encroach slightly into Poverty Gulch. As such, a diversion channel is required (reference TR-86) to direct normal flows in Poverty Gulch around the encroachment and back into the lower segment of Poverty Gulch and on to Cripple Creek. The upper ~15-foot segment of this diversion is relatively steep requiring the addition of grout to help stabilize the riprap armoring this portion of the channel. The primary purpose of this inspection was to observe the installation of the grout in this segment of the diversion channel. The grout crew appeared to do an adequate job of working the grout into the lower voids of the previously placed riprap (**See Photo 1**) and leaving the upper portions of the riprap exposed (**See Photo 2**) to enhance the roughness of the channel for energy dissipation.

Photo 1. Crew working grout into lower voids.

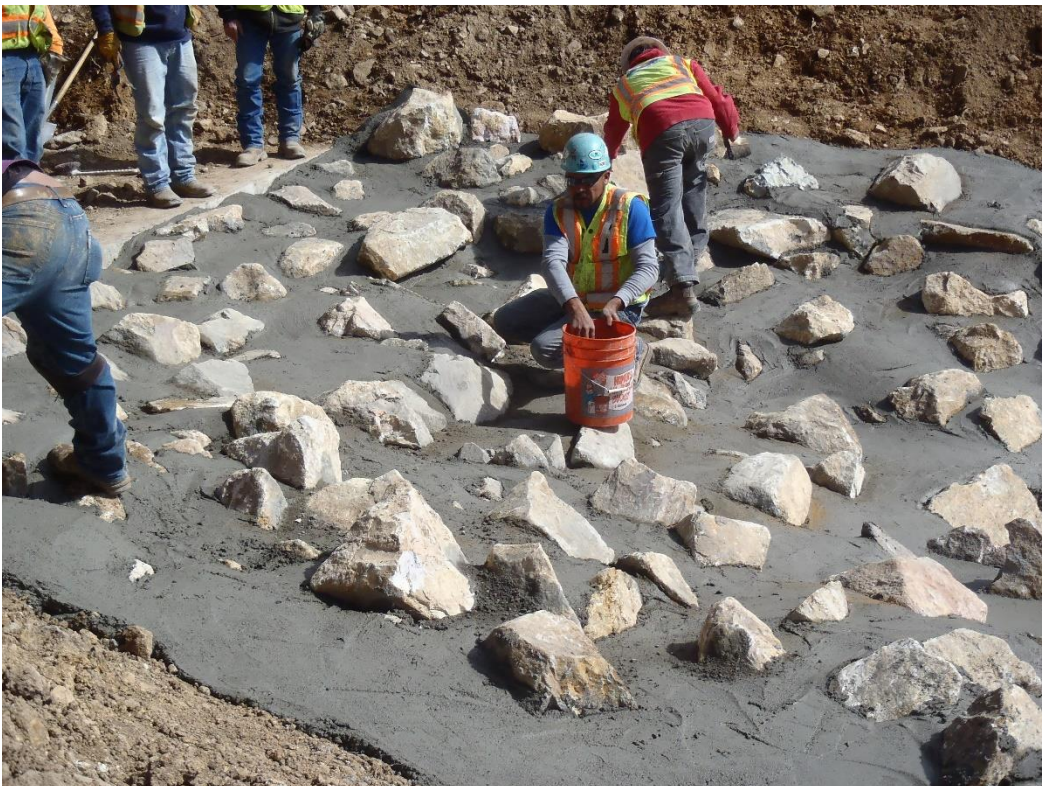
Photo 2. Finished grout, leaving upper portions of rock exposed.

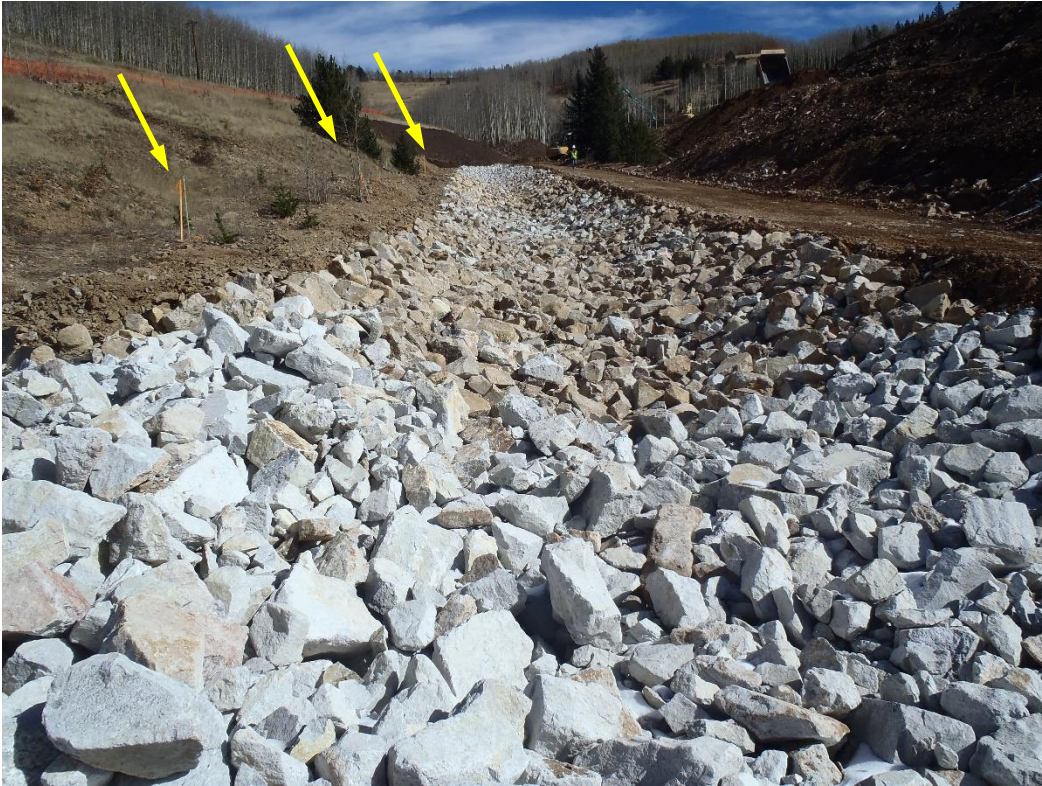
The remainder of the riprap lined channel was inspected and was observed to be within the permit boundary (**See Photo 3**). Riprap appeared to be well graded and adequately placed (**See Photo 4**). The Record of Construction report for the completed diversion channel was received by the Division on December 11, 2017 and accepted on February 14, 2018. The Division observed the contractor placing geotextile (**See Photo 5**) and riprap (**See Photo 6**) in smaller side channels (approx. channel design station 4+75) to transition into the main diversion channel. The Division noted the topsoil placed on the north side of the channel (**See Photo 9**) where the native material had been excavated to construct the diversion channel.

Photo 3. Completed portion of riprap channel within permit boundary (note stakes on left).

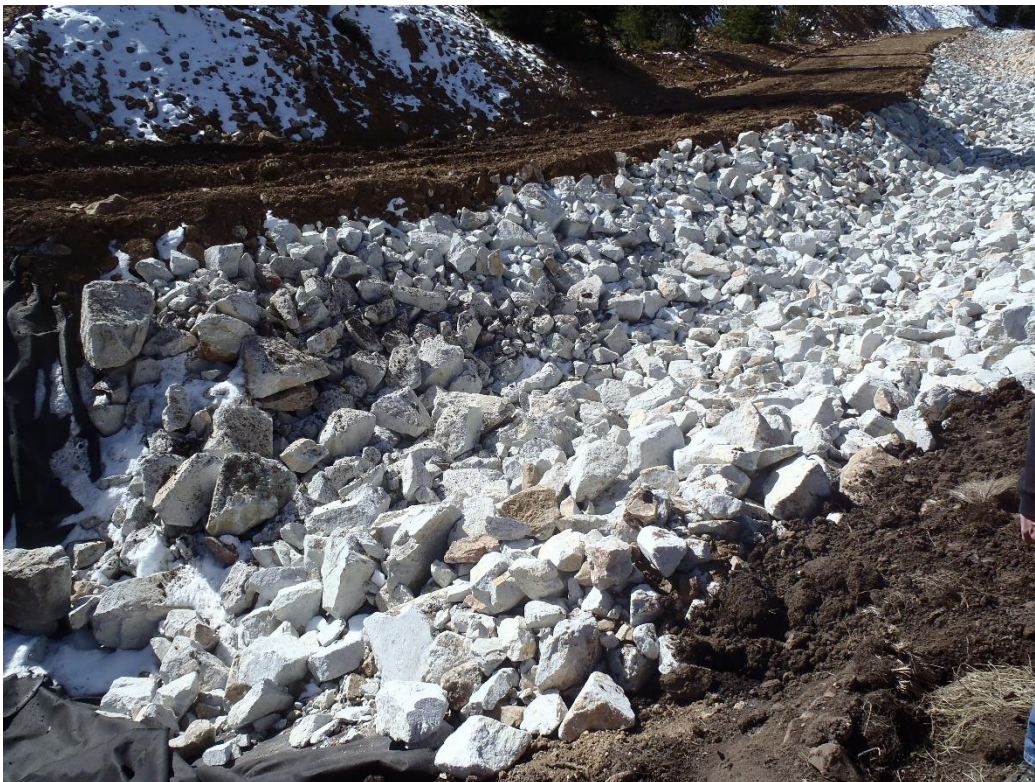
Photo 4. Well graded and placed riprap.

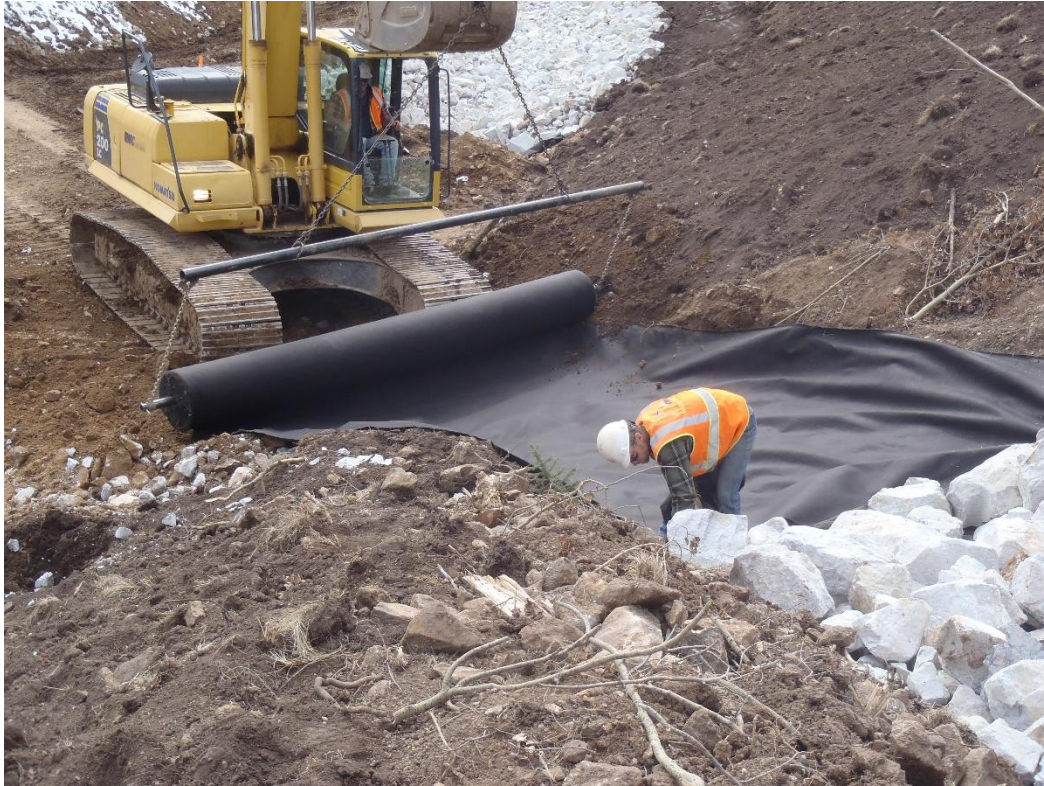
Photo 5. Laying geotextile in side drainage (~ Sta. 4+75).

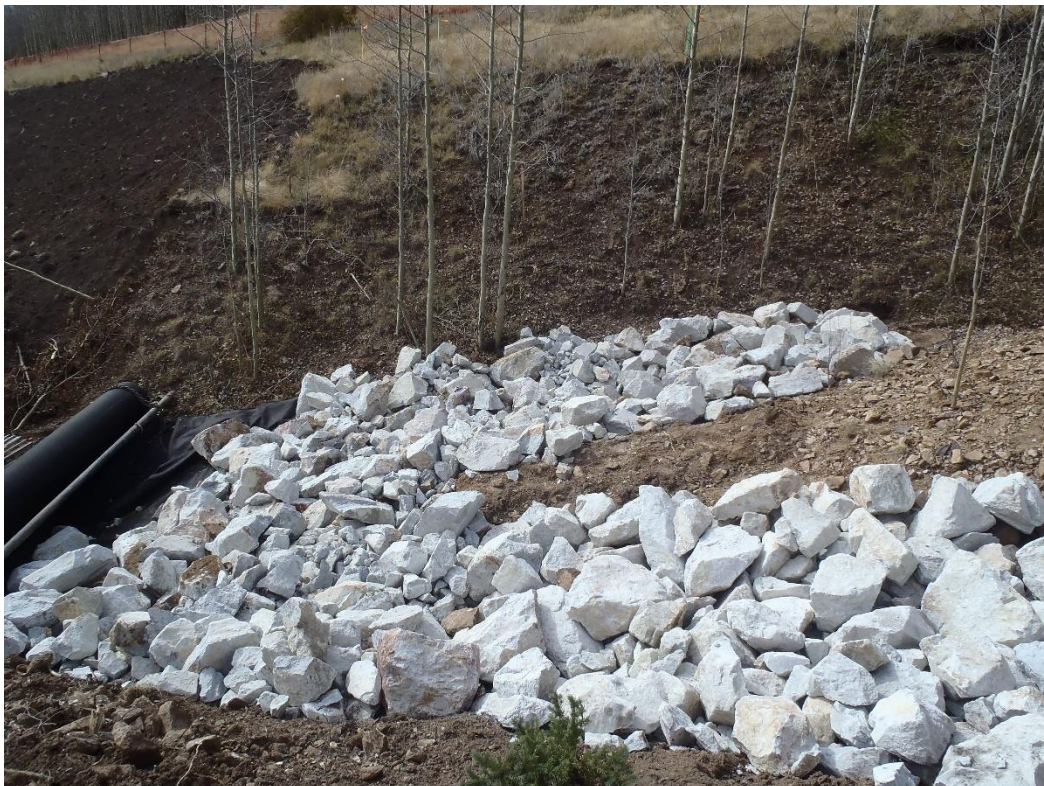
Photo 6. Placed riprap in side drainage (~ Sta. 4+75).

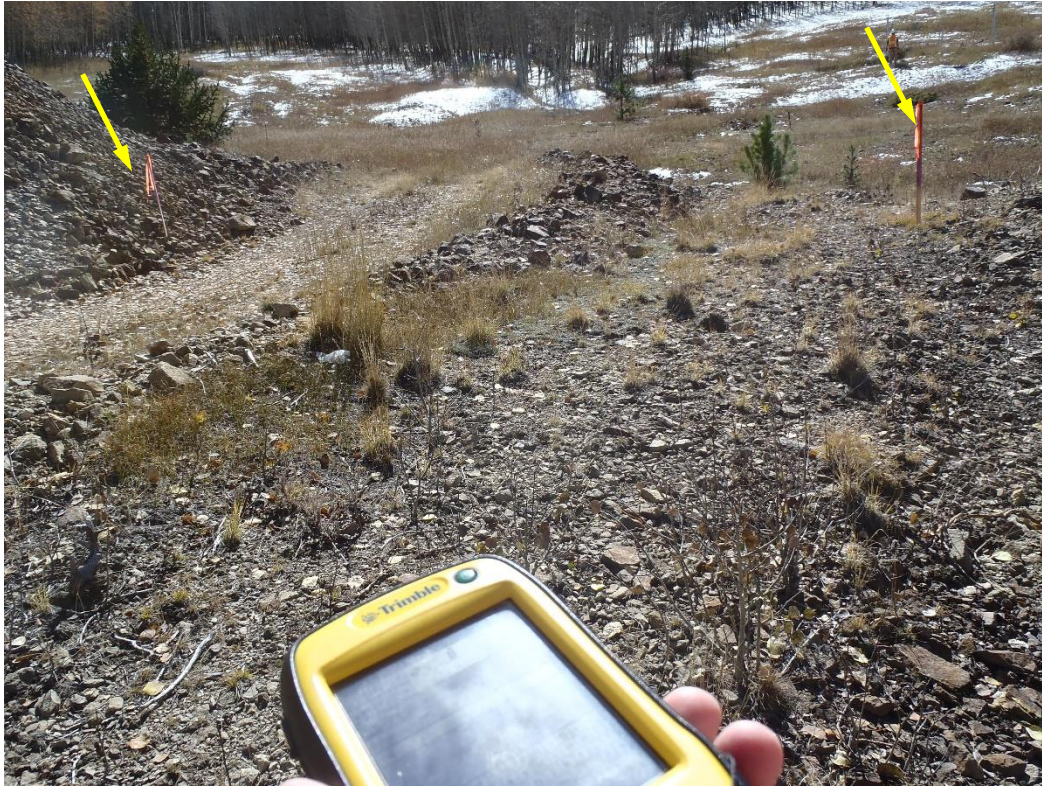
AM-12 Boundary: Mr. Gaul accompanied the Division to the Chicago Tunnel area where CC&V had staked the proposed AM-12 permit boundary extension. The Division collected GPS points (**See Photo 7**) for each survey stake (**See Figure 1**) using a handheld GPS unit (Trimble Juno 3B). The previously disturbed area (**See Photo 8**) south and west of the Chicago Tunnel area that initiated the Division's requirement for AM-12 appeared adequately contained within the proposed boundary extension. Subsequent to this inspection, the Division approved AM-12 on November 14, 2017.

Photo 7. Collecting GPS points on handheld unit (AM-12 survey stakes).

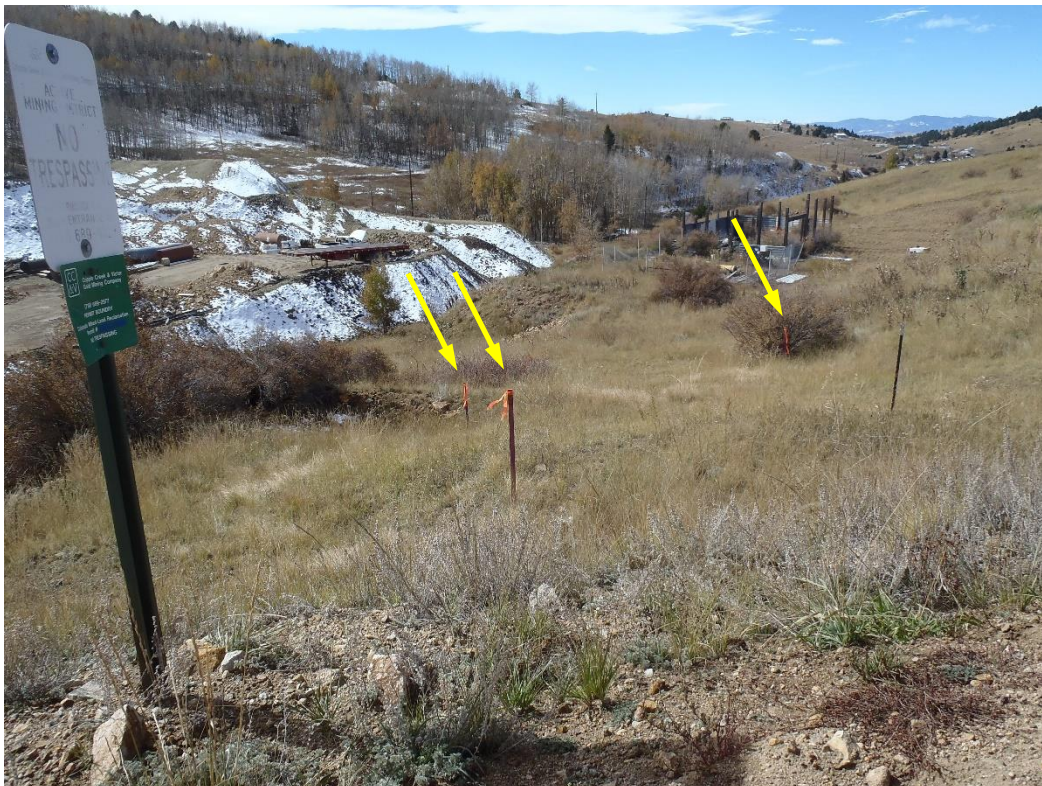
Photo 8. AM-12 permit boundary survey stakes (near Poverty Gulch/Chicago Tunnel area) .

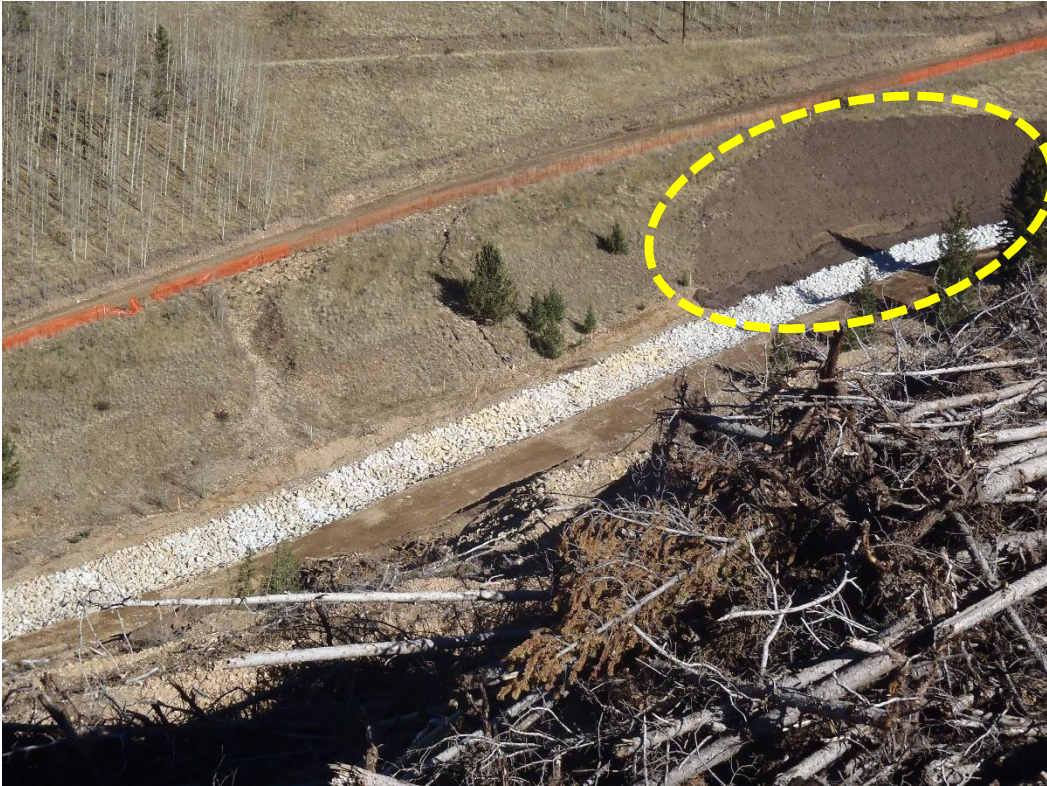
Photo 9. Topsoil placed on are disturbed for channel construction.
(note grubbed trees in foreground for Globe Hill Pit development).
