**COLORADO**Division of Reclamation,
Mining and Safety

MINERALS PROGRAM INSPECTION REPORT**PHONE: (303) 866-3567**

MINE NAME: Hazeltine Mine	MINE/PROSPECTING ID#: M-2004-031	MINERAL: Sand and gravel	COUNTY: Adams
INSPECTION TYPE: Monitoring	INSPECTOR(S): Jared L. Ebert	INSP. DATE: February 1, 2018	INSP. TIME: 08:45
OPERATOR: Aggregate Industries - WCR, Inc.	OPERATOR REPRESENTATIVE: Connie Davis	TYPE OF OPERATION: 112c - Construction Regular Operation

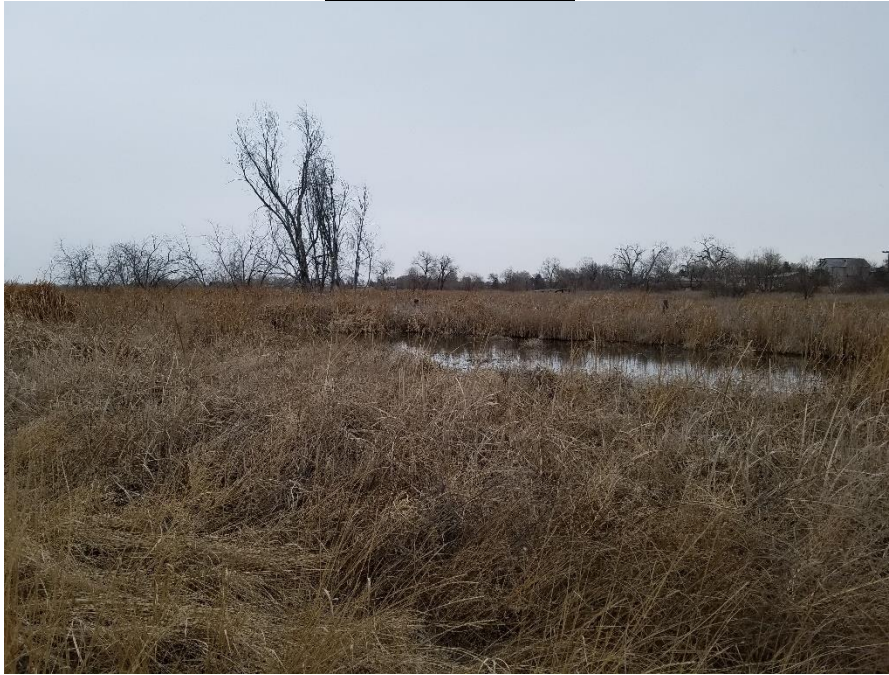
Figure 1. From the Hazeltine Mine access road on the east side, south of the Orr Drain looking east.

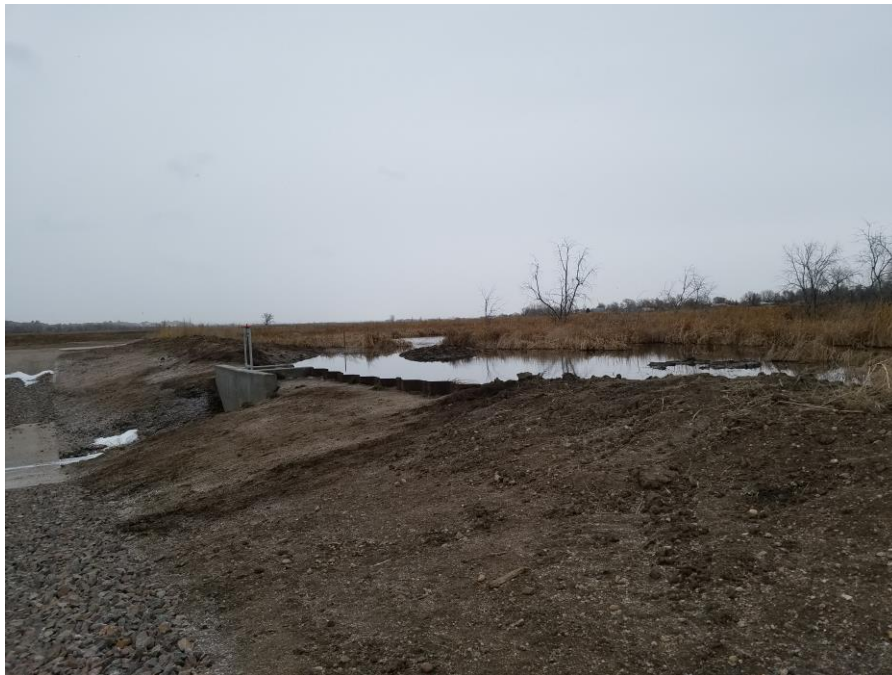
At the time of this inspection, the Orr Drain was closed and not discharging. Also, the Fulton Ditch was turned out and flowing into the Bull Seep. Water is ponded above the Orr Drain. The Orr property is still flooded and the Operator has failed to mitigate the disturbance to the prevailing hydrologic balance in the surrounding area and has failed to protect areas outside of the affected land from damage. The Division considers this to be a possible violation and will begin enforcement action.

Figure 2. Orr Drain on the southwest side looking northeast.

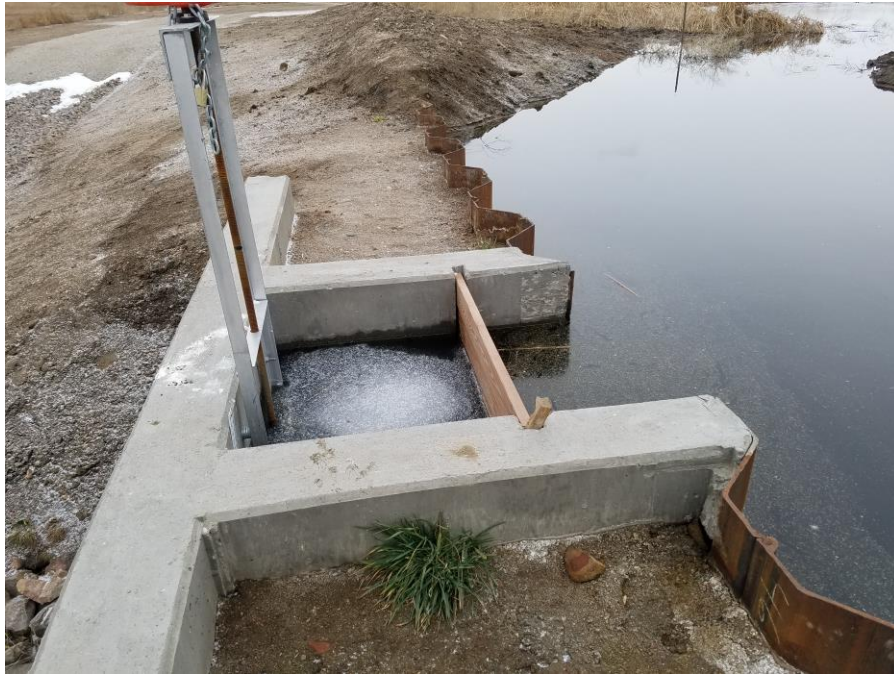
Figure 3. Orr Drain headgate closed.

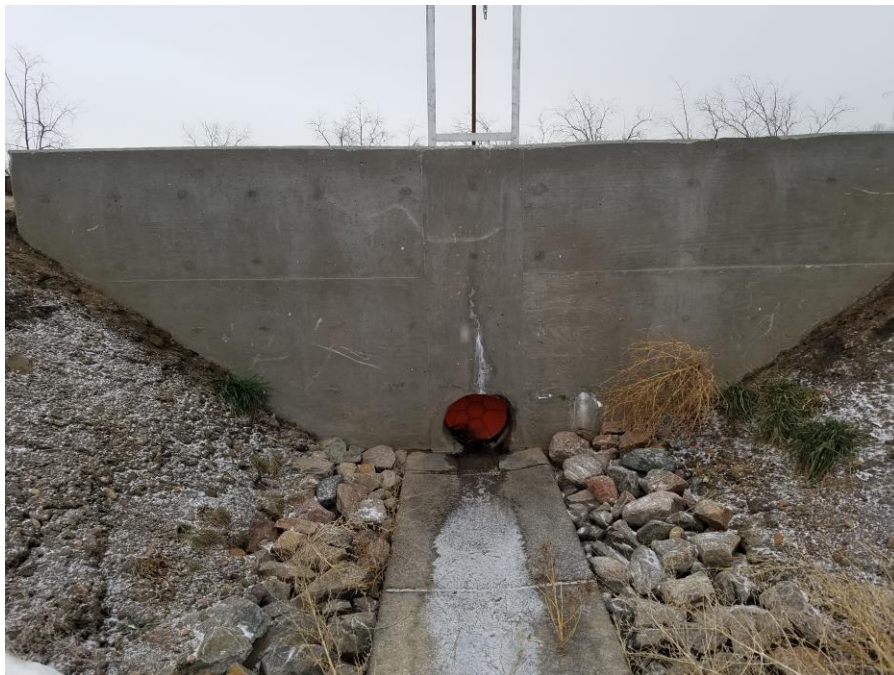
Figure 4. Orr Drain outlet.

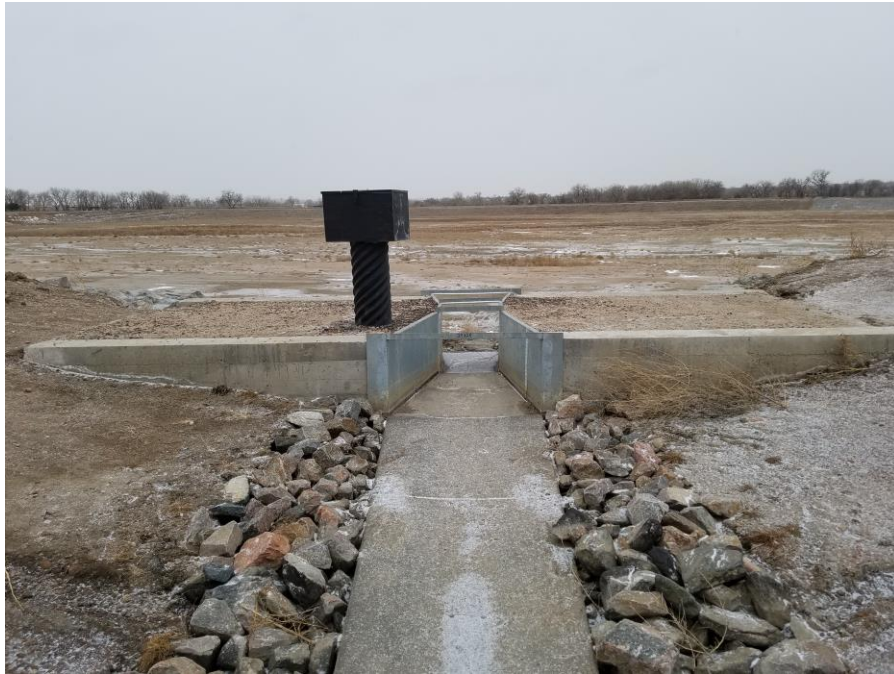
Figure 5. Orr drain flume.

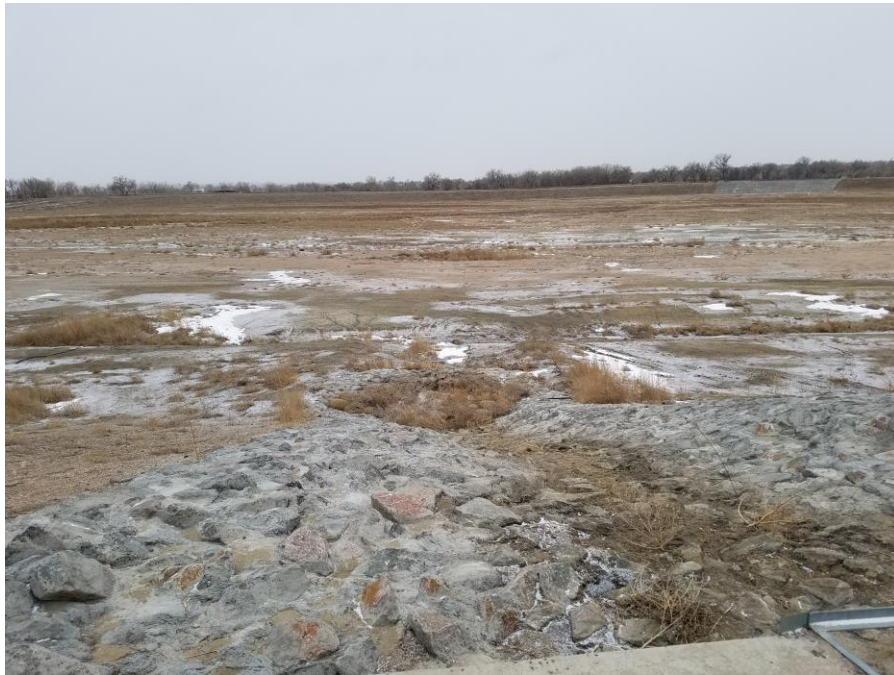
Figure 6. Run-down channel from Orr drain into pit.

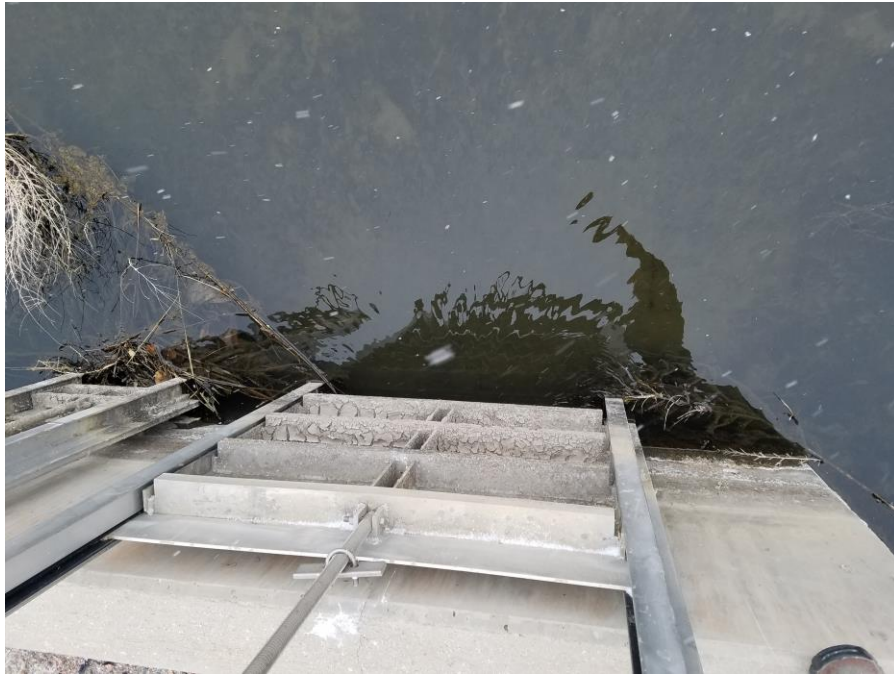
Figure 7. Fulton Ditch turnout, open.

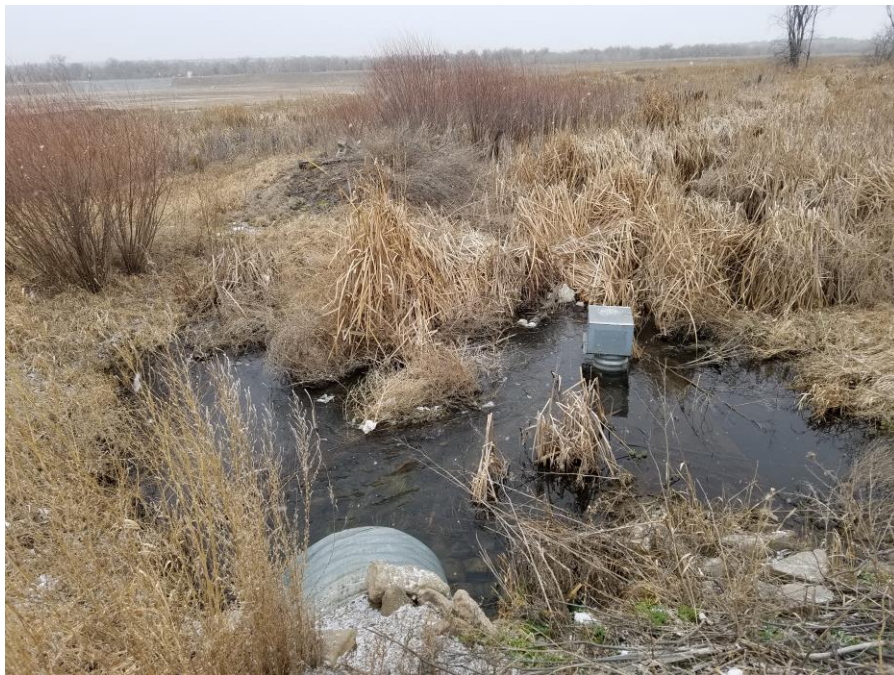
Figure 8. Fulton Ditch turnout, outlet flowing into the Bull Seep.

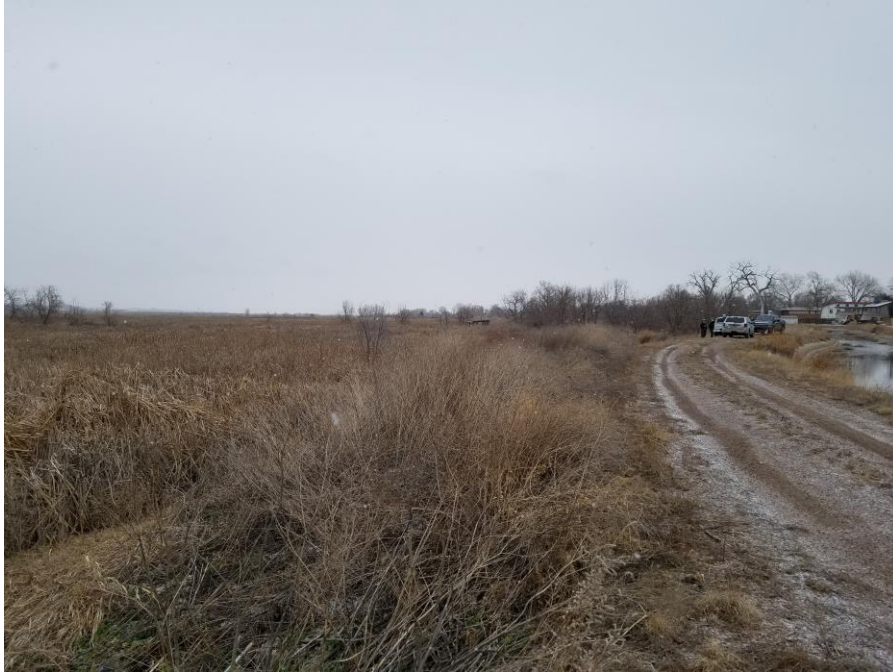
Figure 9. From the southwest corner of the Orr property looking north.

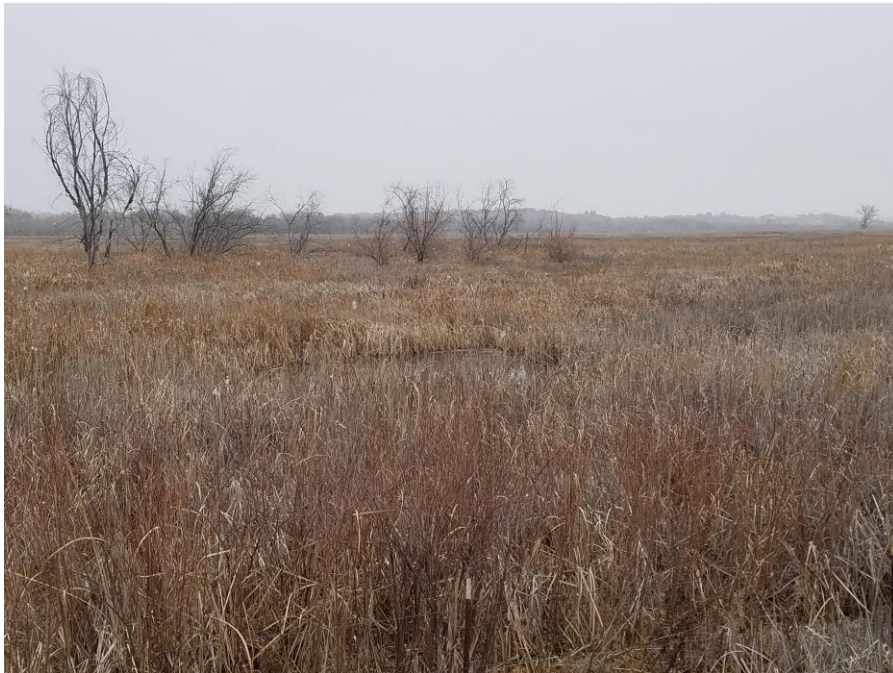
Figure 10. From the southwest end of the Orr property along the access road looking west.

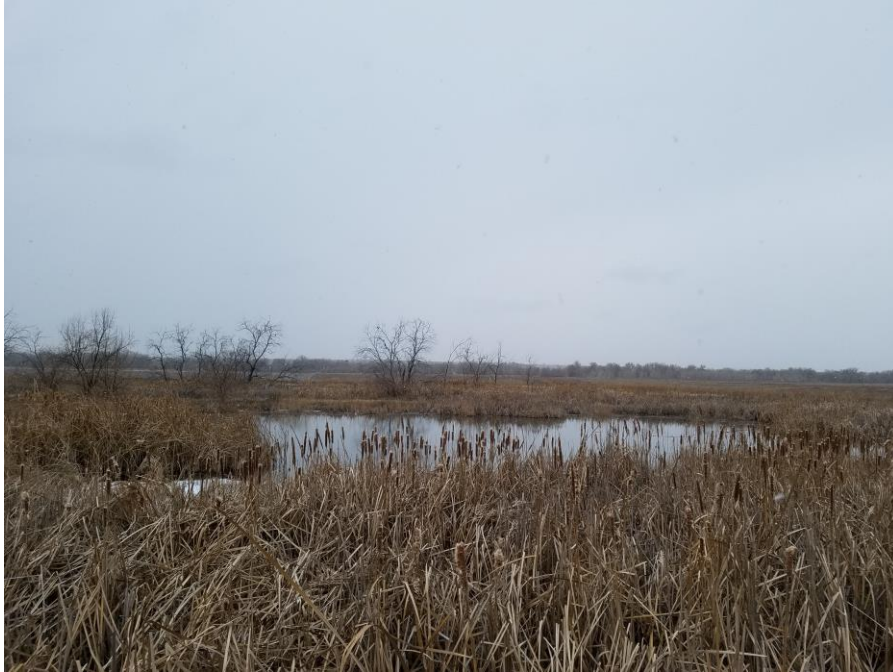
Figure 11. From near the center of the Orr property looking west.
