2018 ANNUAL REPORT STRUCTURAL GEOLOGY EVALUATION SPECIFICATIONS AGGREGATE QUARRY

**Martin Marietta Materials
Golden, Colorado**

17C64009.00
February 14, 2018

**Subject: Project 17C64009.00, 2018 Annual Report, Structural Geology Evaluation,
Specification Aggregates Quarry, Golden, Colorado**

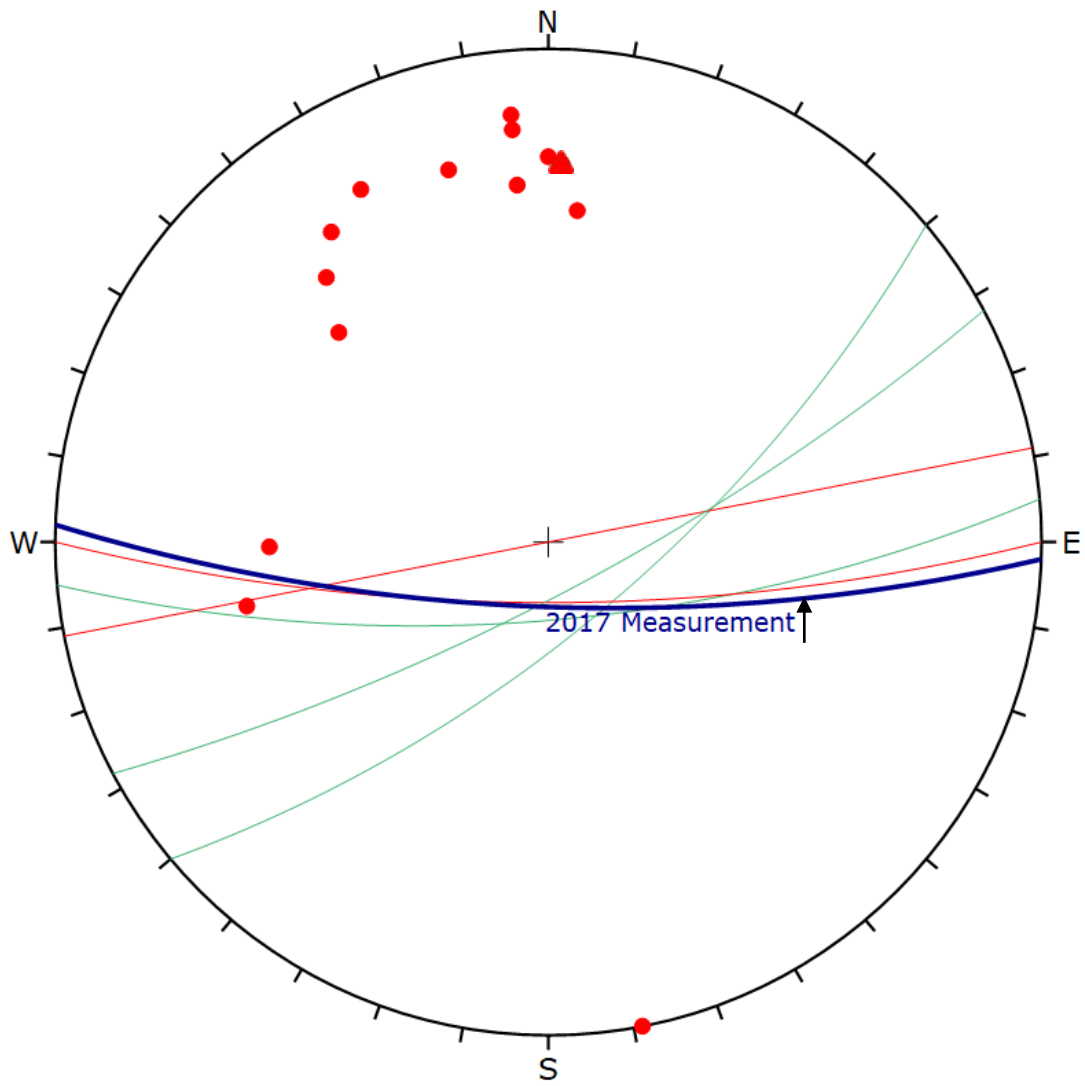
Figure 4

During our July and December 2017 site visits, we observed two fault exposures (probably of the same fault) along the temporary excavation wall in the Southern Expansion Area at stations 18-01 and 18-SHEAR (Figure 2, and Photo 3). The fault is oriented approximately east-west, with apparent dip/dip direction of 75-87/170-182 and was exposed in the north to north-east facing temporary wall of the expansion area. The fault zone consists of orange-reddish weathered, broken and blocky pegamatite rock, with parallel fracturing, and iron-stained slickenside surfaces with local clayey gouge. The location of this fault is, in general, a good match with the previously mapped trace. The apparent width of the fault zone varies from 20 to 30 feet. The fault orientation measurements for this annual report are presented with previous fault measurements and differentiated by the fault feature they represent in Figure 4.

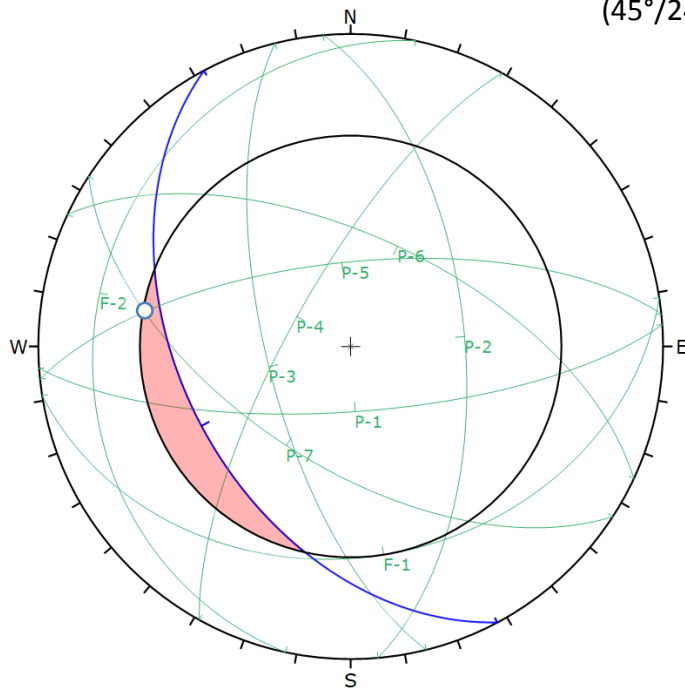
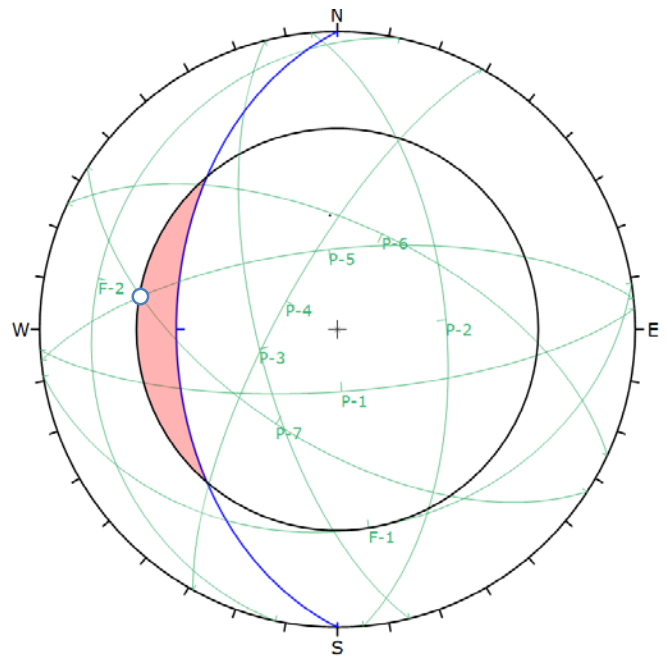
Figure 8

The stereonet plots for East Walls 1 and 2 each show one discontinuity intersection that falls within the failure envelope, suggesting that wedge failure is kinematically possible for these slope orientations (Figure 8). The intersecting set that may result in wedge failure are joint sets P-5 and joint P-7.

The development and size of these wedge failures will be controlled by the variability and limited lateral extent of the discontinuities. Based on the current and previous years' data sets, joint sets P-5 and P-7 have weak signatures represented by relatively few measured orientations representing these features (Figure 6). As excavation proceeds in the vicinity of the eastern walls, additional measurements are needed to refine the representative discontinuity orientations of these joint and foliation sets in this area to evaluate their potential to contribute to large-scale slope failure modes.

As shown in Figure 8, the stereonet plot for East Walls 1 and 2 do not indicate the possibility of planar failure.

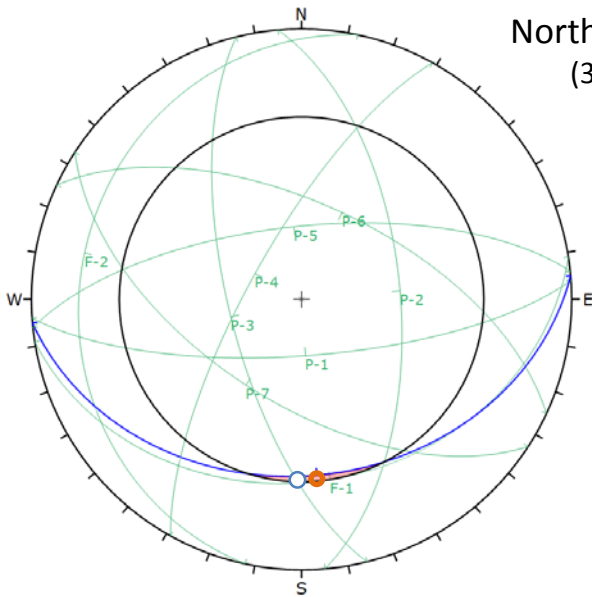
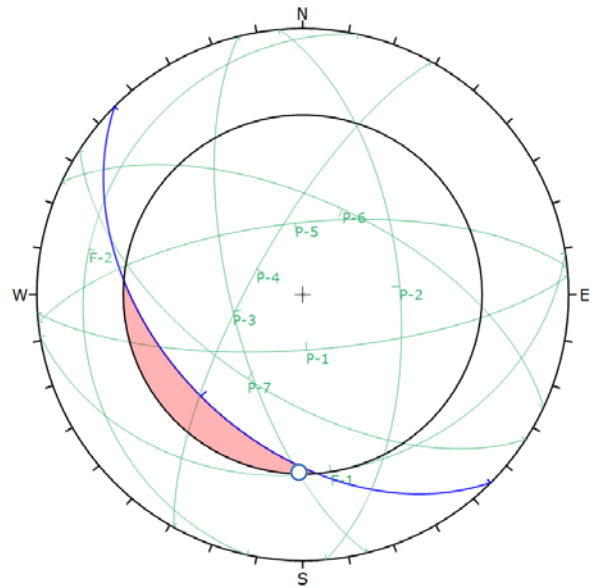
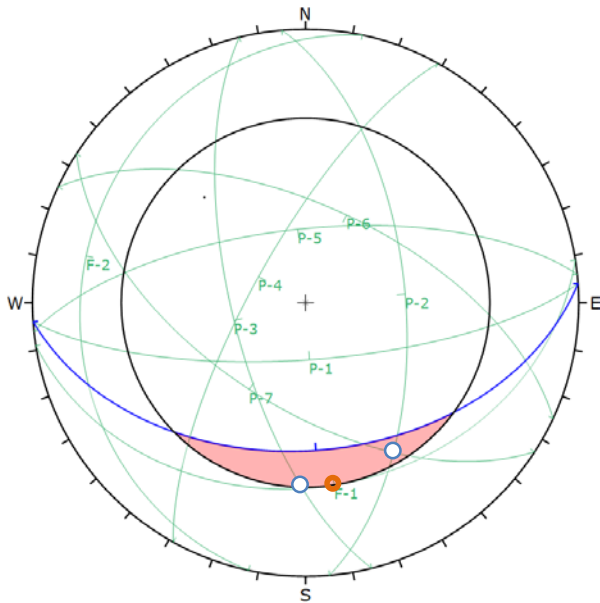
Figure 9

The stereonet plot for Northeast Wall 1 indicates a potential planar failure mode along foliation F-1 for this slope orientation (Figure 9). This is the same foliation orientation that was believed to contribute to the 1998 slope instability (Photo 5). The stereonet plot for Northeast Wall 1 also shows one discontinuity intersection that falls within the failure envelope, suggesting that wedge failure is kinematically possible for this slope orientation (Figure 9). The intersecting sets that may result in wedge failure include foliation F-1 and joint set P-3.

The stereonet plot for Northeast Wall 2 shows one discontinuity intersection that falls within the failure envelope, suggesting that wedge failure is kinematically possible for this slope orientation (Figure 9). The intersecting sets that may result in wedge failure are foliation F-1 and joint set P-3. As described above, the development and size of wedge failures will be controlled by the variability and limited lateral extent of the discontinuities. As excavation proceeds in the vicinity of the northeastern walls, additional measurements are needed to refine the representative discontinuity orientations of these joint and foliation sets in this area to evaluate their potential contribute to large-scale slope failure modes. Planar failure is not indicated in the stereonet plot for Northeast Wall 2.

The stereonet plot for Northeast Wall 3 indicates a potential planar failure mode along foliation F-1 for this slope orientation (Figure 9). This is the same foliation orientation that was believed to contribute to the 1998 slope instability. The stereonet plot for Northeast Wall 3 shows two discontinuity intersections that fall within the failure envelope, suggesting that wedge failure is kinematically possible for this slope orientation (Figure 9). The intersecting sets that may result in wedge failure are foliation F-1 and joint set P-3, and joint sets P-2 and P-7. Based on the current and previous years' data sets, joint set P-7 has weak signatures represented by relatively few measured orientations representing these features (Figure 6). The Northeast Wall 3 was not accessible for direct measurements or observations during our site visits. Additional measurements and observations are needed to assess the potential for large scale planar sliding along foliation F-1 as excavation continues to extend below Northeast Wall 3 in the future (there is currently no mining activity).

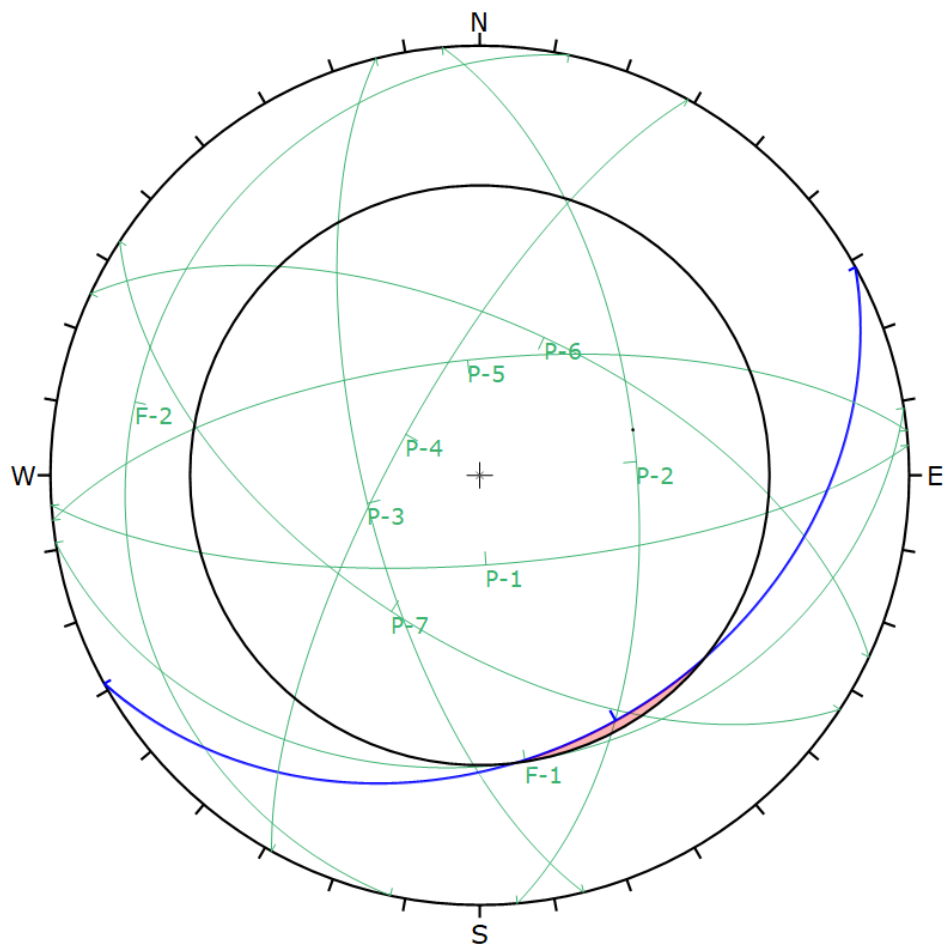
A SCHNABEL ENGINEERING COMPANY	
Spec-Agg Quarry Golden, Colorado Project No. 17C64009.00	Kinematic Analysis: Northwest Wall
Martin Marietta Materials  	Figure 10

The stereonet plot for the Northwest Wall (Figure 10) does not show indications of potential wedge failure modes based on the 2017 discontinuity measurements (Figure 10). However, even a slight variability of the orientation of joint sets P-2 and P-7 and joint set P-2 and foliation F-1 would create the potential to form wedges within the critical zone for this wall. Planar failure is not indicated in the stereonet plot for the Northwest Wall (Figure 10). However, even a slight variation of the foliation F-1 would create the potential for planar sliding.

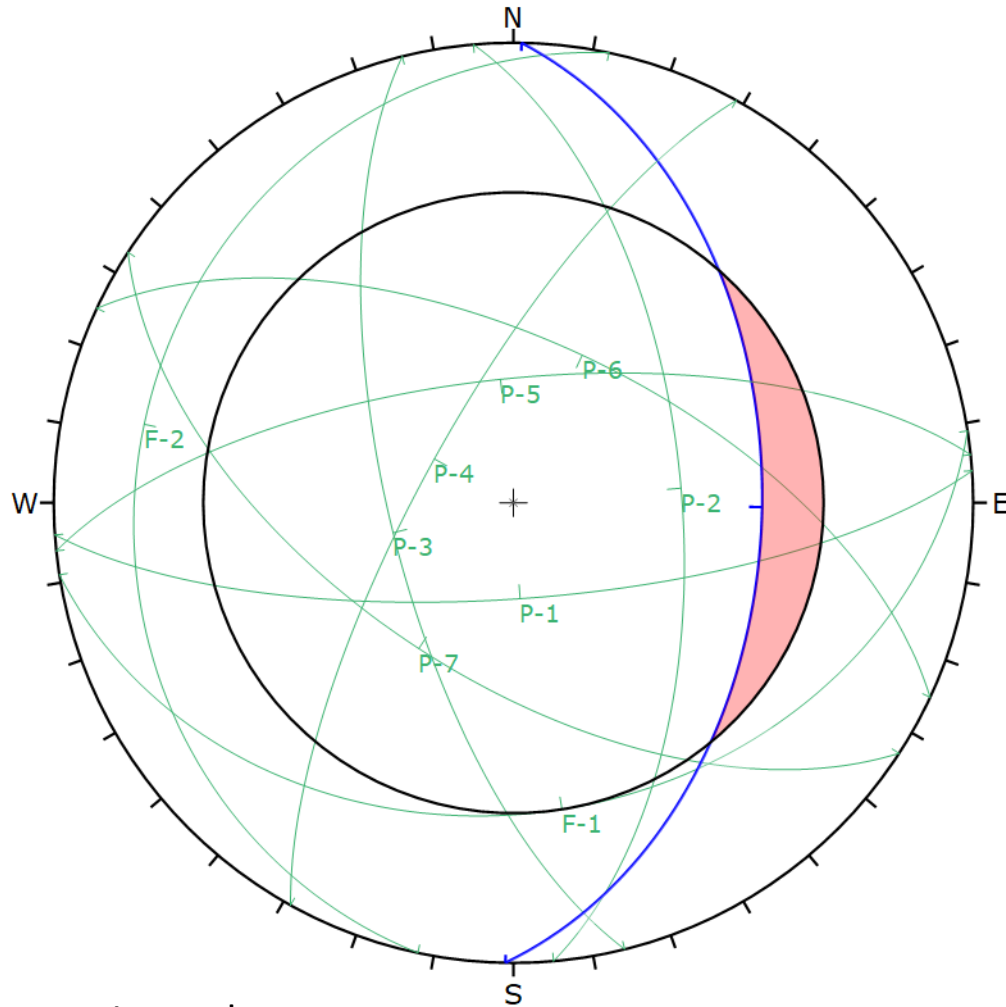
Figure 11

The stereonet plot for West Wall 1 (Figure 11), adjacent to the Main Pit area, does not show indications of potential wedge failure modes based on the 2017 discontinuity measurements. However, even a slight variability in the orientations of the joint sets P-1 and P-6 will have potential to form wedges within the critical zone for this wall. Planar failure is not indicated in the stereonet plot for the West Wall 1 (Figure 11).

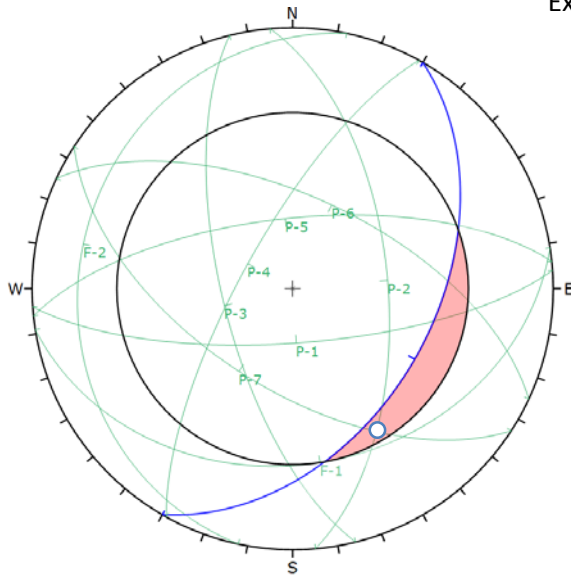
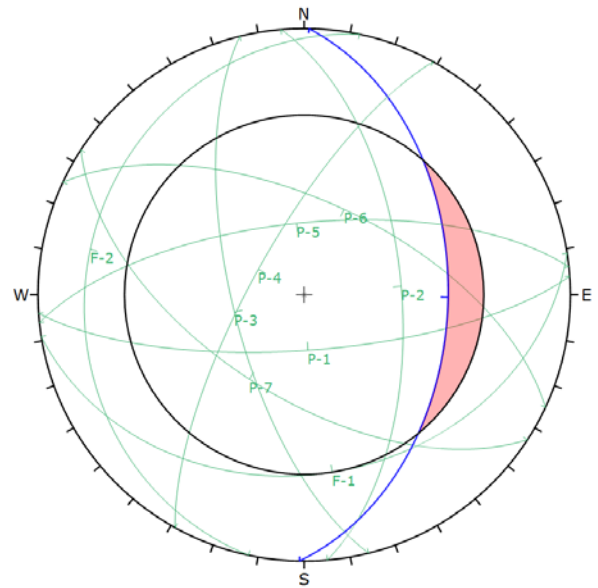
Figure 12

The stereonet plot for West Wall 2, adjacent to the access road in the Southern Expansion Area, shows one discontinuity intersection that falls within the failure envelope, suggesting that wedge failure is kinematically possible for this slope orientation (Figure 12). The intersecting sets that may result in wedge failure include joint sets P-2 and P-7. Based on the current and previous years' data sets, joint set P-7 has weak signatures represented by relatively few measured orientations representing these features (Figure 6). Planar failure is not indicated in the stereonet plot for West Wall 2 (Figure 12).

The stereonet plot for West Wall 3 does not show indications of potential wedge failure modes based on the 2017 discontinuity measurements (Figure 12). However, even a slight variability of the joint sets P-1 and P-6 would create the potential to form wedges within the critical zone for this wall. Planar failure is not indicated in the stereonet plot for the West Wall 3 (Figure 12).

The development and size of wedge failures will be controlled by the variability and limited lateral extent of the discontinuities. As excavation proceeds in the west walls area, additional measurements are needed to refine the representative discontinuity orientations of these joint and foliation sets in this area to evaluate their potential contribute to large-scale slope failure modes.

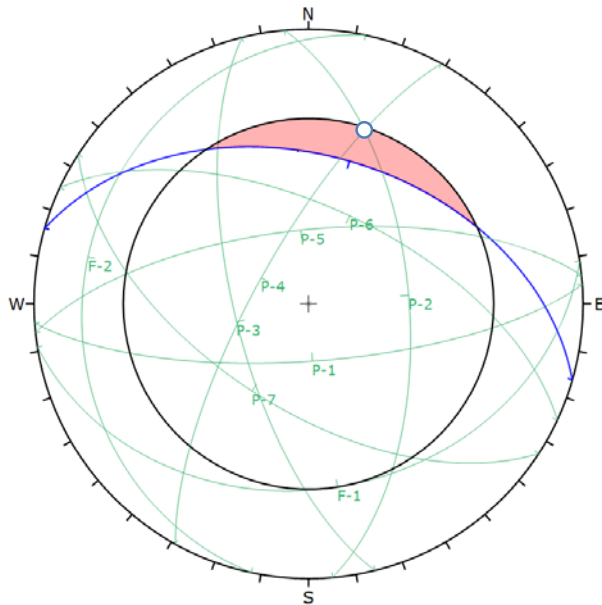
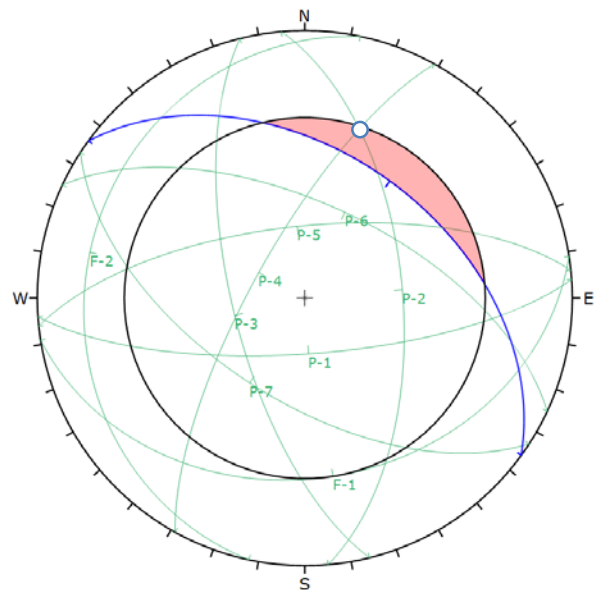
Figure 13

The stereonet plots for the Southwest Wall 1, Southwest Wall 2, and South Wall each show one discontinuity intersection that falls within the critical zone, suggesting that wedge failure is kinematically possible for these slope orientations (Figures 13 and 14). The intersecting sets that may result in wedge failure are joint sets P-2 and P-4. The signatures of P-4 appear to be relatively weak in the Southern Expansion Area (Figure 6). Planar failure is not indicated in the stereonet plots for the Southwest Wall 1, Southwest Wall 2, and South Wall (Figures 13 and 14).

As described above, the development and size of wedge failures will be controlled by the variability and limited lateral extent of the discontinuities. As excavation proceeds in the vicinity of the southern walls, additional measurements are needed to refine the representative discontinuity orientations of these joint and foliation sets in this area to evaluate their potential contribute to large-scale slope failure modes.

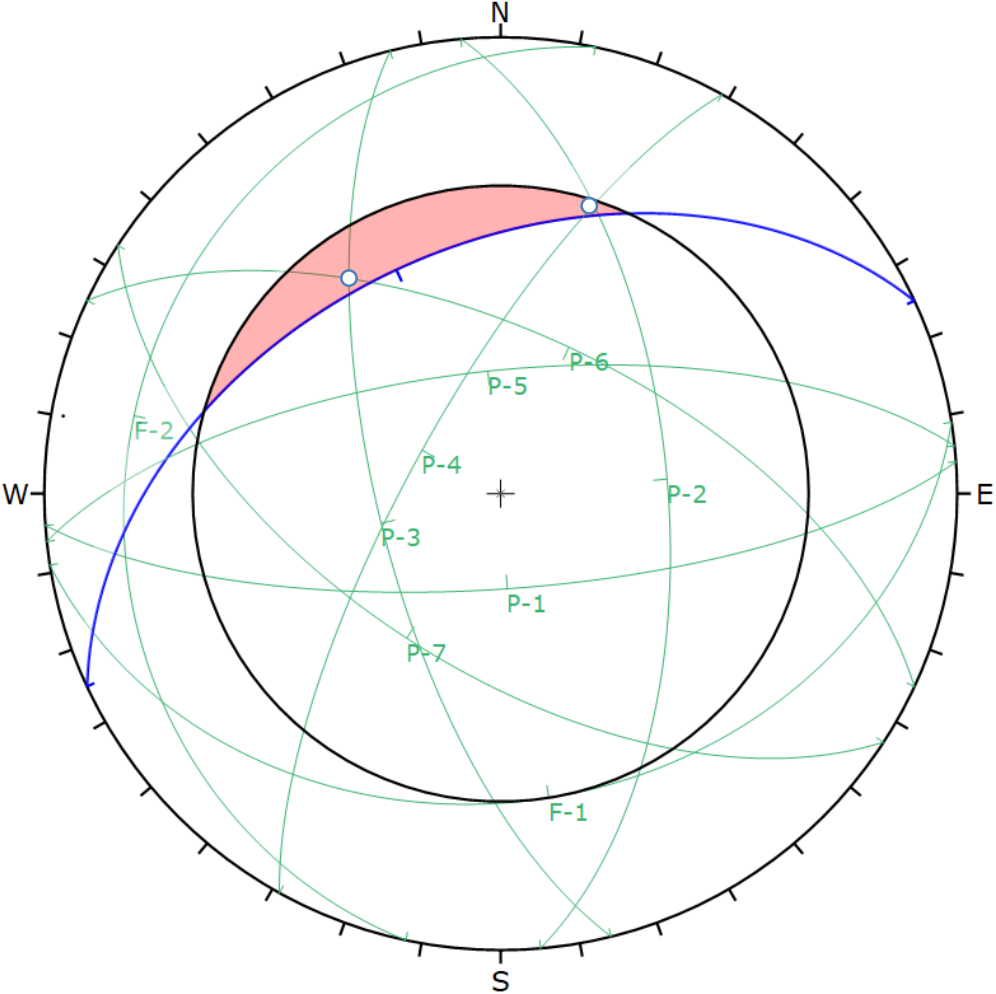
Figure 15

The stereonet plot for the Southeast Wall shows two discontinuity intersections that fall within the failure envelope, suggesting that wedge failure is kinematically possible for this slope orientation (Figure 15). The intersecting sets that may result in wedge failure are joint sets P-2 and P-4, and joint sets P-3 and P-6. Based on the current as well as previous year's data set, joint set P-4 has weak signatures represented by relatively few measured orientations representing these features (Figure 6). Planar failure is not indicated in the stereonet plot for the Southeast Wall (Figure 15).

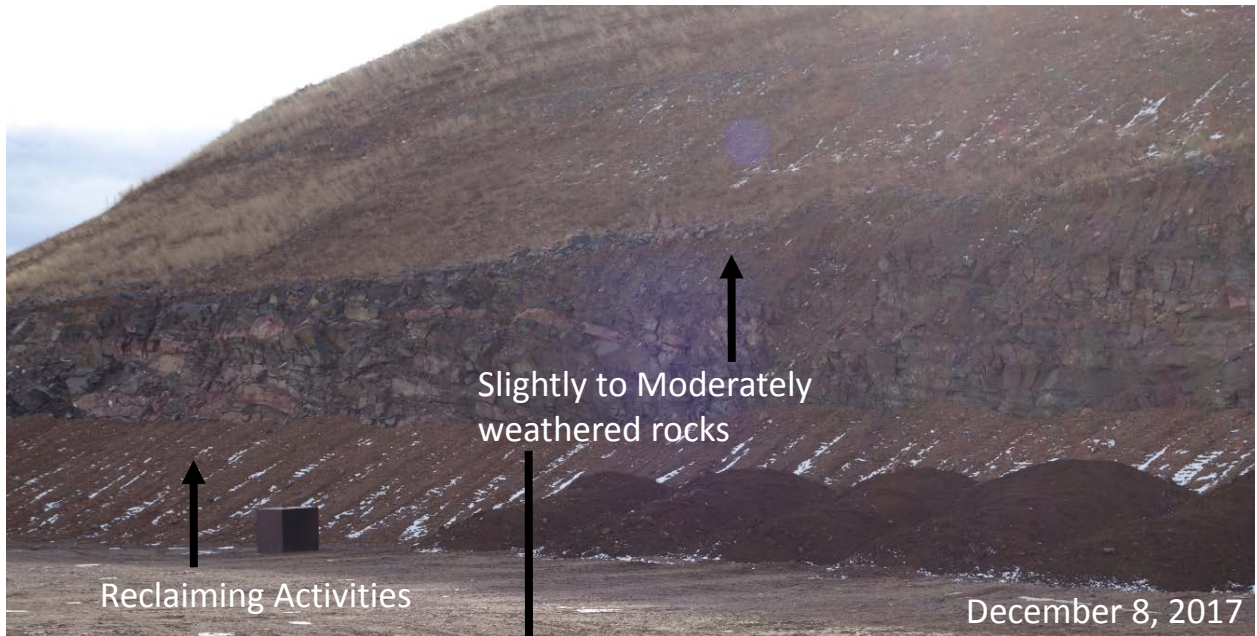
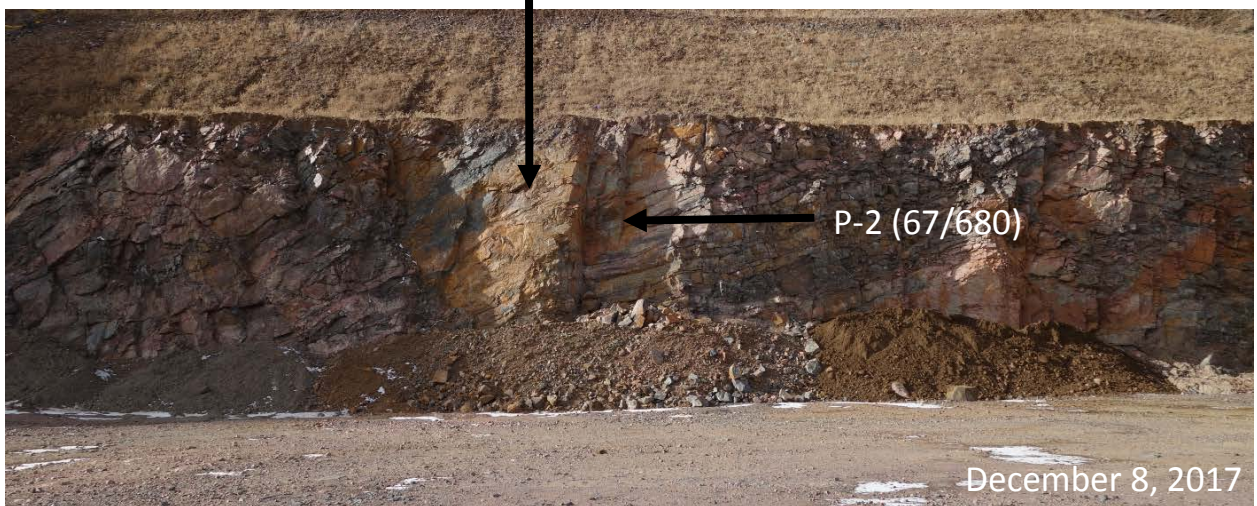
Photo 1

Looking west (West Wall 3) during reclaiming activities in an actively-mined area (upper bench, Elevation ~6685') of the Southern Expansion Area near Station 18-04 (Figure 2).

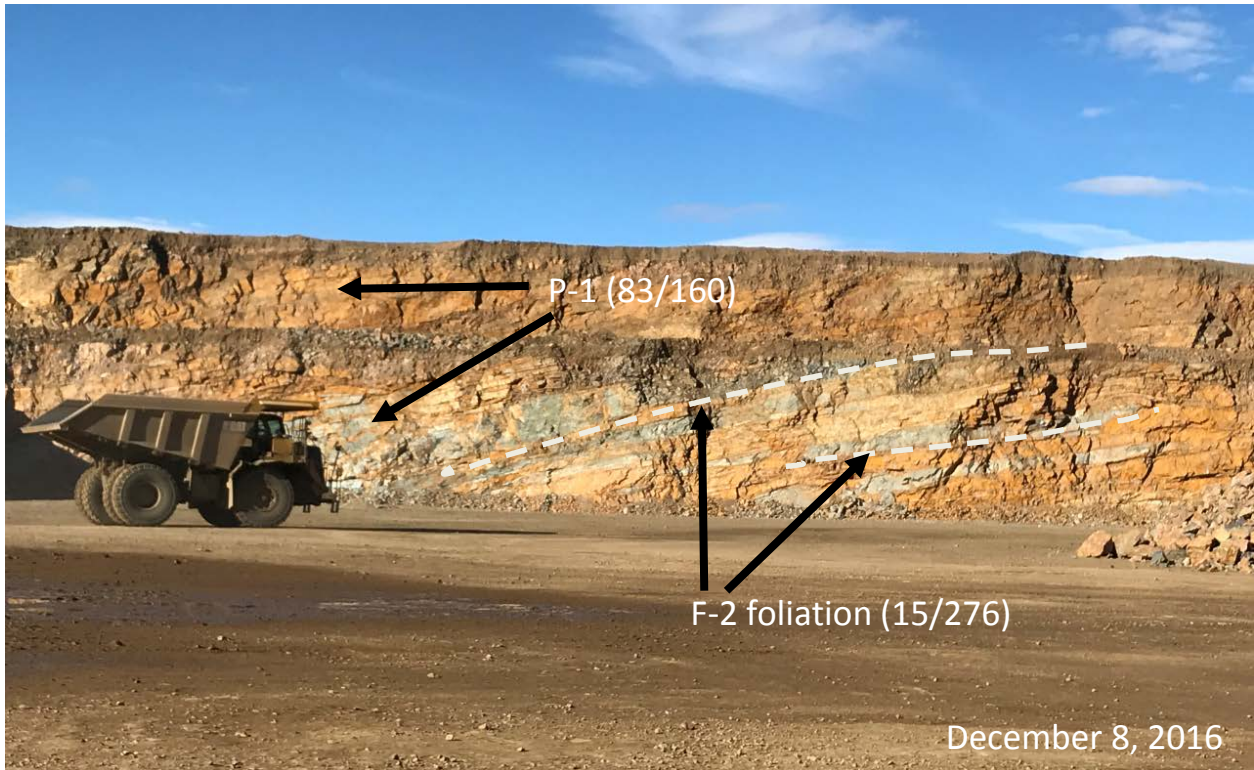
Photo 2

Fresh exposed, slightly to moderately weathered rock in temporary southeast facing wall of the Southern Expansion Area near Station 18-07 (~Elevation 6580, Figure 2).

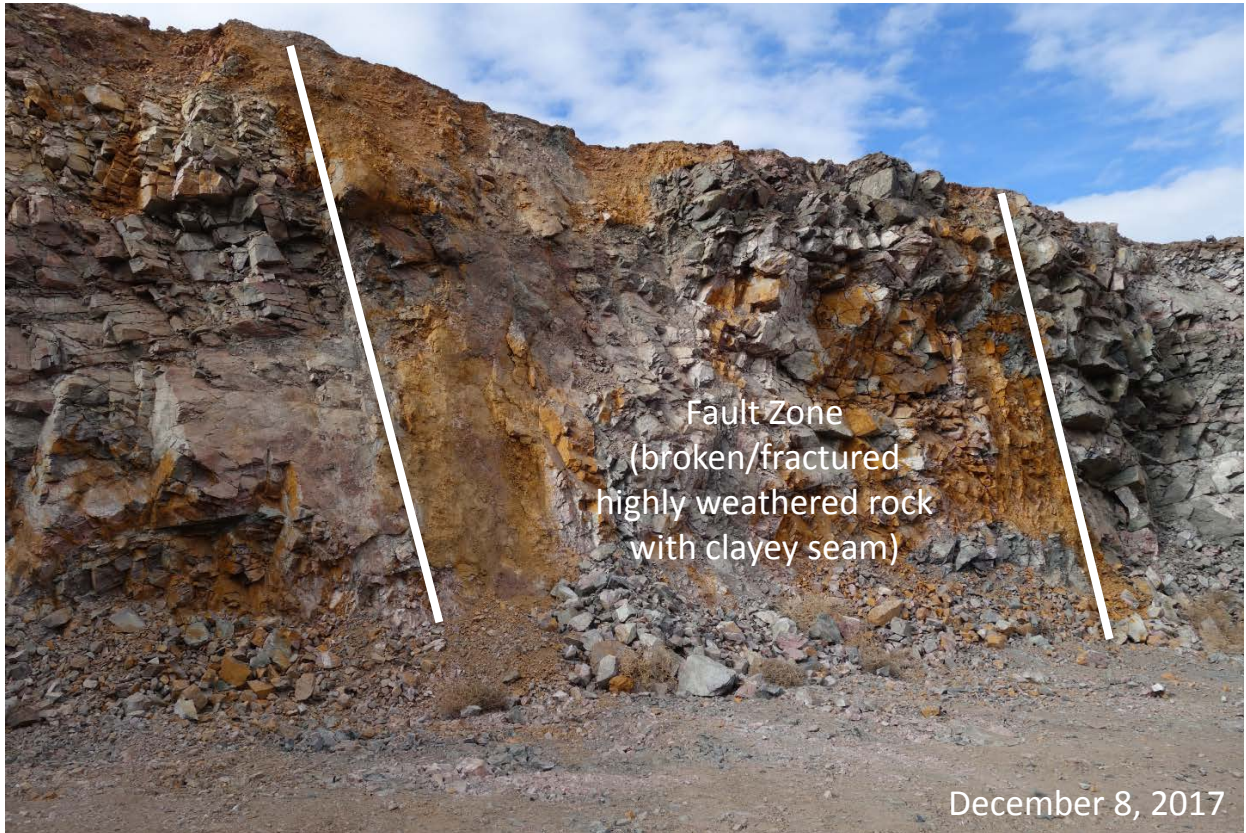
Photo 3

Near vertical east-west trending fault (20 to 30 feet wide) observed in an actively-mined area of the Southern Expansion Area (~Elevation 6615 feet) looking from Station 18-SHEAR (Figure 2).

We also recommend that known faults are tracked and observed in new exposures to confirm orientation and character for supplemental stability analysis, as needed. We expect the southern fault identified by Gable (1968) and in previous years site visits (Figure 3) may be exposed in other locations as excavation continues in the Southern Expansion Area. Additionally, the unmapped fault generally located in the central portion of the quarry may be exposed for mapping in the future. As recommended in the previous reports, evaluations will be conducted during future investigations to assess whether or not any of the foliation sets (F-1 through F-3) are caused due to localized faulting that may have resulted in “structural regions” that have created areas in which the varying orientation of the foliation planes occur. These questions will continue to be addressed as more data is collected.

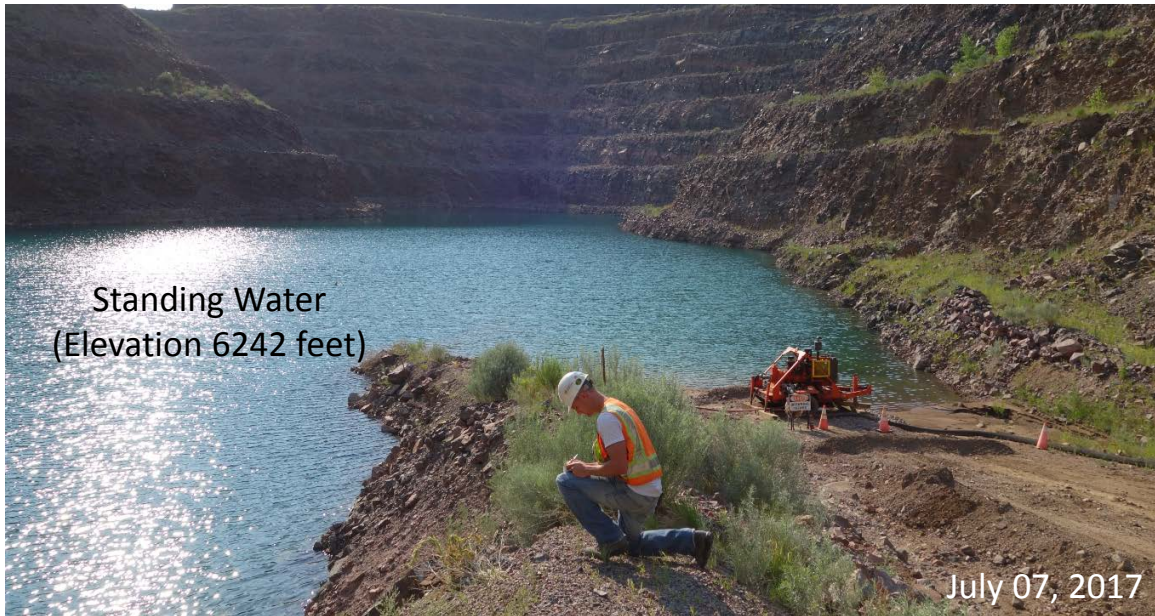
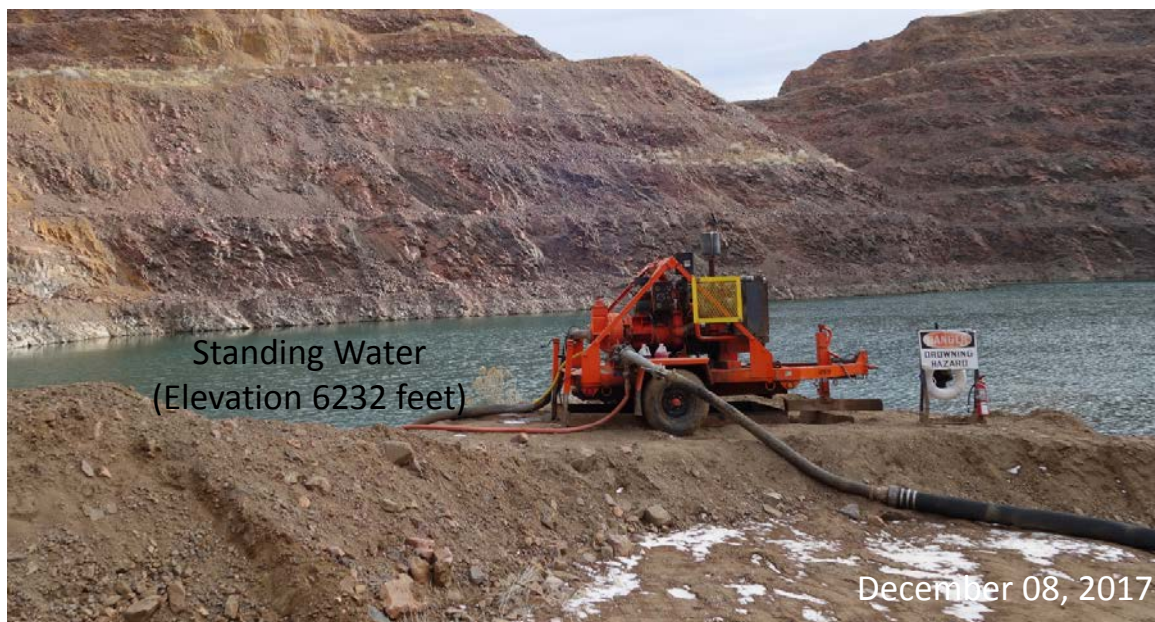
Photo 4

Looking east and north respectively in the Main Pit area showing impounded water (water level lowered 10 feet between July and December 2017 visits)

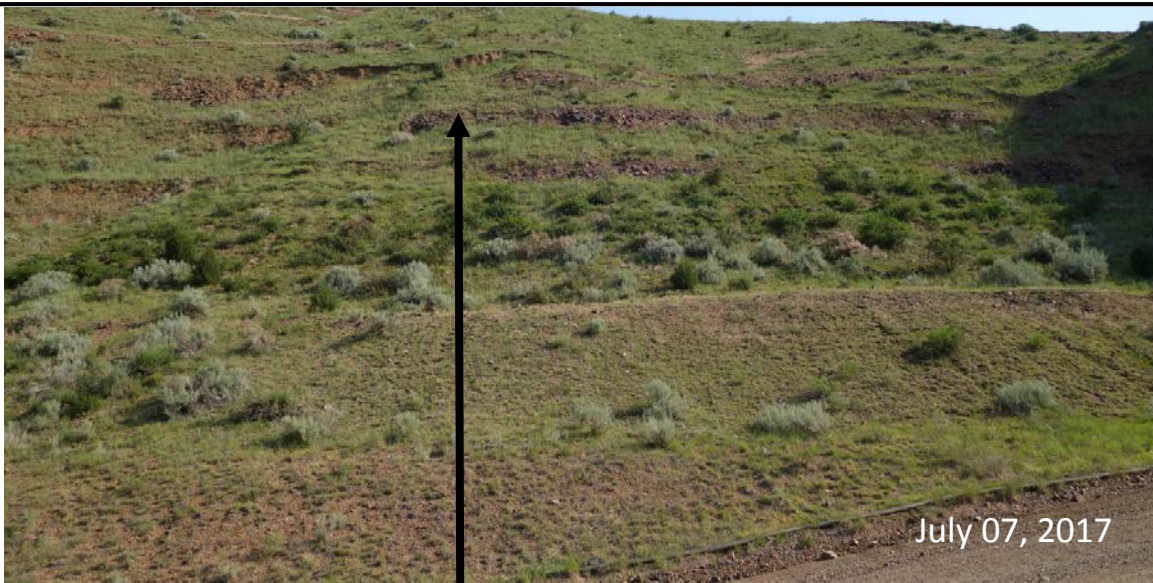
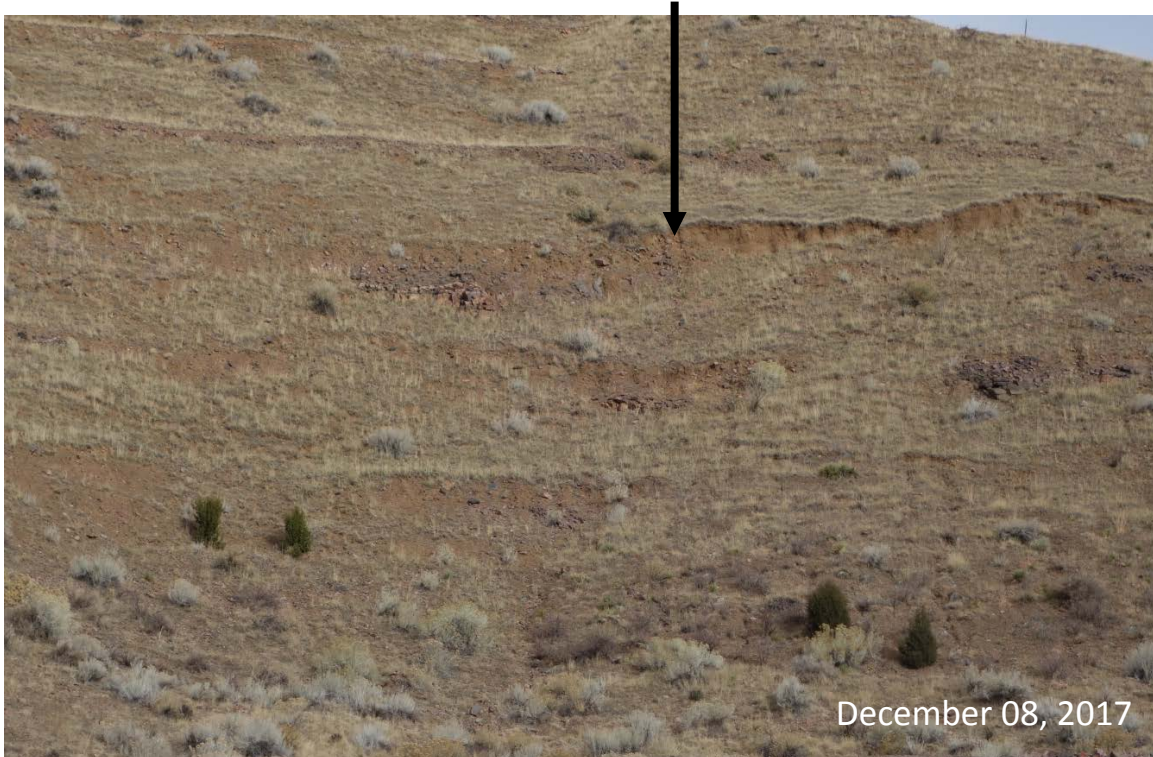
Pre-existing scarp

along which movement has occurred) remain at a “residual strength” and therefore are less resistant to additional loading. Based on visual inspection from the access road and bottom of the pit, these slopes did not appear to show signs of additional movement during the site visits for this study (Photo 5). Although the slope configuration is currently stable, the failure mechanism could potentially be reactivated, resulting in movement of additional material. The Northwest Wall, Northeast Wall 1, and Northeast Wall 3 (Figure 2) should continue to be visually monitored for indications of instability.

Looking north from the Main Pit Area showing pre-existing scarp feature on the north slope. It appears unchanged since previous year's visit in December 2016.
