## MINERALS PROGRAM INSPECTION REPORT

| <b>MINE NAME:</b><br>Cresson Project | <b>MINE/PROSPECTING ID#:</b><br>M-1980-244 | <b>MINERAL:</b><br>Gold | <b>COUNTY:</b><br>Teller |
| <b>INSPECTION TYPE:</b><br>Monitoring | <b>INSPECTOR(S):</b><br>Timothy A. Cazier | <b>INSP. DATE:</b><br>October 11, 2017 | <b>INSP. TIME:</b><br>9:15 |

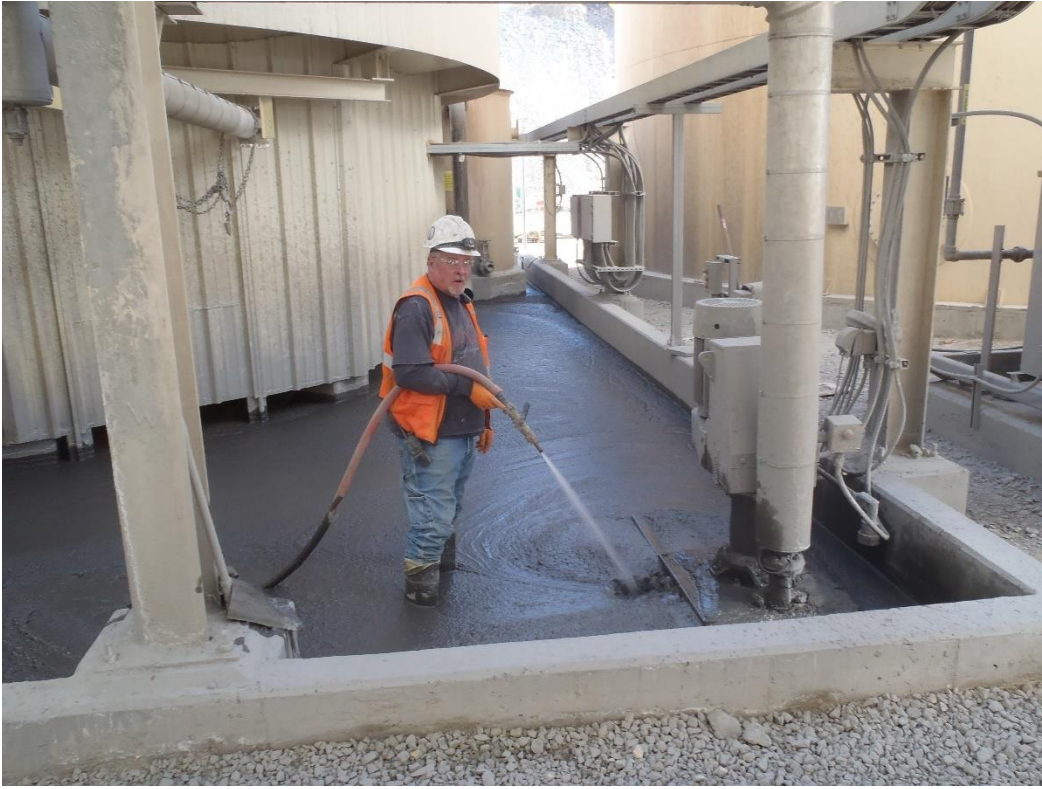
High Grade Mill: The Division was accompanied by Dave Rigsby at the HGM to perform an exterior walk-around inspection. The focus was to observe the status of secondary containment on both the west side (vat leach area) and the east side. On the east side, the secondary containment areas for the Process Ore Thickener and High pH Water Tank showed no significant reduction in capacity. Mine personnel were adding water to slurry in the secondary containment area on the west side of the High pH Thickener (**Photo 1**). Mr. Rigsby explained the situation as being a result of a pump being down for maintenance and water was being added for the restart of the pump. The slurried material appeared to be confined to the west side of the High pH Thickener secondary containment area, as the east side (Neutral Process Water Tank) was clean (**Photo 2**). Secondary containment on the vat leach side was observed to be partially consumed (**Photo 3**). Mr. Rigsby stated it would be cleaned up. The Division received photographic evidence of the cleaned up secondary containment on December 4, 2017.

Photo 1. Crew washing slurry out of High pH Thickener secondary containment area.

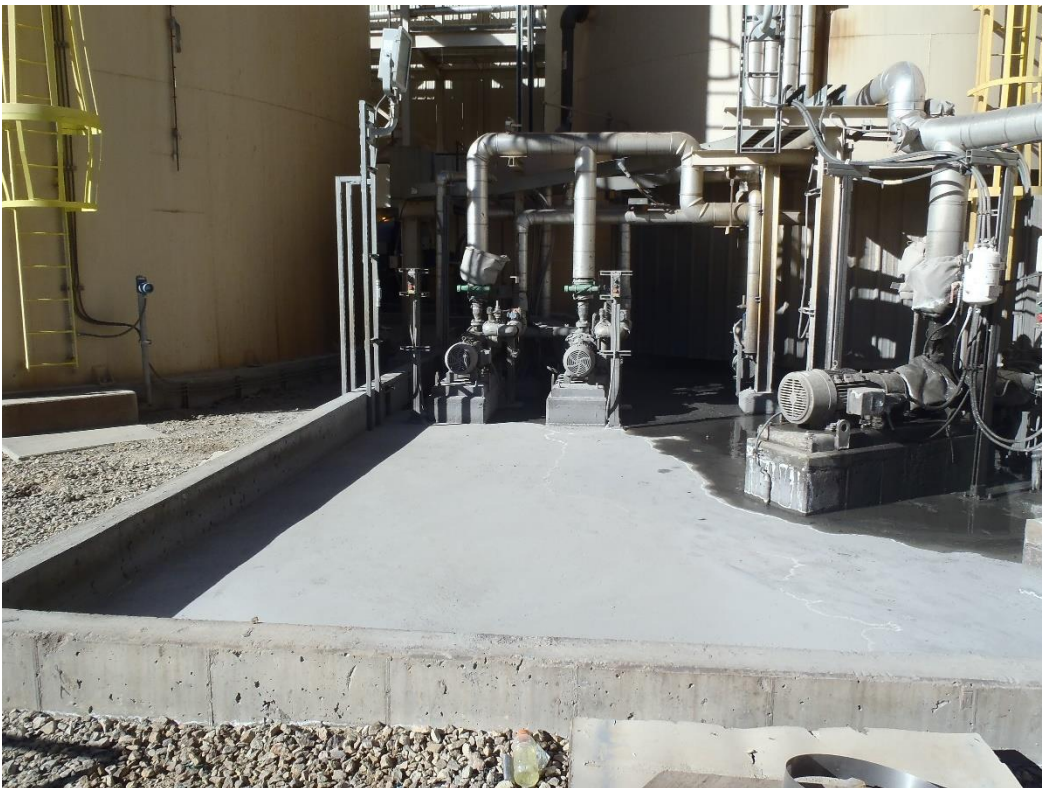
Photo 2. Neutral Process Water Tank secondary containment area.

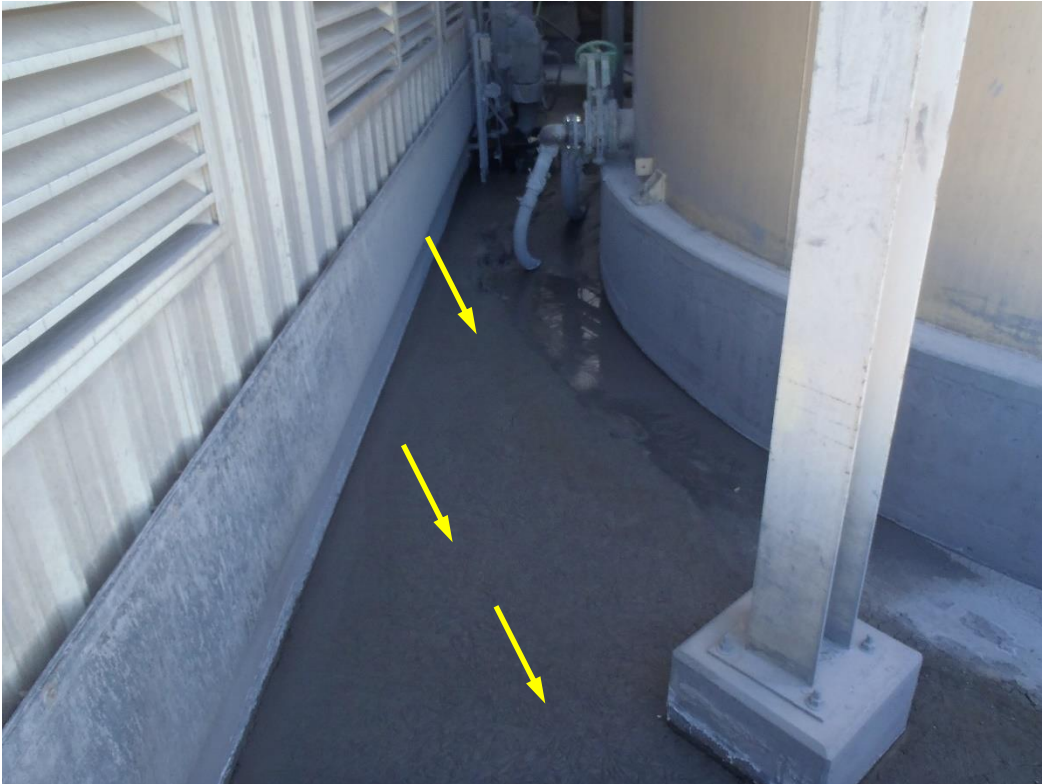
Photo 3. Vat leach secondary containment observed to be partially consumed.

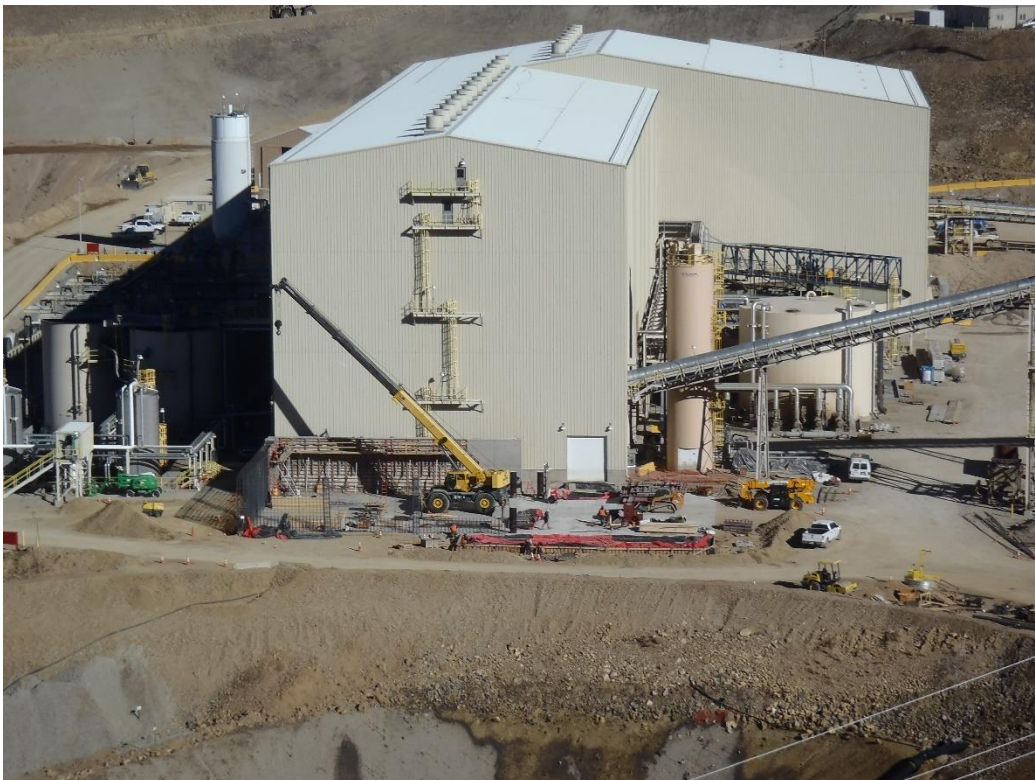
The Division observed the construction status of the new concentrate shipping facility (reference TR-89, Con Barn) as seen in **Photos 4** and **5**.

Photo 4. Concentrate shipping facility (Con Barn) construction (from AGVLF overlook, looking NNE).

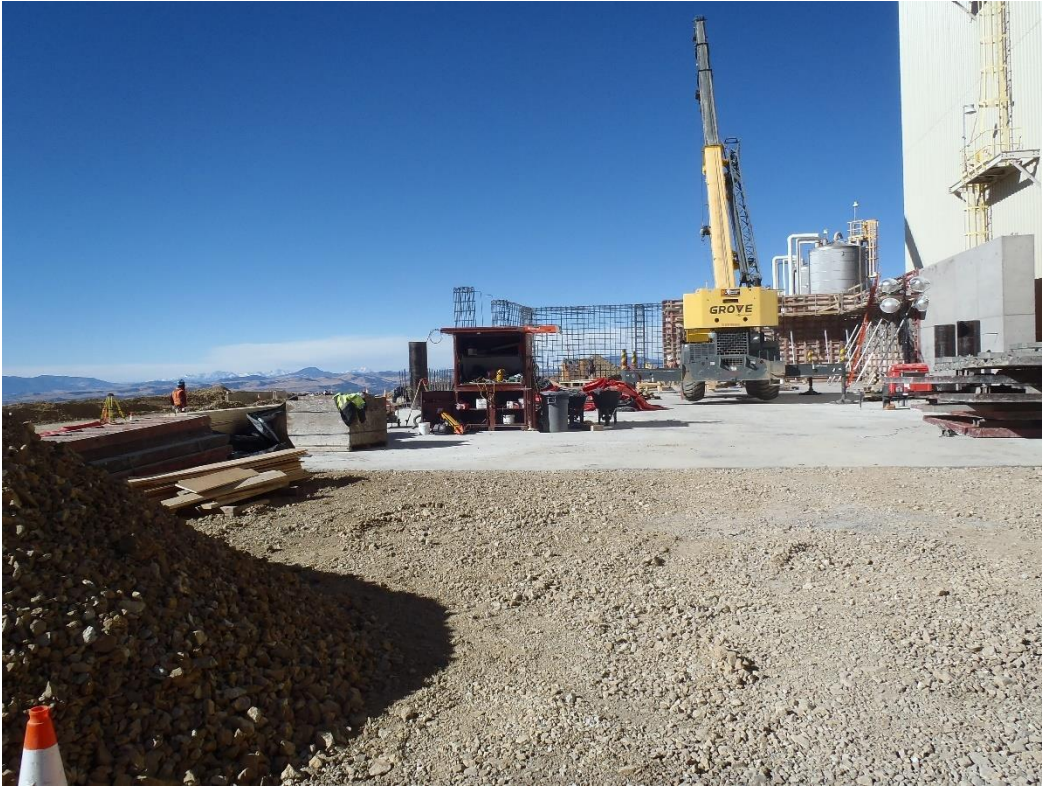
Photo 5. Concentrate shipping facility (Con Barn) construction (looking NW).

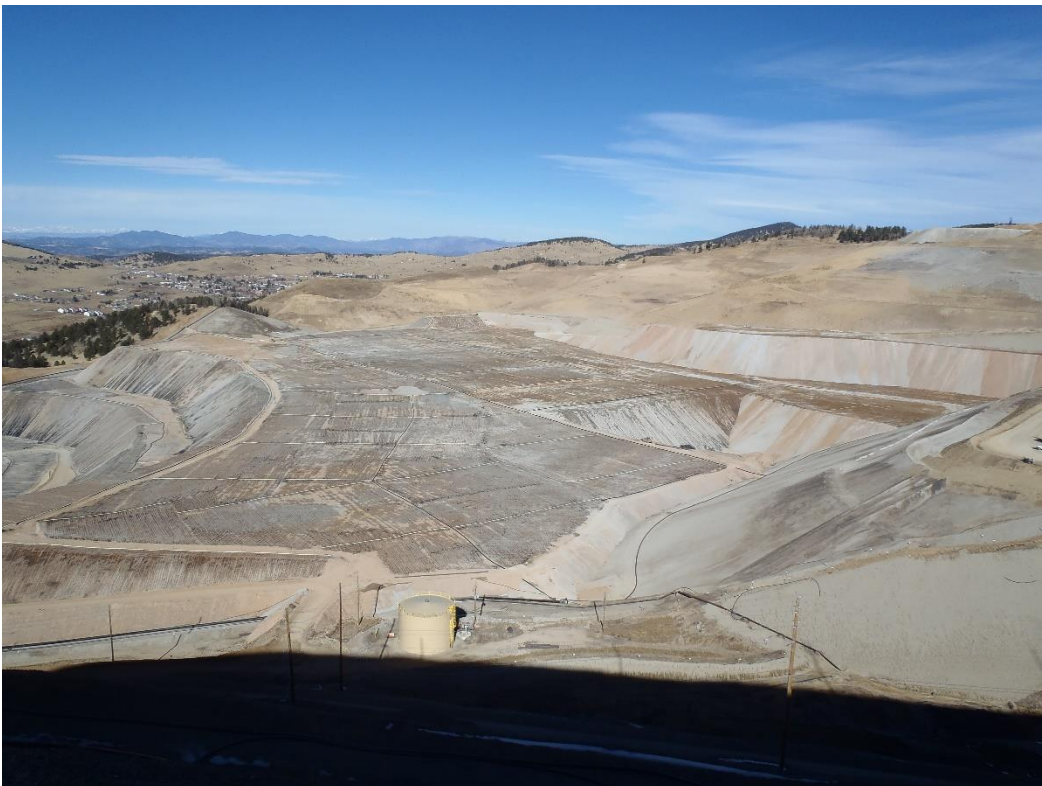
Squaw Gulch Valley Leach Facility: The Division was accompanied by Ms. Steward and Mr. Bills to observe the surface for ponded solution and general slope stability concerns (**Photo 6**). A small area of ponded solution was observed (**Photo 7**). CC&V's Process Group was contacted to address the ponded solution. The Division received photographic evidence of the ponded solution being eliminated on December 4, 2017. No slope concerns were observed.

Photo 6. SGVLF (from AGVLF overlook, looking NW).

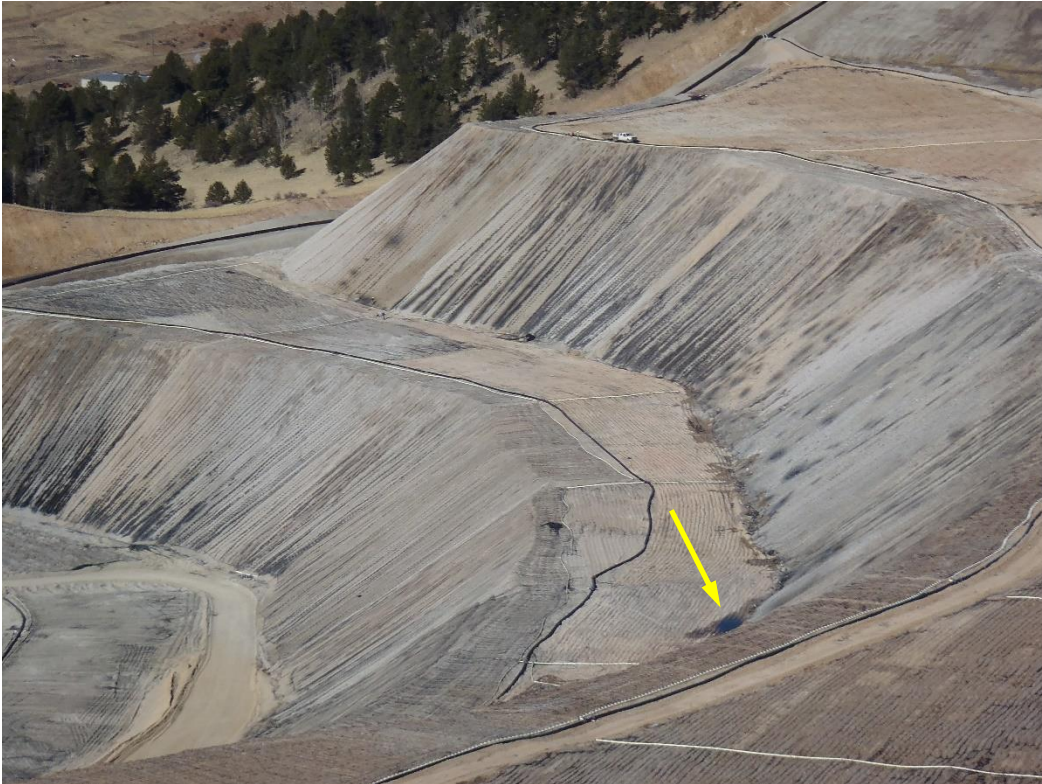
Photo 7. Ponded solution on SGVLF (from AGVLF overlook, looking NW).

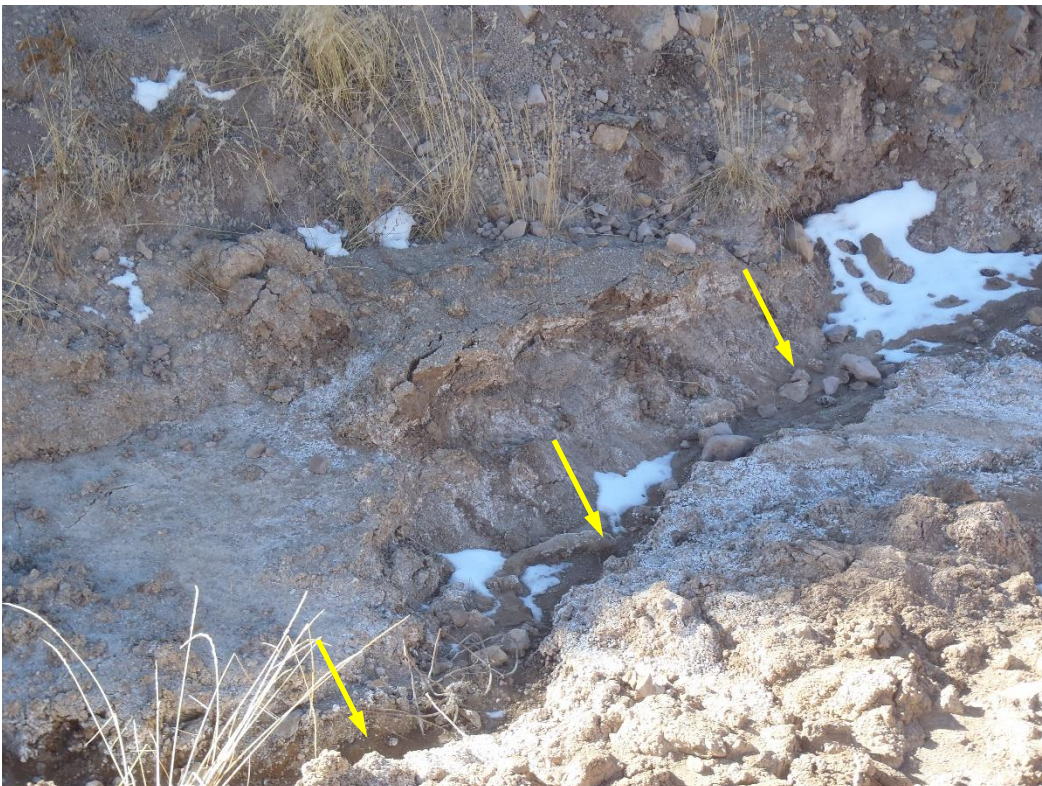
During this inspection, the Division was accompanied by Ms. Steward, Mr. Bills and Mr. Brian Crawford to observe the seep area. No flow was observed (see **Photo 8**) as the length of the seep area previously observed was walked. Ice and sediment were observed in the seep ponding area where CC&V has been collecting the seep water using a pump (see **Photo 9**).

Photo 8. No flow in ECOSA seep area.

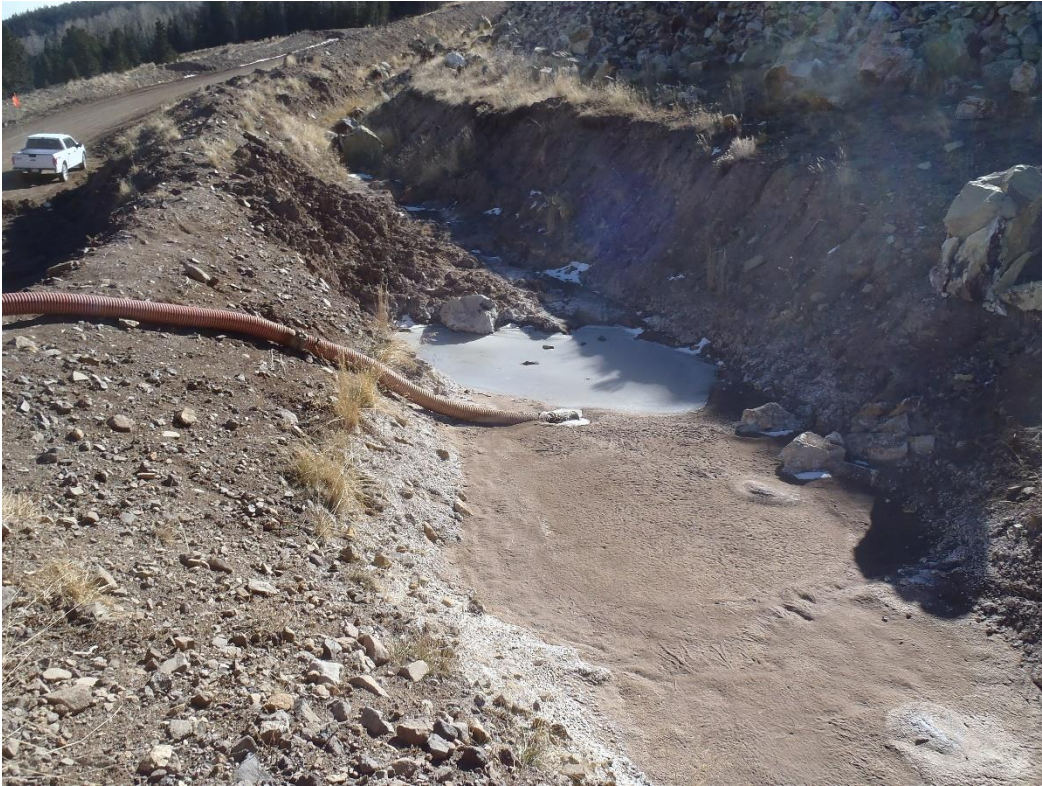
Photo 9. Ice and sediment observed in the ECOSA seep ponding area (looking south).
