COLORADO
Division of Reclamation,
Mining and Safety
Department of Natural Resources

PERMIT INFORMATION

Permit Number: C-1981-015 Mine Name: Fruita No 1 & 2 Operator: Dorchester Coal Company Operator Address: Greg Lewicki 9054 South Forrest Drive Highlands Ranch, CO 80126	County: Mesa Operation Type: Underground Permit Status: Revoked Ownership: Private
	Operator Representative Present: NA
Operator Representative Signature: (Field Issuance Only)

Inspection Start Date: October 24, 2017 Inspection Start Time: 15:00 Inspection End Date: October 24, 2017 Inspection End Time: 16:15		Inspection Type: Coal Complete Inspection Inspection Reason: Normal I&E Program Weather: Clear	
Joint Inspection Agency: None		Joint Inspection Contacts:	
Post Inspection Agency: None		Post Inspection Contacts:	
Inspector(s): Janet H. Binns	Inspector's Signature:

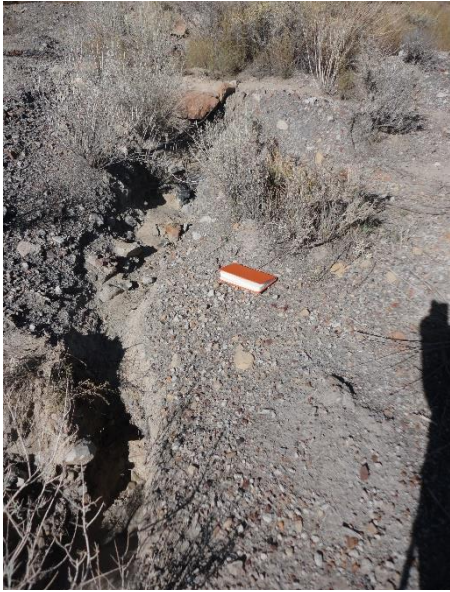
The regraded and reclaimed road to the portal bench remains in good condition. There is limited rill formation of short dlength. Surface roughness is effective in reducing the development of rills of long distance. Though there was evidence of trespass by the public (occasional water bottles), no damage to the reclamation was noted. The portal bench and out slope remain in good condition as well. Rilling is observed on the steep out slope of the bench, but this is expected and not concentrating into gully formation. The pond remains functional and slowing large flows of runoff prior to flowing off the site.

Photo 1: rill formation at base (south end) of road

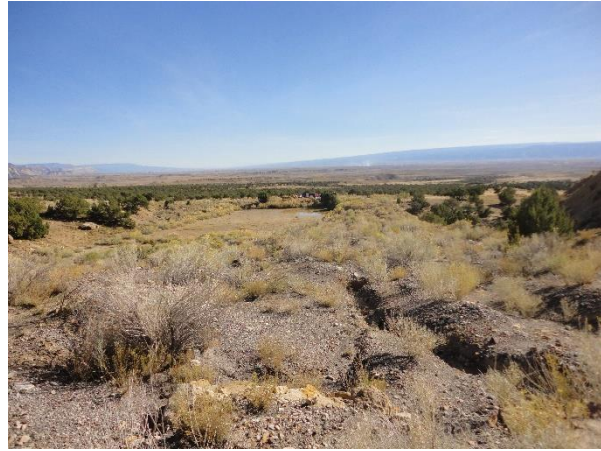
The pond was holding a shallow pool of clear water. New sediment had settled into the bottom of the pond. A couple feet of sediment storage remains before the pond will discharge out the channel. It did not appear

Photo 2: Reclaimed road and pond looking South

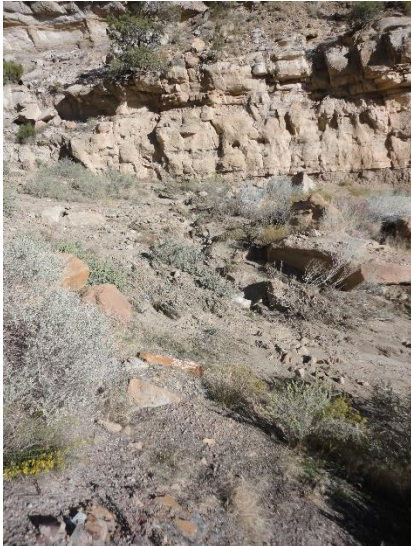
that the pond had discharged anytime recently. There was evidence of large flows of water across portions of the reclaimed mine. Some channeling had occurred on the reclaimed road, but this channeling merged into the permanent ditch and does not severely impact the reclamation. Another large flow crossed the reclaimed road at the drainage that previously had been controlled with a culvert. The flow did not cause significant erosion to the out slope. Another concentration of flow occurred where the road turns eastward. This flow also did not cause significant cutting on the out slope of the road. All runoff is directed to the pond.

Photo 3: sediment flow across reclaimed road

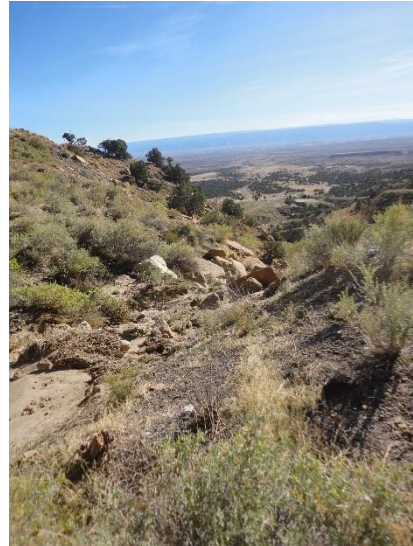
Photo 4: drainage that flow from photo 3 enters

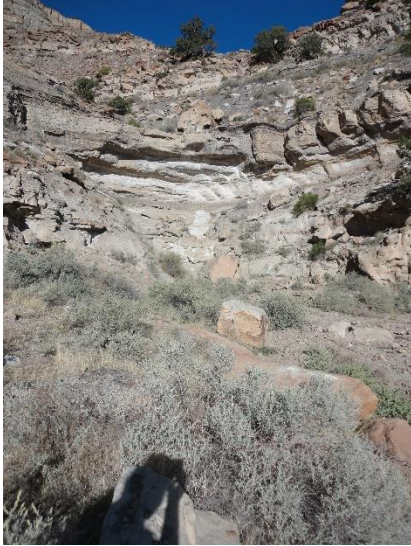
Photo 5: corner where road turns east, heavy run-on From upland undisturbed area.

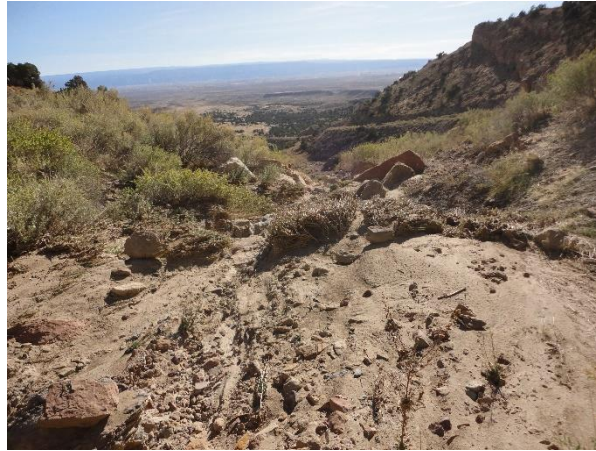
Photo 6: Sediment flow across reclaimed road at Photo 5 Location (looking SE)

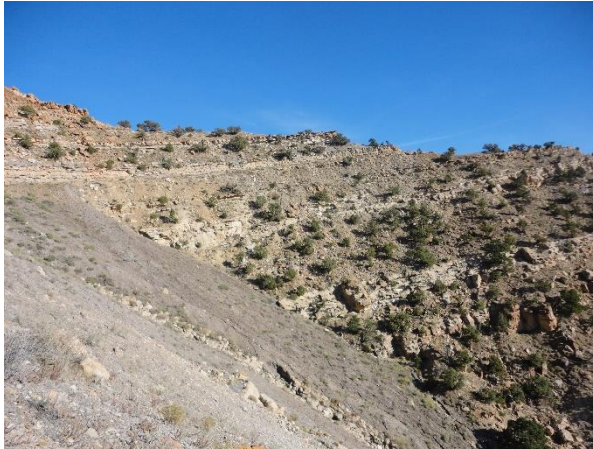
The permanent drainage across the top of the reclaimed portal bench and down the face of the out slope appears to be holding up well. There is some side cutting on the lower portion of the drainage on the out slope, but the majority of the flow remains within the drainage. There was evidence that this drainage has seen a large intense runoff event in the recent history.

Photo 7: Out slope of portal bench, some side cutting Of drainage visible

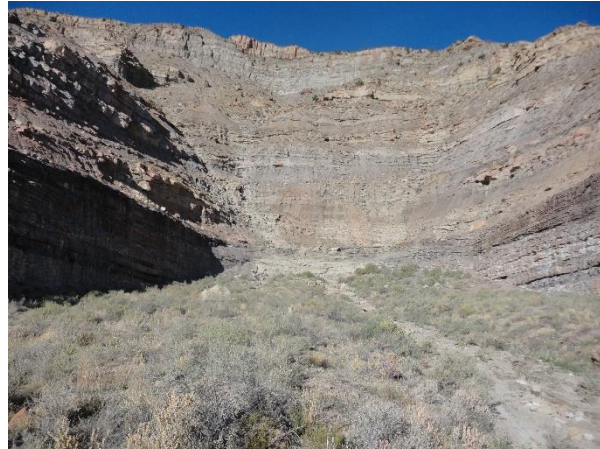
The mine portal appears stable. Some rock fall was apparent above the portal area that has obstructed the western upland collection ditch. No recent damage was noted on the reclaimed portal bench, bench out slope or reclaimed haul road.

Photo 8: Backfilled portals and portal bench

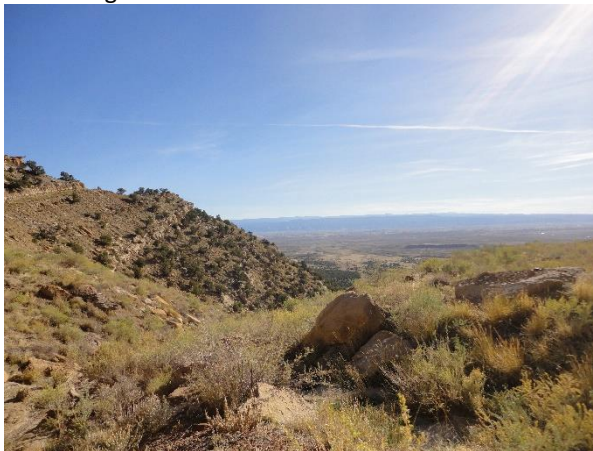
Photo 9: Drainage off portal bench, looking SE
