**MINERALS PROGRAM INSPECTION REPORT**  
**PHONE: (303) 866-3567**

<b>MINE NAME:</b> Cresson Project	<b>MINE/PROSPECTING ID#:</b> M-1980-244	<b>MINERAL:</b> Gold	<b>COUNTY:</b> Teller
<b>INSPECTION TYPE:</b> Monitoring	<b>INSPECTOR(S):</b> Timothy A. Cazier	<b>INSP. DATE:</b> November 29, 2017	<b>INSP. TIME:</b> 9:15
<b>OPERATOR:</b> Cripple Creek & Victor Gold Mining Company	<b>OPERATOR REPRESENTATIVE:</b> Justin Bills & Clara Steward	<b>TYPE OF OPERATION:</b> 112d-3 - Designated Mining Operation	
<b>REASON FOR INSPECTION:</b> Normal I&E Program	<b>BOND CALCULATION TYPE:</b> None	<b>BOND AMOUNT:</b> \$207,991,188.00	
<b>DATE OF COMPLAINT:</b> NA	<b>POST INSP. CONTACTS:</b> None	<b>JOINT INSP. AGENCY:</b> None	
<b>WEATHER:</b> Clear	<b>INSPECTOR'S SIGNATURE:</b>

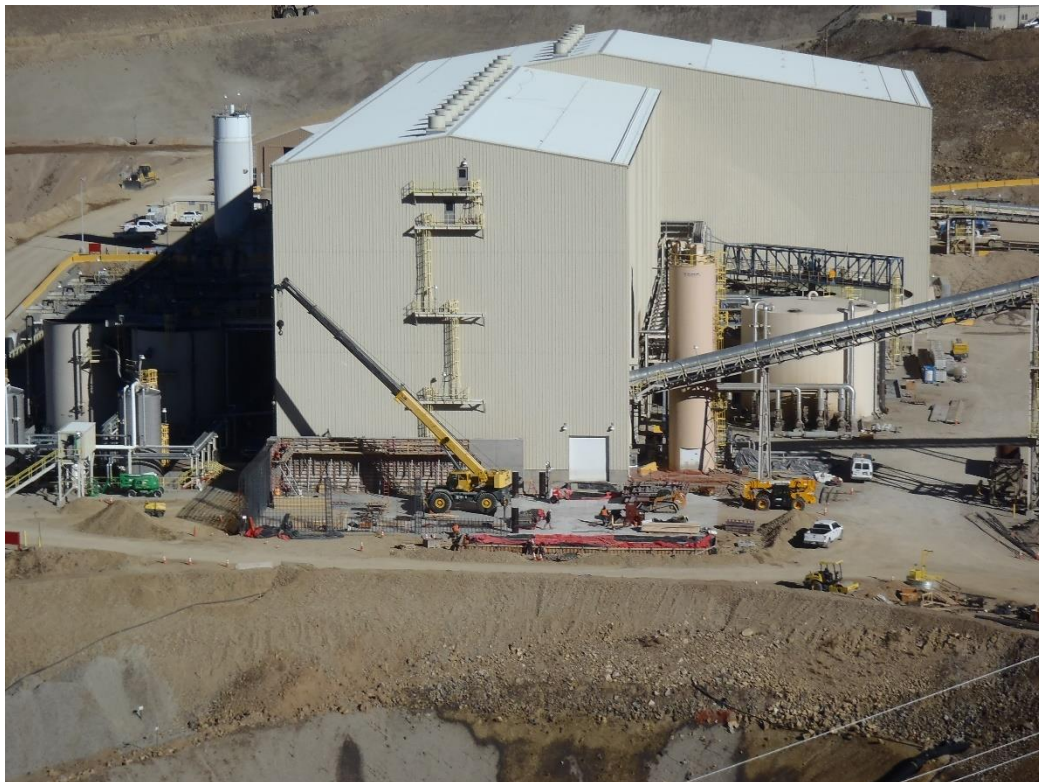
The Division observed the construction status of the new concentrate shipping facility (reference TR-89, Con Barn) as seen in **Photos 4** and **5**.

Photo 4. Concentrate shipping facility (Con Barn) construction (from AGVLF overlook, looking NNE).

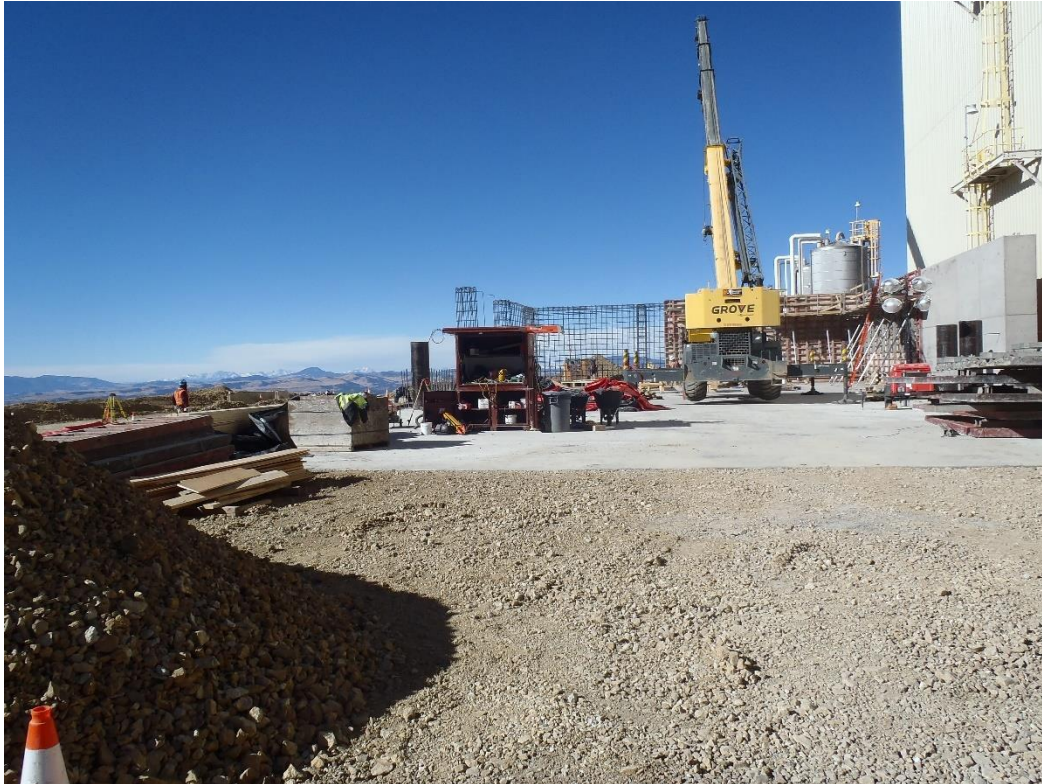
Photo 5. Concentrate shipping facility (Con Barn) construction (looking NW).

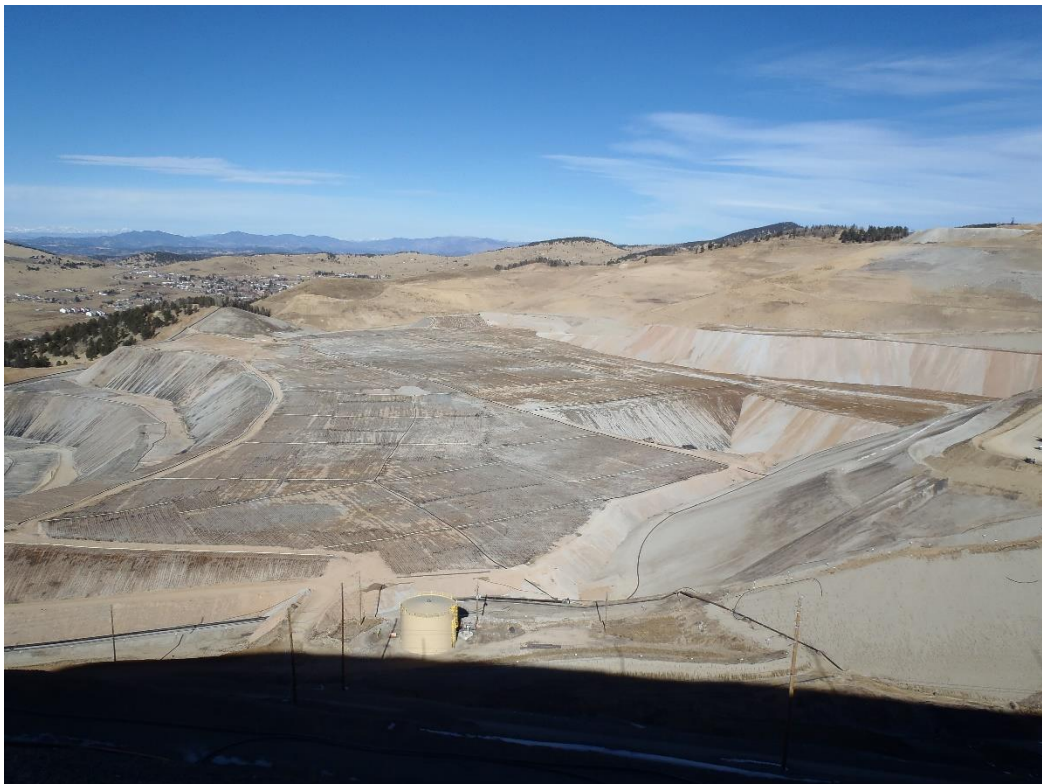
Squaw Gulch Valley Leach Facility: The Division was accompanied by Ms. Steward and Mr. Bills to observe the surface for ponded solution and general slope stability concerns (**Photo 6**). A small area of ponded solution was observed (**Photo 7**). CC&V's Process Group was contacted to address the ponded solution. The Division received photographic evidence of the ponded solution being eliminated on December 4, 2017. No slope concerns were observed.

Photo 6. SGVLF (from AGVLF overlook, looking NW).
