**COLORADO**Division of Reclamation,
Mining and Safety

MINERALS PROGRAM INSPECTION REPORT**PHONE: (303) 866-3567**

MINE NAME: Red Canyon Quarry	MINE/PROSPECTING ID#: M-1985-043	MINERAL: Aggregate and sand and gravel	COUNTY: Fremont
INSPECTION TYPE: Monitoring	INSPECTOR(S): Timothy A. Cazier	INSP. DATE: January 29, 2018	INSP. TIME: 09:30
OPERATOR: Rocky Mountain Materials and Asphalt, Inc.	OPERATOR REPRESENTATIVE: Dave Bieber, M.Sheahan, R.Cochrane, W. Stoughton	TYPE OF OPERATION: 112c - Construction Regular Operation

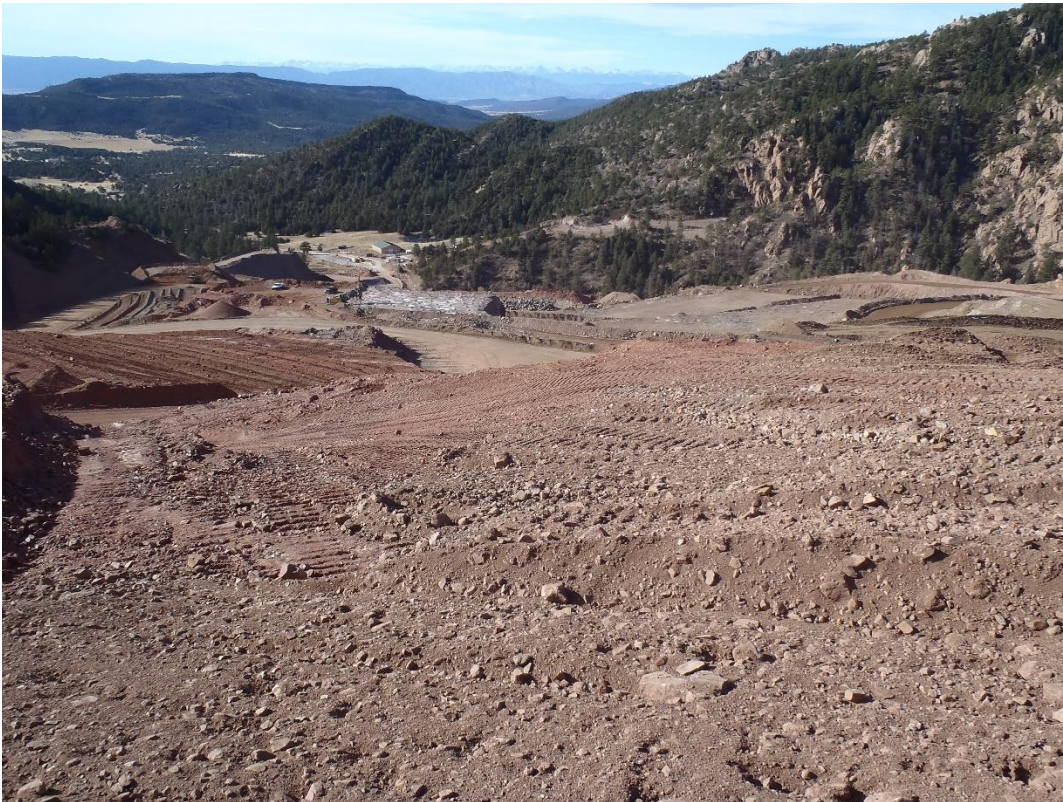
Backfilling and Grading: The Operator had begun grading material for reclamation prior to this inspection (**Photo 1**). Sufficient backfill material appeared available for reclamation.

Photo 1. Grading material for reclamation (top of Phase 1 ridge, looking SSW).

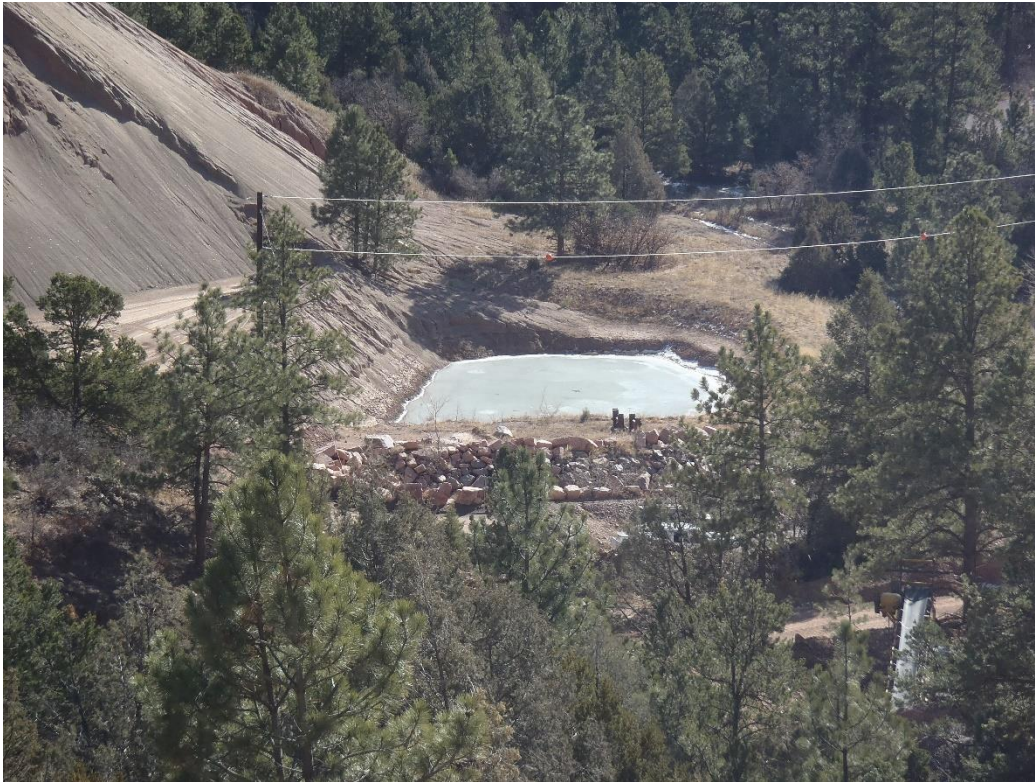
Hydrologic Balance: The Division was recently notified of an application for a Substitute Water Supply Plan (SWSP) through the Division of Water Resources for the site sediment pond (**Photo 2**) which has been determined to expose groundwater. Mr. Bieber stated during this inspection the SWSP had been approved by the DWR. The Division received a copy of the SWSP on February 9, 2018. During the review of the need for an SWSP, the Permittee committed to submitting a technical revision (TR) to adjust the size of the sediment pond as some of the design volume is now consumed by exposed groundwater. The Division expects to receive this TR within 60 days of the date of this report (April 28, 2018).

Photo 2. Site sediment pond (looking east).

- The technical revision for the redesign of the sediment pond is due to the Division 60 days after the

signature date of this report **(due April 28, 2018)**.

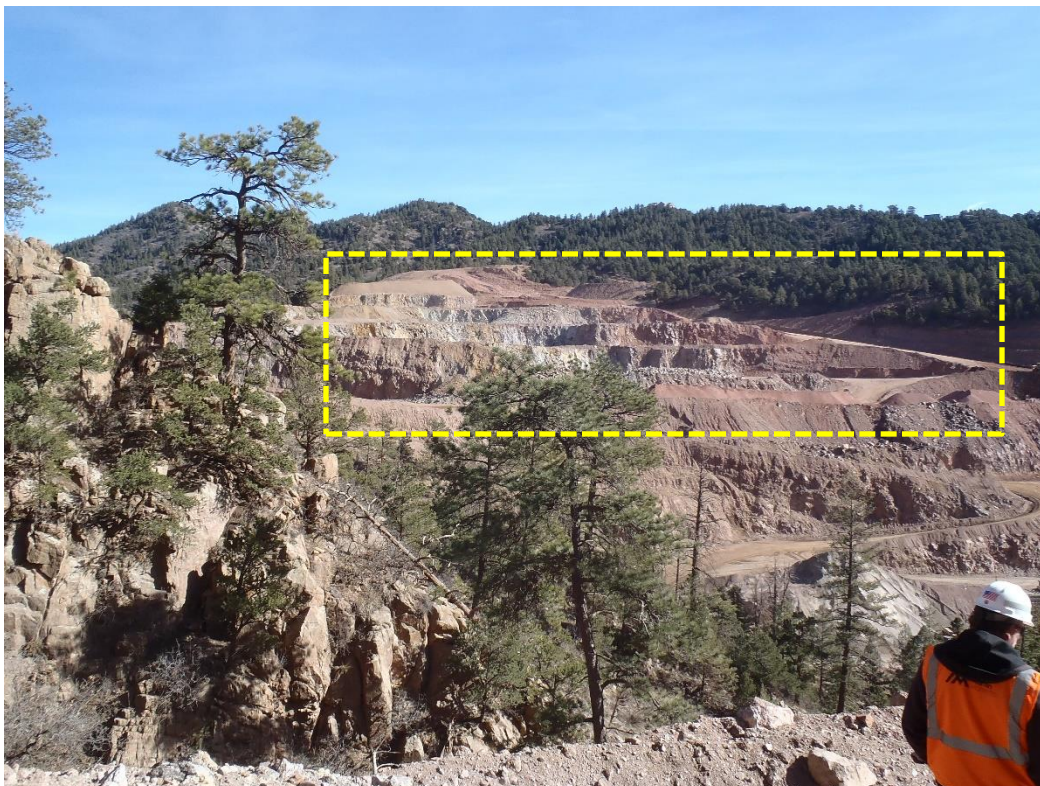
Reclamation Success: The Operator has begun grading and topsoil placement on the top of the ridge (**Photo 3**) in Phase 1. Mr. Bieber indicated the topsoil would likely need fertilizer and/or soil amendments.

Photo 3. Highwalls between benches, approximately 40 feet in height and stable (looking NE).

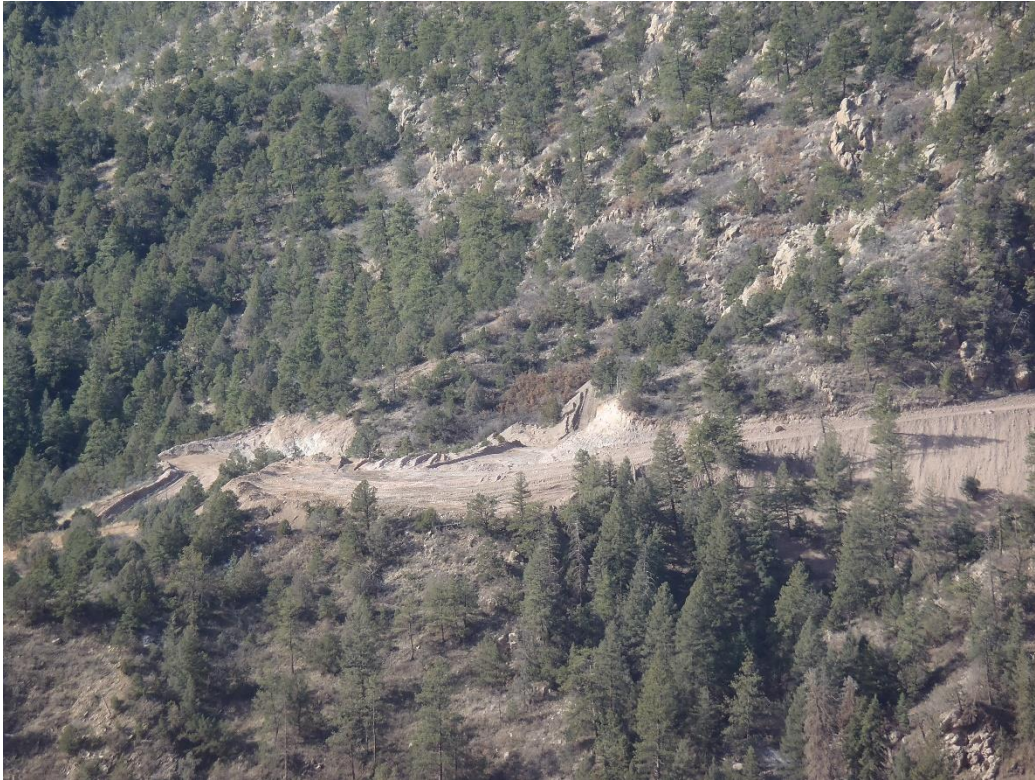
Off-site Damage: The operation appeared to be confined to the permit boundary, with the possible exception of the exploration road cut (**Photo 4**) west and uphill of the truck scale. Mr. Bieber pointed out the new road thinking it may be outside the permit boundary. The west side of the permit boundary has not been marked as

it was not planned to be disturbed for quite some time. Now that mine disturbance has progressed to the west, the lack of boundary markers on the west permit boundary is cited as a problem under Signs and Markers. The west boundary markers will need to be placed as part of the Corrective Action for this problem. Once the boundary markers are placed, the Division will determine whether or not mining activity has occurred outside the permit boundary. If this proves to be the case, additional problems may be cited. As this disturbance is related to exploration and Mr. Bieber indicated the Operation is interested possible westward expansion, the Division strongly encourages the Permittee to apply for a construction materials Notice of Intent (NOI) to explore. When approved by the Division, an NOI would cover reclamation requirements for exploration related activity.

Photo 4. Exploration road cut west and uphill of the truck scale (looking SW).

- Documentation demonstrating the installation of west side permit boundary markers is due **April 28, 2018) to the Division.**
- The Operator is performing exploration near the boundaries of the current permit boundary. The Division strongly recommends an application for Notice of Intent to conduct exploration (NOI) be submitted to the Division as soon as possible to cover potential exploration activity outside the permit boundary.

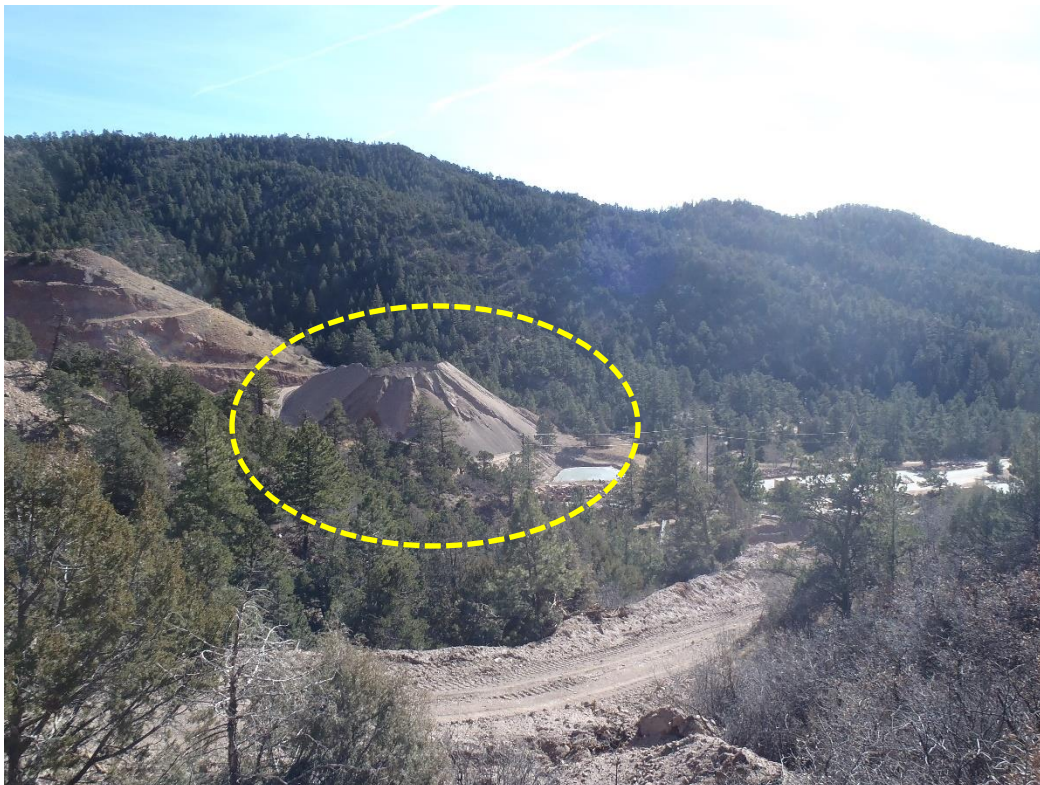
Processing Waste: The Operator has found a market for the fines stockpile (**Photo 5**), so it is now considered product, rather than waste.

Photo 5. Fines stockpile, now considered product, rather than waste (looking east).

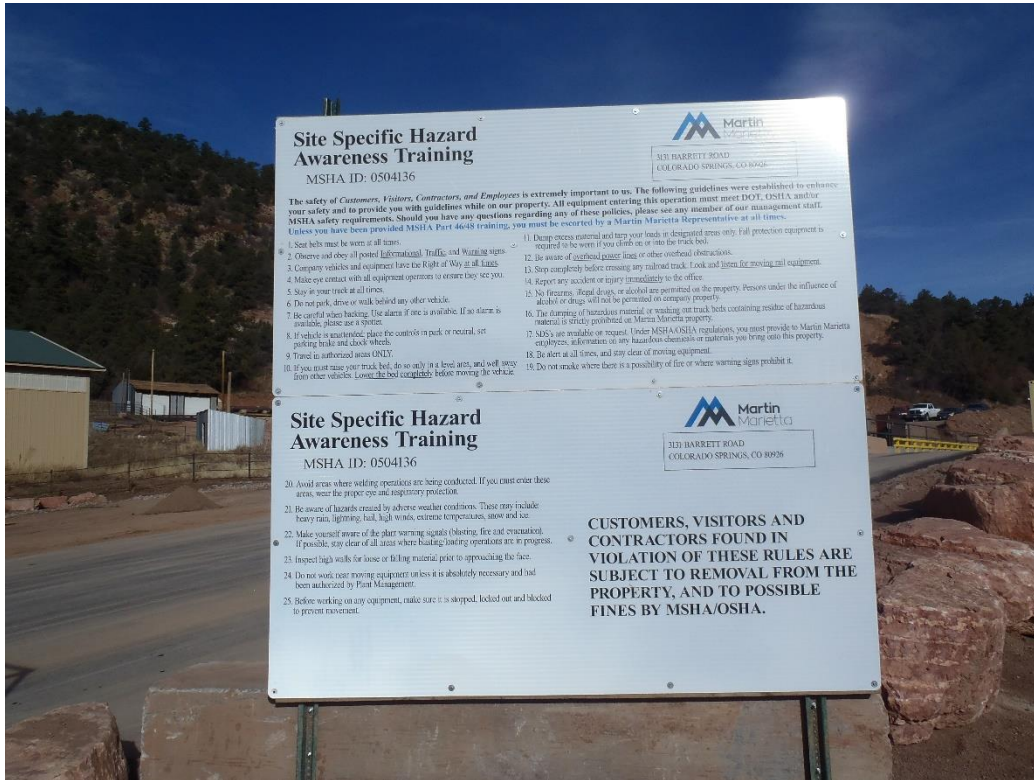
Signs and Markers: The permit number was missing from the mine's sign (see **Photo 6**) at the time of the inspection. The Permittee added the MLRB permit number to the sign and emailed a photo (see **Photo 7**) to the Division two days after this inspection. As discussed above under Off-site Damage, **the lack of boundary markers on the west permit boundary is cited as a problem on page 1 of this report.**

Photo 6. Sign near entrance missing permit number.

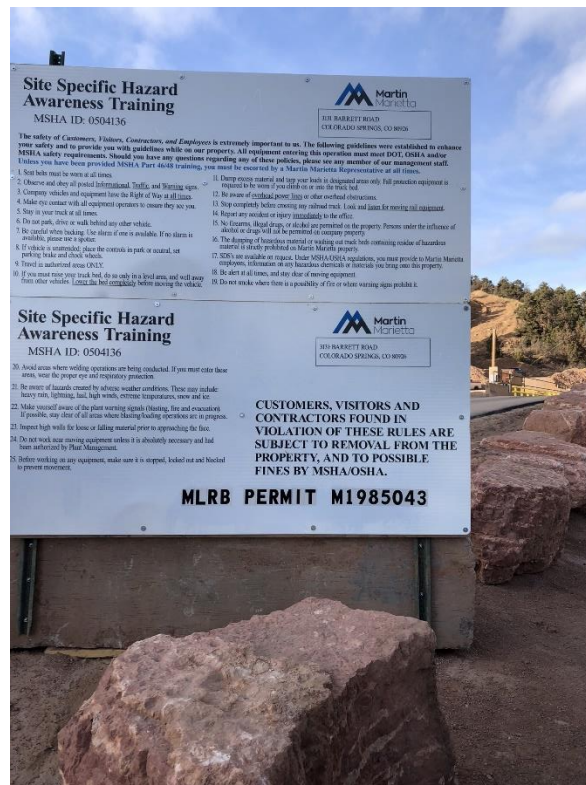
Photo 7. Permit number added to sign near entrance.
