PERMIT INFORMATION

Permit Number: C-1981-012 Mine Name: New Elk Mine Operator: New Elk Coal Company, LLC Operator Address: Mr. Louis Head 12250 Highway 12 Weston, CO 81091	County: Las Animas Operation Type: Underground Permit Status: Active Ownership: Private
	Operator Representative Present: None
Operator Representative Signature: (Field Issuance Only)

Inspection Start Date: February 26, 2018 Inspection Start Time: 10:41 Inspection End Date: Inspection End Time:	Inspection Type: Aerial Inspection Inspection Reason: Normal I&E Program Weather: Clear
Joint Inspection Agency: None	Joint Inspection Contacts:
Post Inspection Agency: None	Post Inspection Contacts:
Inspector(s): Harry B. Ranney	Inspector's Signature: <i>Robert D. Z...</i> Signature Date: 2/27/2018

The New Elk Mine was photographed from an airplane by Harry Ranney of DRMS on February 26, 2018. These photos were reviewed by Rob Zuber of DRMS on February 27, 2018. The weather was clear.

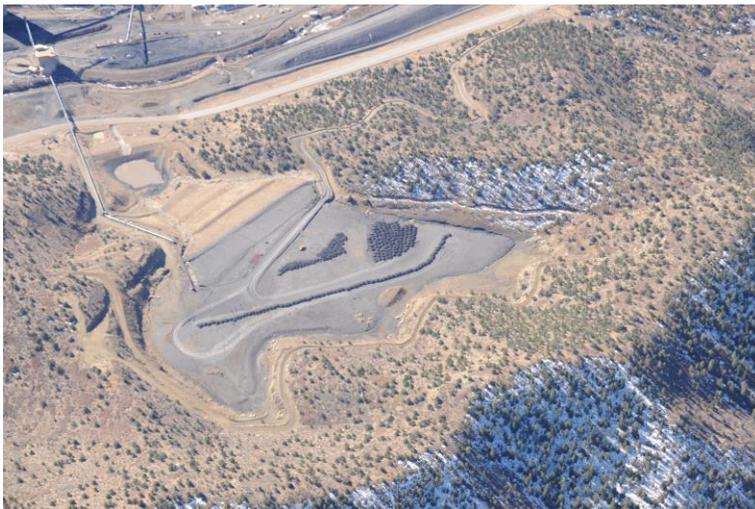
RDA and Pond 08

No erosion was seen on the face of the lower RDA (reclaimed portion). The ditch and sumps between the upper RDA and lower RDA appear to be functioning well. No problems were seen with the upper (un-reclaimed) portion of the RDA, but many piles of material (likely Pond 007A cleanings, which were stored for months at the Clean Coal Storage area) need to be spread soon to prevent ponding on the RDA.

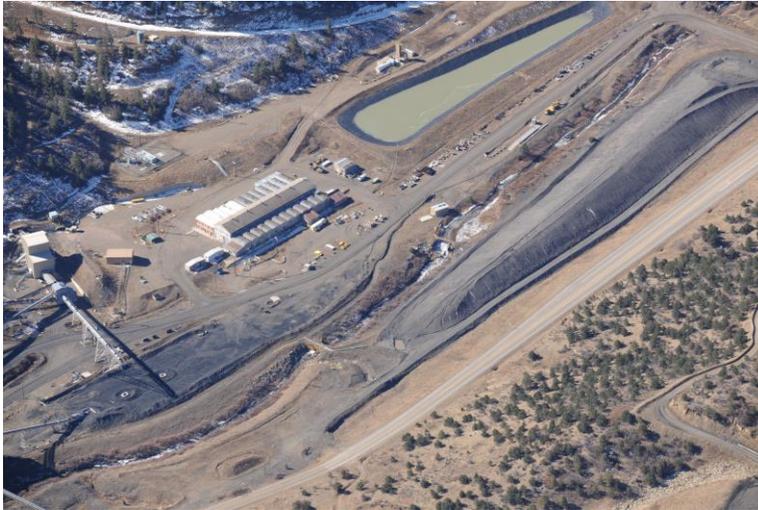
Areas around Pond 001A, DWDA#2, and Raw Coal Storage

No problems were identified with the reclaimed Development Coal Waste Pile. As in the past, the overall shape of the DWDA#2 looks good, but there are many rills on the sides of this pile.

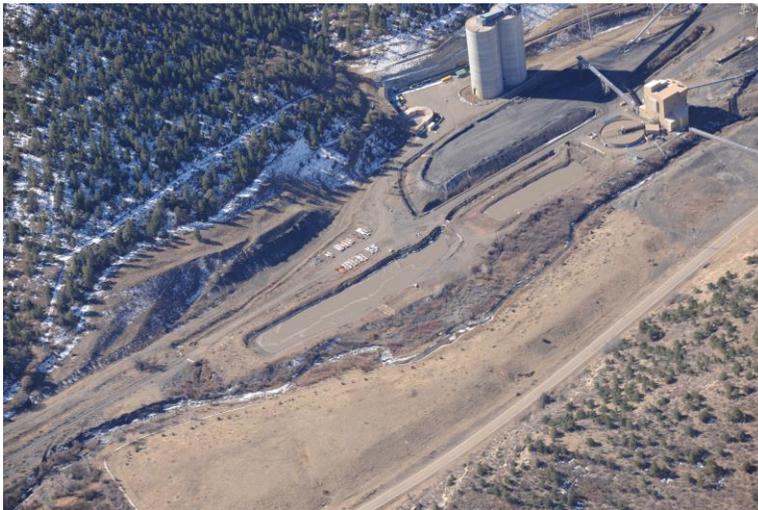
Areas around Pond 006A and Pond 007A

The following ponds were inspected: Pond 001A, Pond 004A, Pond 006A, Pond 007A, and Pond 08. All of the ponds were holding water (relatively small amount in Pond 004A). No issues were identified with any embankments or spillways.
