COLORADO
Division of Reclamation,
Mining and Safety
Department of Natural Resources

Permit Number: C-1981-008 Mine Name: New Horizon Mine Operator: Elk Ridge Mining and Reclamation, LLC Operator Address: Mr. Tony Tennyson 5731 State Highway 13 Meeker, CO 81641	County: Montrose Operation Type: Surface Permit Status: Active Ownership: Private
	Operator Representative Present: Frank Ferris
Operator Representative Signature: (Field Issuance Only)

Inspection Start Date: February 21, 2018 Inspection Start Time: 09:30 Inspection End Date: February 22, 2018 Inspection End Time: 13:00		Inspection Type: Coal Complete Inspection Inspection Reason: Normal I&E Program Weather: Clear	
Joint Inspection Agency: None		Joint Inspection Contacts: 	
Post Inspection Agency: None		Post Inspection Contacts: 	
Inspector(s): Brock F. Bowles	Inspector's Signature:

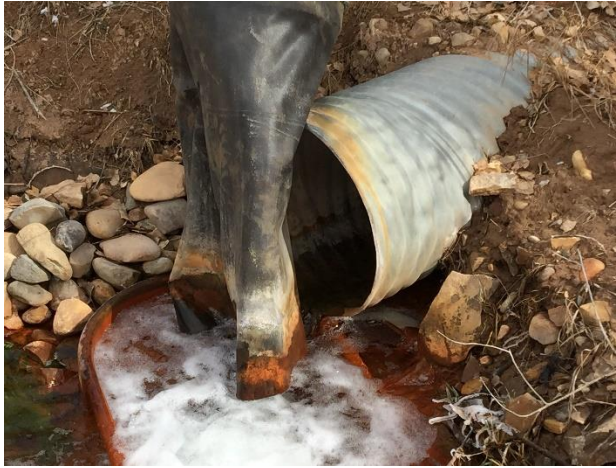
Photo 1 – Pond 13 and Trench Drain Discharge

Pond 13 contained water and was discharging. The emergency spillway was free and clear of obstructions. The embankment appeared to be stable. The trench drain was discharging (photo 1)

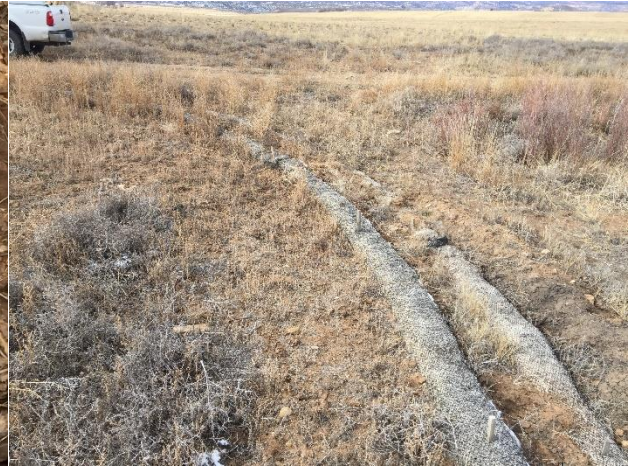
Photo 2 – Erosion Wattles

Erosion waddles were in good condition on the two adjacent support facilities located on the former northeast haul road (photo 2).

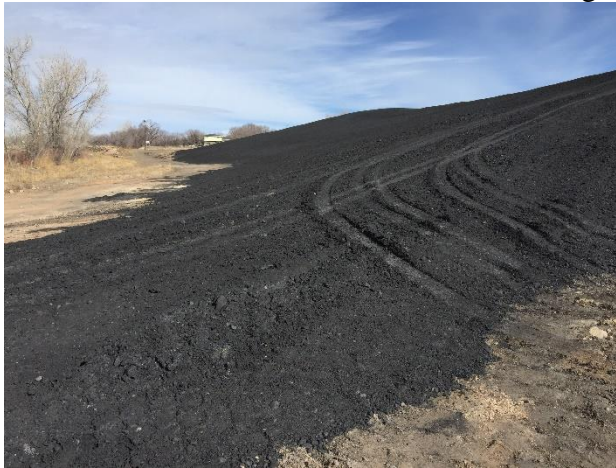
Photo 3 – Coal Stockpile

The coal stockpile was finished being stacked. The surface of the pile was treated with a surfactant to prevent blowing dust (photo 3).

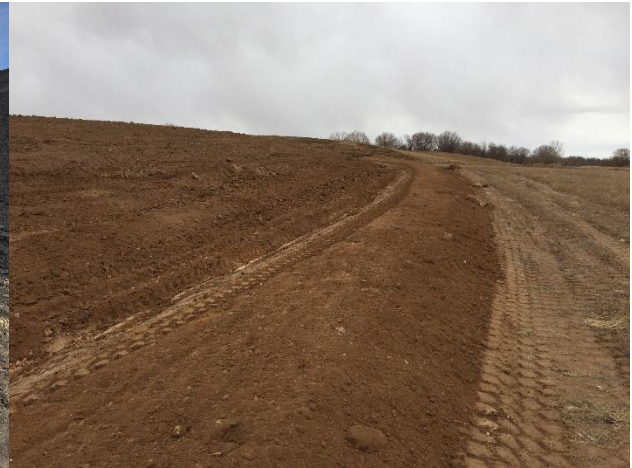
Photo 4 – Topsoil Stockpile South of Coal Pile

The topsoil pile south of the coal stockpile has been shaped to have shallow side slopes. The slopes were not measured but they appear to be less than 4h:1v and were ripped along the contour. A ring ditch was in place with sediment filters that drain into ditch C4A. Topsoil was used to construct the ring ditch berm on the south and west sides of the pile because the berm was constructed on topsoil (photo 4). The ring ditch berm on the east and north sides were constructed of subsoil because it was constructed on subsoil. The ring ditch berm on the north side of the topsoil pile was built with an extra sturdy berm to prevent runoff from the coal stockpile from entering the ring ditch (photo 5).

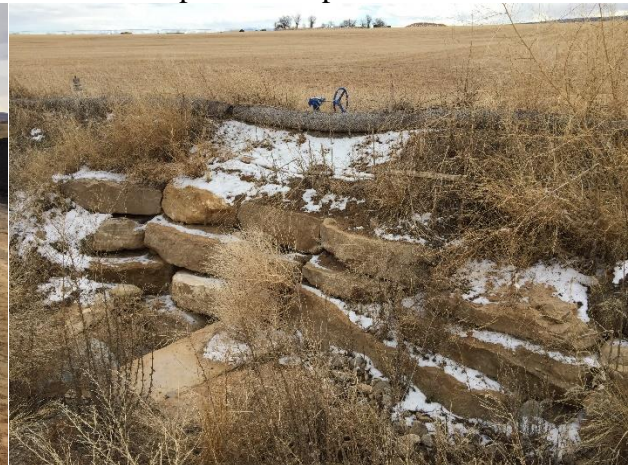
Photo 6 – Rock Retaining Wall

The rock retaining wall (photo 6) and sediment filter and rock cages on the northwest corner of the Morgan property appeared to be stable.
