**COLORADO**  
Division of Reclamation,  
Mining and Safety  
Department of Natural Resources

**PERMIT INFORMATION**

| <b>Permit Number:</b> C-2010-089<br><b>Mine Name:</b> New Horizon North Mine<br><b>Operator:</b> Elk Ridge Mining and Reclamation, LLC<br><b>Operator Address:</b><br>Mr. Tony Tennyson<br>5731 State Highway 13<br>Meeker, CO 81641 | <b>County:</b> Montrose<br><b>Operation Type:</b> Surface<br><b>Permit Status:</b> Active<br><b>Ownership:</b> Private |

| <b>Inspection Start Date:</b> February 22, 2018<br><b>Inspection Start Time:</b> 08:00<br><b>Inspection End Date:</b><br><b>Inspection End Time:</b> | | <b>Inspection Type:</b> Coal Partial Inspection<br><b>Inspection Reason:</b> Normal I&E Program<br><b>Weather:</b> Snowing | |

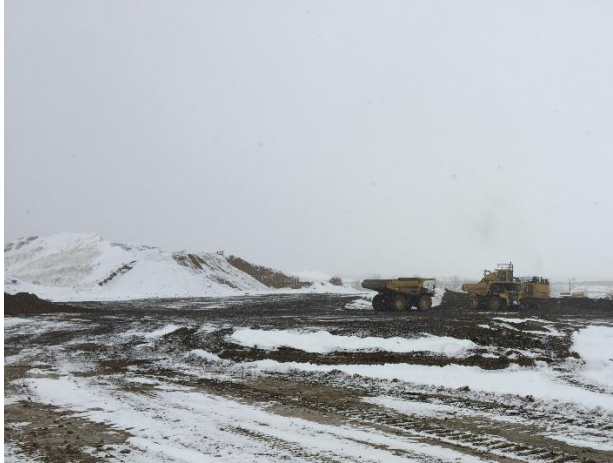
Some of topsoil stockpiles 1 & 2 was recently spread. The subsoil that was under these parts of the topsoil stockpiles was being recontoured to final PMT (photo 1). No topsoil was being handled due to the wet conditions. Only subsoil was being moved.

Photo 1 – Moving Subsoil

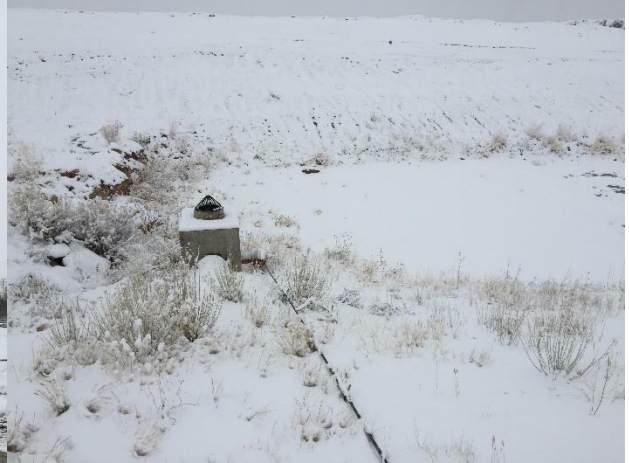
Pond 001 contained water but was not discharging. The pond was mostly snow covered. The primary spillway was clear of obstructions (photo 2). The embankment was snow covered but appeared to be stable.

Photo 2 – Pond 001 Primary Discharge

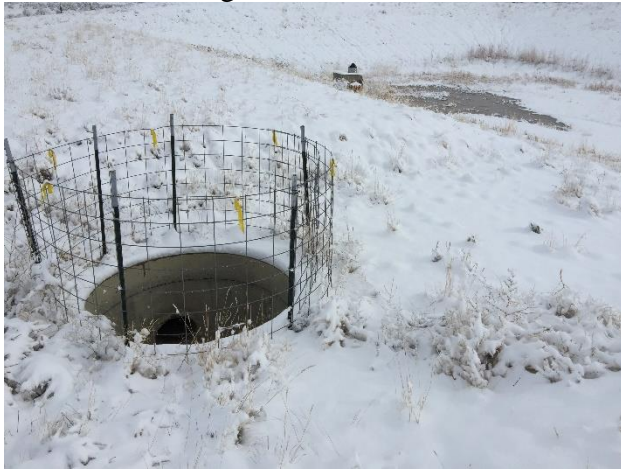
Pond 002 contained a small amount of water but was not discharging. The pond was mostly snow covered. The primary and emergency spillways were clear of obstructions (photo 3). The embankment was snow covered but appeared to be stable.

Photo 3 – Pond 002 Primary and Emergency Spillways
