Permit Number: C-1996-084 Mine Name: Lorencito Canyon Mine Operator: New Elk Coal Company, LLC Operator Address: Mr. Louis Head 12250 Highway 12 Weston, CO 81091 **County:** Las Animas **Operation Type:** Surface **Permit Status:** Permanent Cessation **Ownership:** Private

INSPECTION INFORMATION

COMMENTS

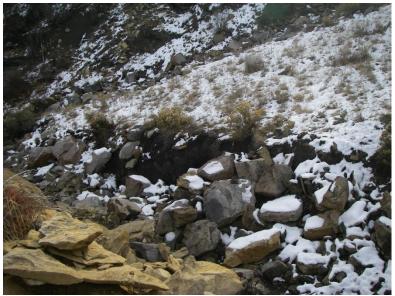
Fills 7, 8, and 9 were inspected (only a portion of Fill 9 was seen, from above). All were generally in good condition with good vegetation cover. The channel below Fill 8 appeared to be stable. NECC has placed large rocks to protect the partially bare bank of this channel (see photos).

PHOTO FROM NOVEMBER 2017 Channel below Fill 8

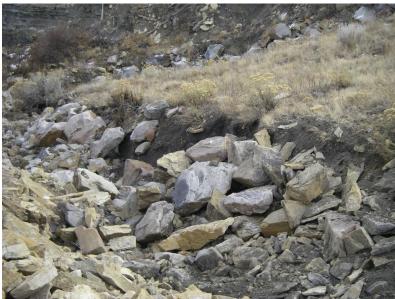
Channel below Fill 8 (January 2018) – channel has remained stable

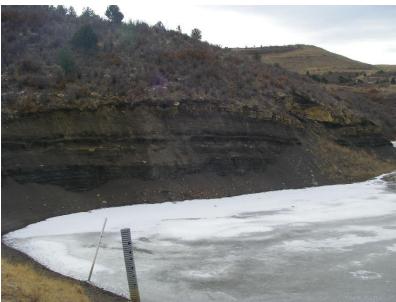
Three ponds were inspected: 6, 8, and 9. All three of these ponds were holding water but not discharging. No problems were identified with embankments or spillways.

Pond 8 – steep slope appears stable

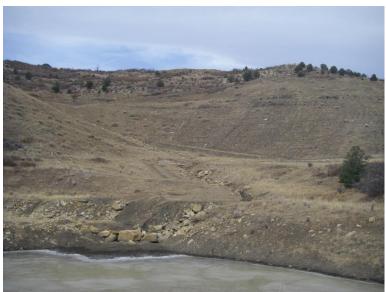
Hillside above Pond 6

The hillside above Pond 6 looked relatively stable. The rills do not appear to be getting worse.
