**PERMIT INFORMATION**

<b>Permit Number:</b> C-1996-084 <b>Mine Name:</b> Lorencito Canyon Mine <b>Operator:</b> New Elk Coal Company, LLC <b>Operator Address:</b> Mr. Louis Head 12250 Highway 12 Weston, CO 81091	<b>County:</b> Las Animas <b>Operation Type:</b> Surface <b>Permit Status:</b> Permanent Cessation <b>Ownership:</b> Private
	<b>Operator Representative Present:</b>  None
<b>Operator Representative Signature: (Field Issuance Only)</b>

**INSPECTION INFORMATION**

<b>Inspection Start Date:</b> February 26, 2018 <b>Inspection Start Time:</b> 10:45 <b>Inspection End Date:</b> <b>Inspection End Time:</b>		<b>Inspection Type:</b> Aerial Inspection <b>Inspection Reason:</b> Normal I&E Program <b>Weather:</b> Clear	
<b>Joint Inspection Agency:</b>  None		<b>Joint Inspection Contacts:</b>  	
<b>Post Inspection Agency:</b>  None		<b>Post Inspection Contacts:</b>  	
<b>Inspector(s):</b>  Harry B. Ranney	<b>Inspector's Signature:</b>

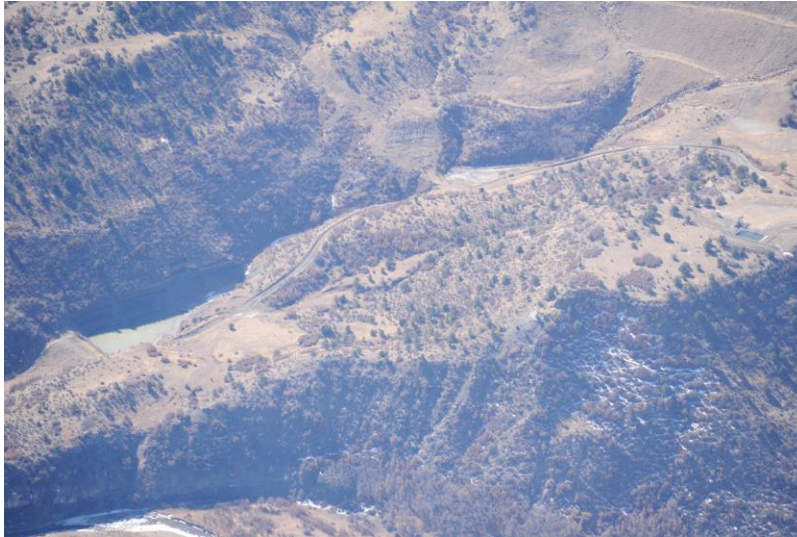
No large rills or other problems were identified with Fills 7, 8, or 9.

Ponds 6, 7, 8, 9, and 9A were inspected, and all contained water. No issues were identified with embankments or spillways.

**Pond 8 on left side of photo. Fill 8 in upper right.**

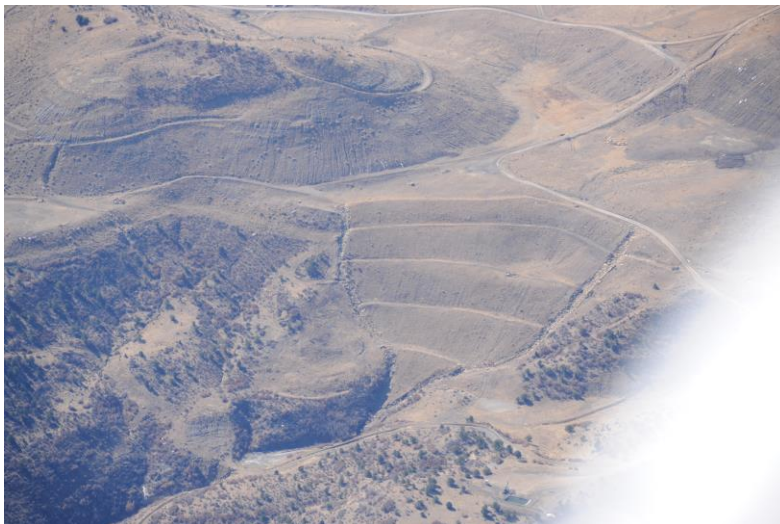
The east, west, and north sides of the large hill (aka “the knob”) have many rills. NECC should continue to monitor these to determine which rills require maintenance. The same is true for other hills within the disturbed area, including the hill south of Fill 8 (above the sediment dump area).

**Fill 8 and west side of “the knob”**

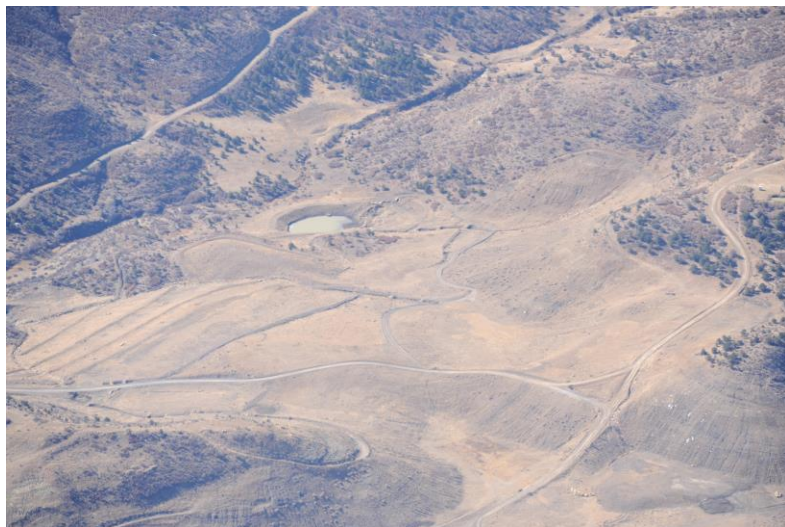
**Fill 7 and Pond 6 in left side**

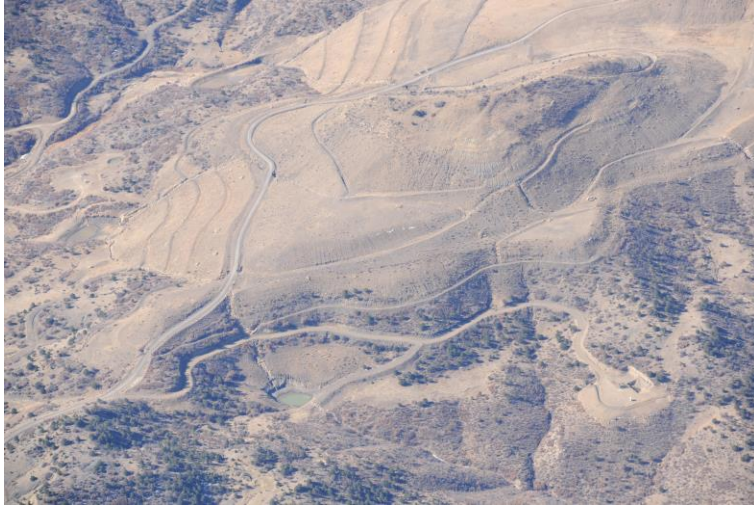
**Fill 7, Fill 9, and “the knob”**

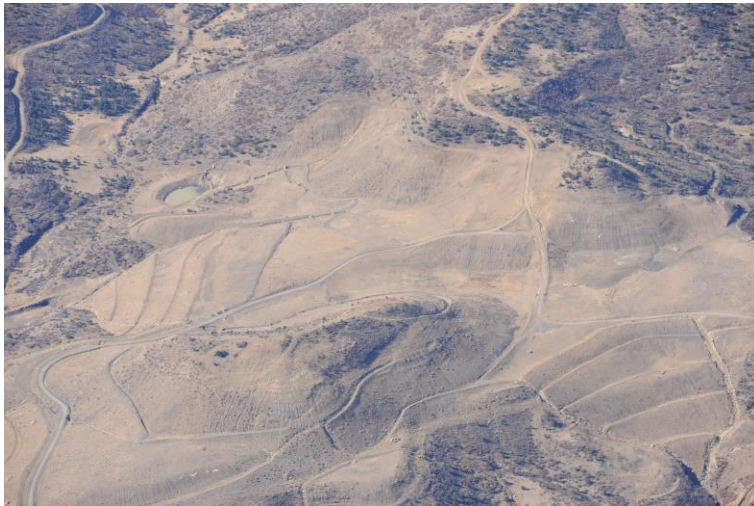
**Fill 7, Fill 8, and “the knob”**
