**COLORADO**  
Division of Reclamation,  
Mining and Safety  
Department of Natural Resources

<b>Permit Number:</b> C-1981-035 <b>Mine Name:</b> King Coal Mine <b>Operator:</b> GCC Energy, LLC <b>Operator Address:</b> Mr. Tom Bird 6473 County Road 120 Hesperus, CO 81326	<b>County:</b> La Plata <b>Operation Type:</b> Underground <b>Permit Status:</b> Active <b>Ownership:</b> Federal
	<b>Operator Representative Present:</b>  None
<b>Operator Representative Signature: (Field Issuance Only)</b>

<b>Inspection Start Date:</b> February 26, 2018 <b>Inspection Start Time:</b> 12:29 <b>Inspection End Date:</b> <b>Inspection End Time:</b>		<b>Inspection Type:</b> Aerial Inspection <b>Inspection Reason:</b> Normal I&E Program <b>Weather:</b> Clear	
<b>Joint Inspection Agency:</b>  None		<b>Joint Inspection Contacts:</b>	
<b>Post Inspection Agency:</b>  None		<b>Post Inspection Contacts:</b>	
<b>Inspector(s):</b>  Harry B. Ranney	<b>Inspector's Signature:</b>

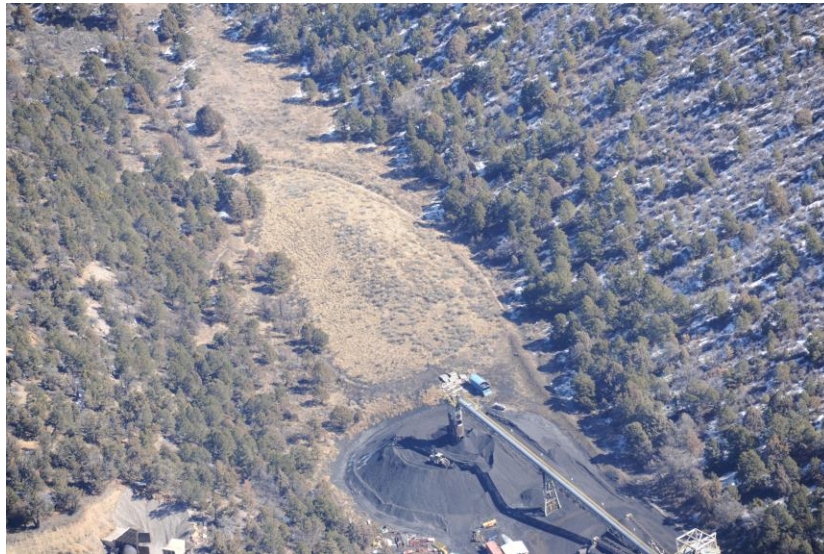
**King II topsoil stockpile**

No problems were seen with the Topsoil Stockpiles at King II. They appear to be well vegetated, and there are no signs that the soil has been transported off the piles by runoff.
