**COLORADO**Division of Reclamation,
Mining and Safety

MINERALS PROGRAM INSPECTION REPORT**PHONE: (303) 866-3567**

MINE NAME: Animas Glacier Gravel (AGG)	MINE/PROSPECTING ID#: M-2011-028	MINERAL: Gravel and sand	COUNTY: La Plata
INSPECTION TYPE: Monitoring	INSPECTOR(S): Lucas J. West	INSP. DATE: February 6, 2018	INSP. TIME: 08:00
OPERATOR: Oldcastle SW Group, Inc. dba Four Corners M	OPERATOR REPRESENTATIVE: Matt Carnahan	TYPE OF OPERATION: 112c - Construction Regular Operation	
REASON FOR INSPECTION: High Priority	BOND CALCULATION TYPE: Complete Bond	BOND AMOUNT: \$78,788.37	
DATE OF COMPLAINT: NA	POST INSP. CONTACTS: None	JOINT INSP. AGENCY: None	
WEATHER: Raining	INSPECTOR'S SIGNATURE:

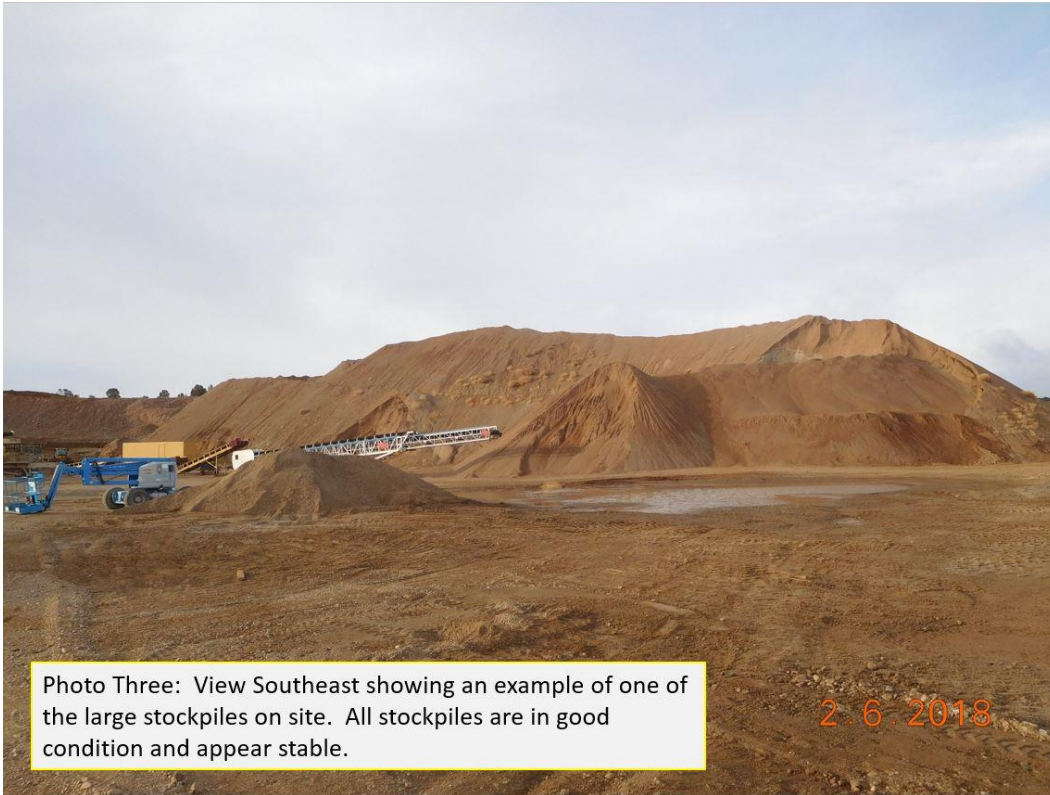
Photo Three: View Southeast showing an example of one of the large stockpiles on site. All stockpiles are in good condition and appear stable.

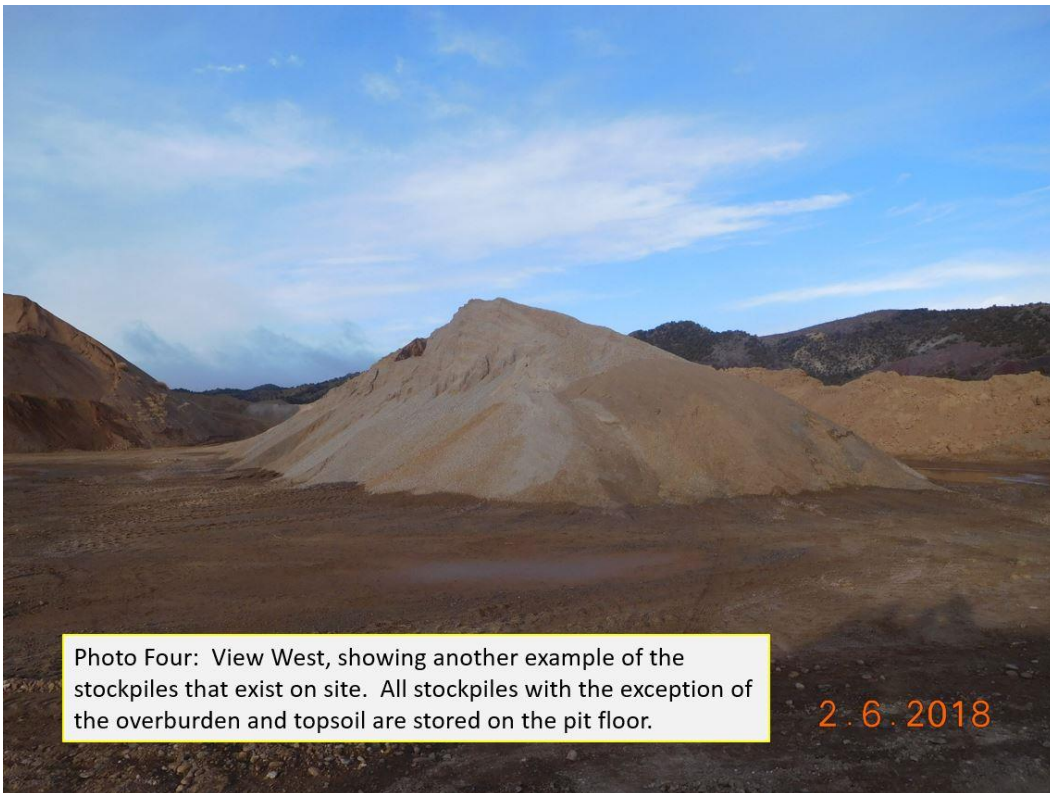
Photo Four: View West, showing another example of the stockpiles that exist on site. All stockpiles with the exception of the overburden and topsoil are stored on the pit floor.

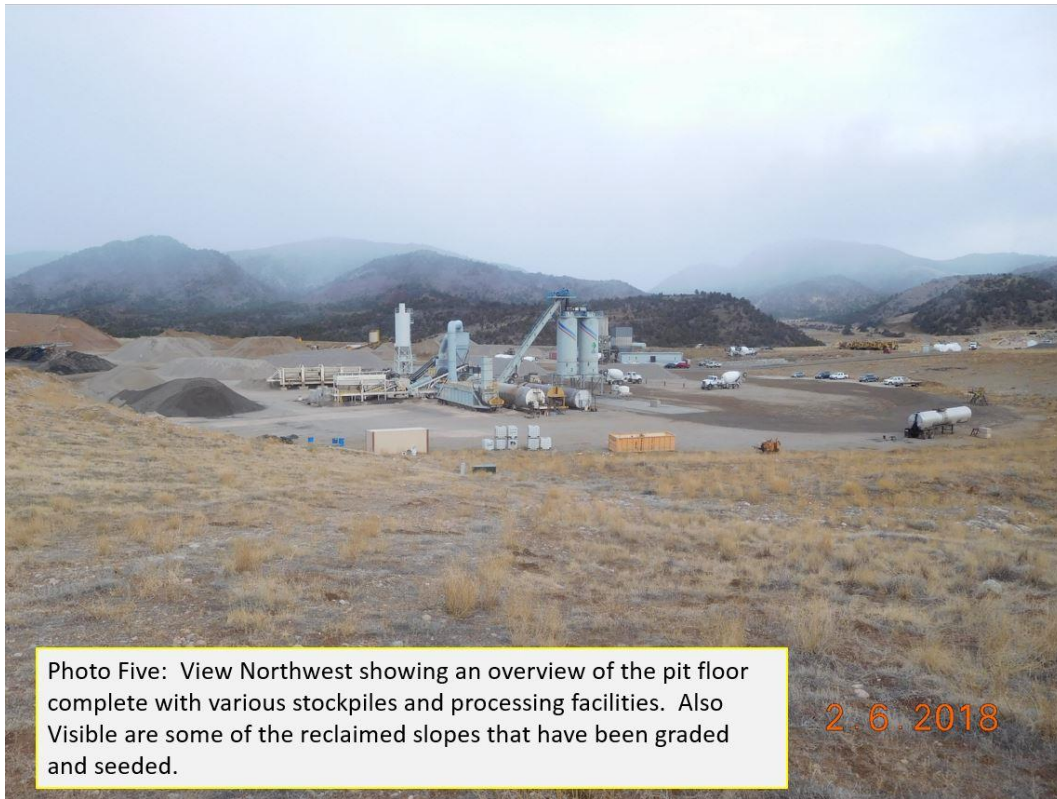
Several large stockpiles of various sized materials were on the pit floor. All stockpiles observed appeared to be in good condition and stable. Examples of the stockpiles can be seen in Photos Three and Four. An overview of the pit floor can be seen in Photo Five. Several facilities exist on the pit floor including the crusher, conveyors, wash plant, concrete batch and asphalt hot plants as well others. All facilities are in excellent condition with all of the ancillary equipment stored in a neat and orderly fashion. Near the asphalt hot plant is a mobile office trailer currently being used as an office as well as a large area being used as a laydown/ storage area. All items being stored in the storage area are in good condition and stored in a neat and orderly fashion. In the storage area are two large double walled above ground fuel storage containers. The proper safety and spill kits are located adjacent to the tanks and because they are double walled with built in secondary containment, no additional containment measures are required.
