MINERALS PROGRAM INSPECTION REPORT
PHONE: (303) 866-3567

MINE NAME: Cresson Project	MINE/PROSPECTING ID#: M-1980-244	MINERAL: Gold	COUNTY: Teller
INSPECTION TYPE: Monitoring	INSPECTOR(S): Timothy A. Cazier	INSP. DATE: January 23, 2018	INSP. TIME: 10:00
OPERATOR: Cripple Creek & Victor Gold Mining Company	OPERATOR REPRESENTATIVE: Justin Bills & Clara Steward	TYPE OF OPERATION: 112d-3 - Designated Mining Operation	
REASON FOR INSPECTION: Normal I&E Program	BOND CALCULATION TYPE: None	BOND AMOUNT: \$207,991,188.00*	
DATE OF COMPLAINT: NA	POST INSP. CONTACTS: None	JOINT INSP. AGENCY: None	
WEATHER: Clear	INSPECTOR'S SIGNATURE:

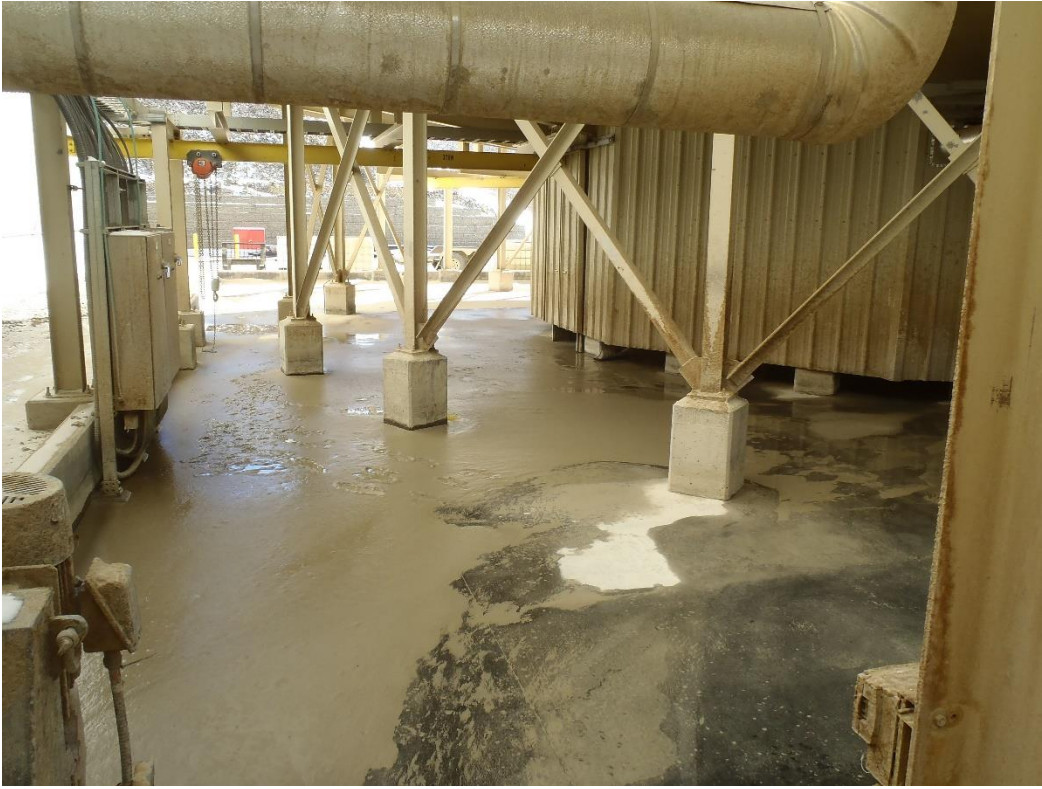
High Grade Mill: The Division was accompanied by Rich Griffin at the HGM to perform an exterior walk-around inspection. The focus was to observe the status of secondary containment on both the west side (vat leach area) and the east side. No significant reduction in the secondary containment volume was observed on the east side, only some water in the secondary containment area for the Process Ore Thickener (**Photo 1**). Secondary containment on the vat leach side was observed to be partially consumed (**Photo 2**). CC&V representatives stated it would be cleaned up. The Division received photographic evidence of the cleaned up secondary containment on February 15, 2018, citing freezing temperatures as causing the delay.

Photo 1. Water observed in secondary containment area for the Process Ore Thickener.

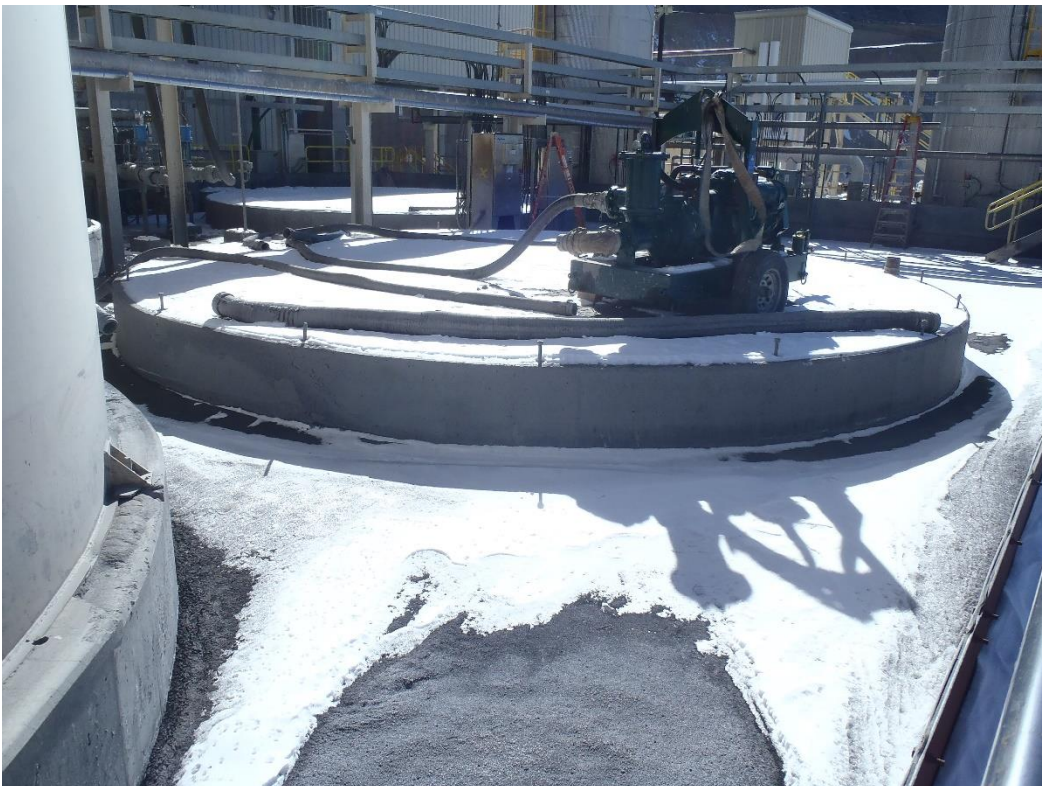
Photo 2. Secondary containment in vat leach area observed to be partially consumed.

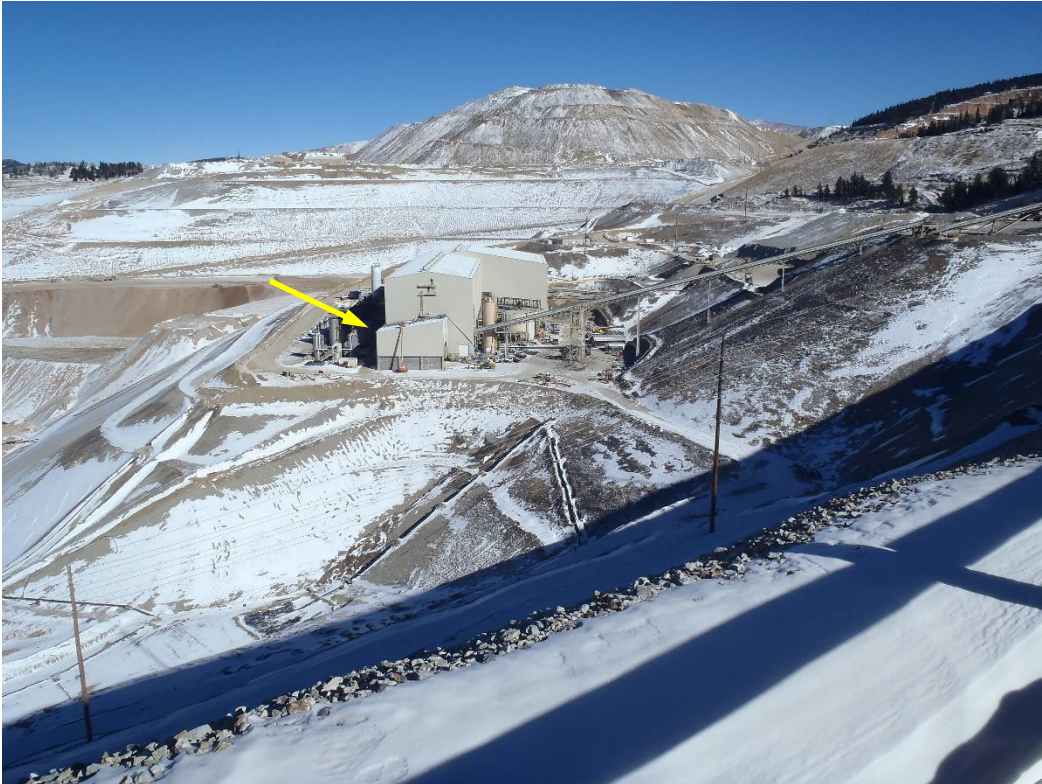
The Division observed the construction status of the new concentrate shipping facility (reference TR-89, Con Barn) as seen in **Photos 3** and **4**.

Photo 3. Concentrate shipping facility (Con Barn) construction (from AGVLF overlook, looking NNE).

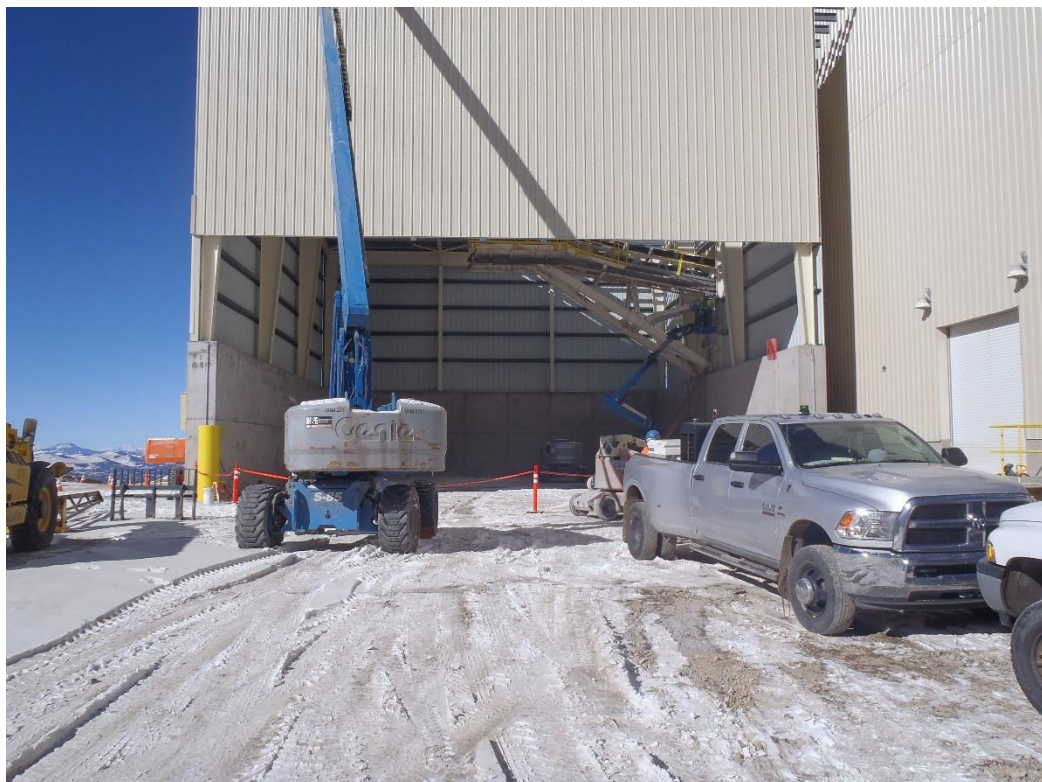
Photo 4. Concentrate shipping facility (Con Barn) construction (looking NW).

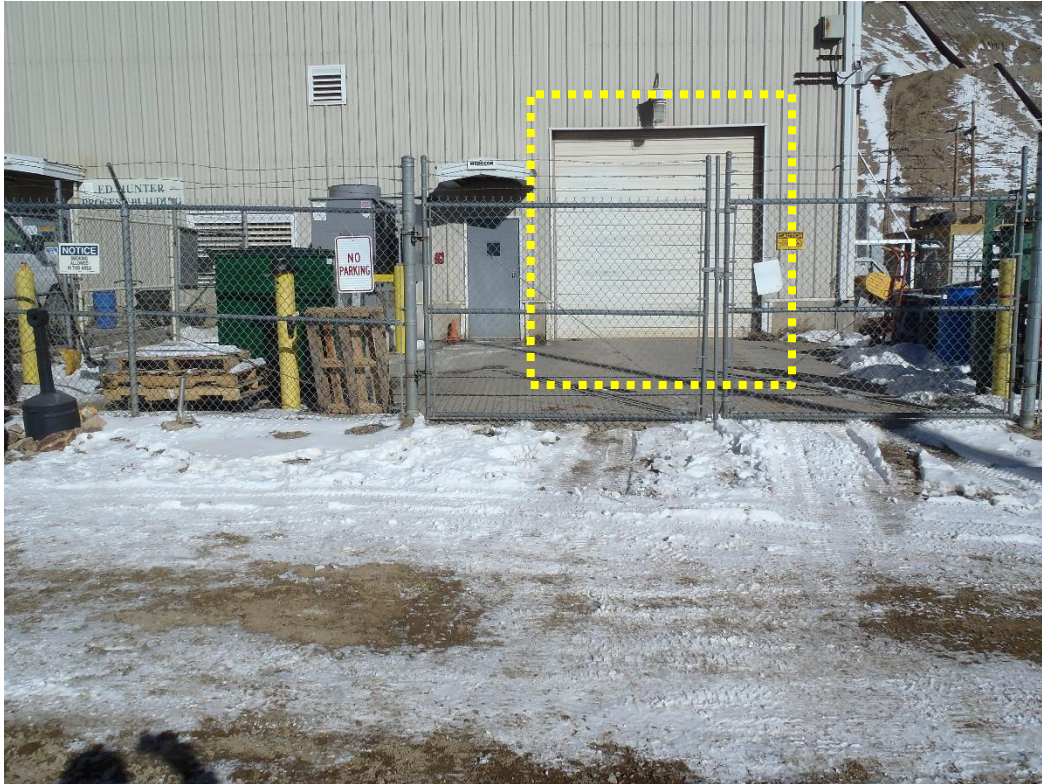
Arequa Gulch Adsorption Desorption Recovery: The Division was accompanied by Ms. Steward and Mr. Bills to investigate the circumstances under which the December 7, 2017 spill occurred. Mr. Tyler O'Donnell pointed out where the spill exited the ADR door (see **Photo 5**) and what areas outside secondary containment were impacted (see **Photo 6**). A CC&V representative explained the freshwater feed to the wet scrubber was turned on; however, the sump pumps were turned off. Consequently, water draining from the wet scrubber overflowed the sumps and drained out the ADR 1 door where the majority collected in two parking ditches.

Photo 5. ADR 1 door from which spill escaped secondary containment.

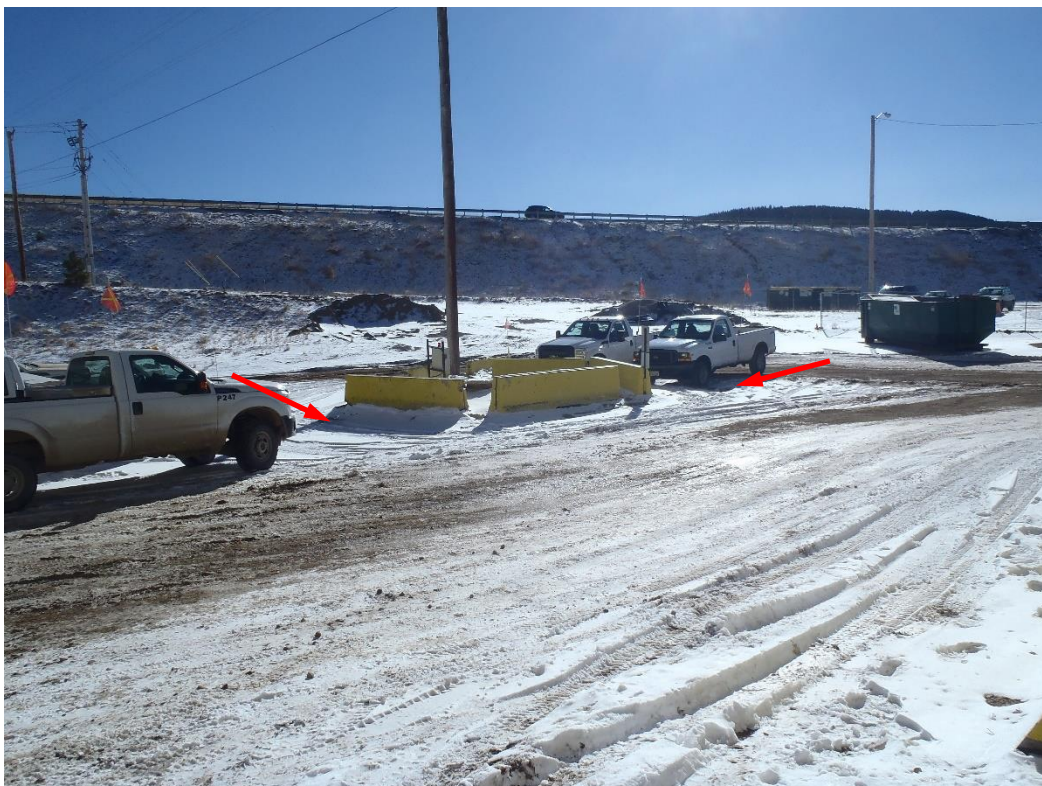
Photo 6. Area outside ADR 1 secondary containment impacted by spill, note parking ditches (looking south).

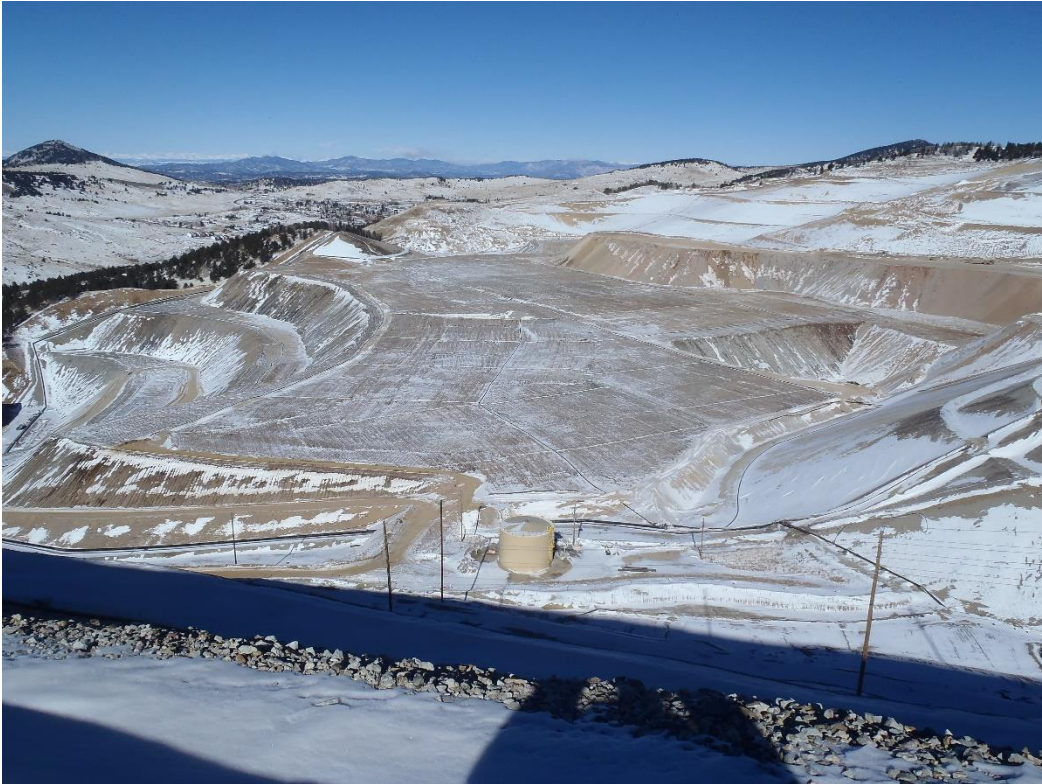
Squaw Gulch Valley Leach Facility: The Division was accompanied by Ms. Steward and Mr. Bills to observe the surface of the SGVLF for ponded solution and general slope stability concerns (**Photo 7**). No slope concerns or ponded solution was observed. However, a large hole in the ore stacking was noted in the northeast portion of VLF near the mill platform (**Photo 8**). CC&V representatives were uncertain as to why this area had been left open when asked about it.

Photo 7. Central portion of the SGVLF (from AGVLF overlook, looking NW).

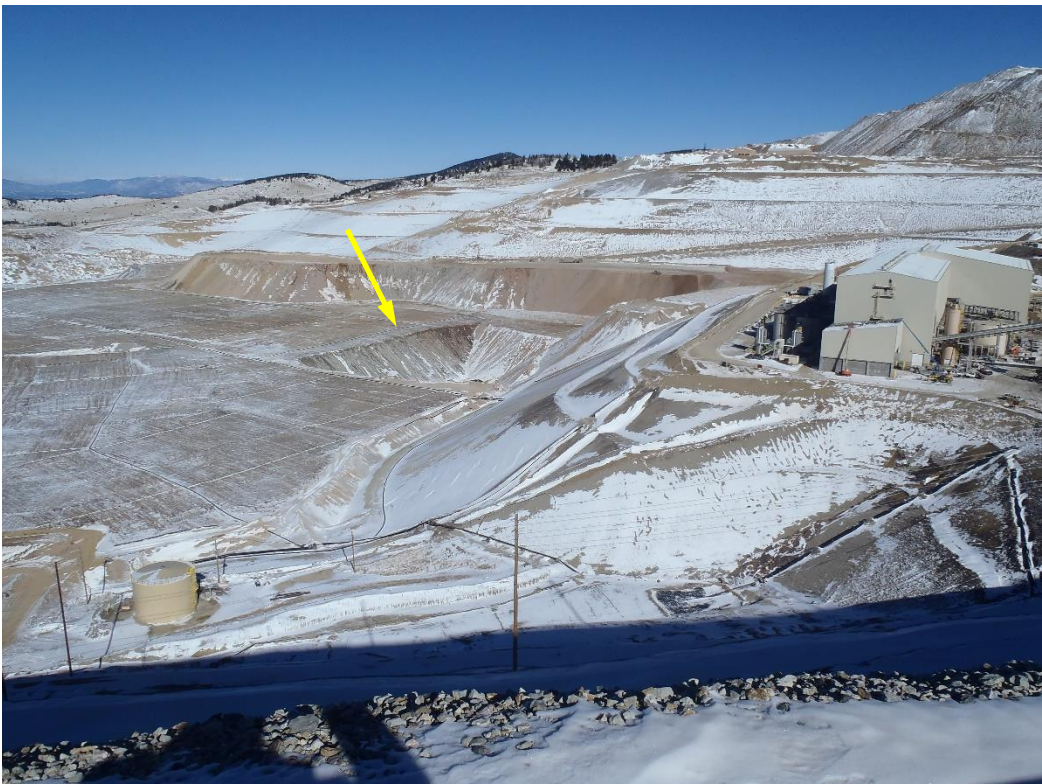
Photo 8. Hole in ore stacking in the SGVLF (from AGVLF overlook, looking NW).

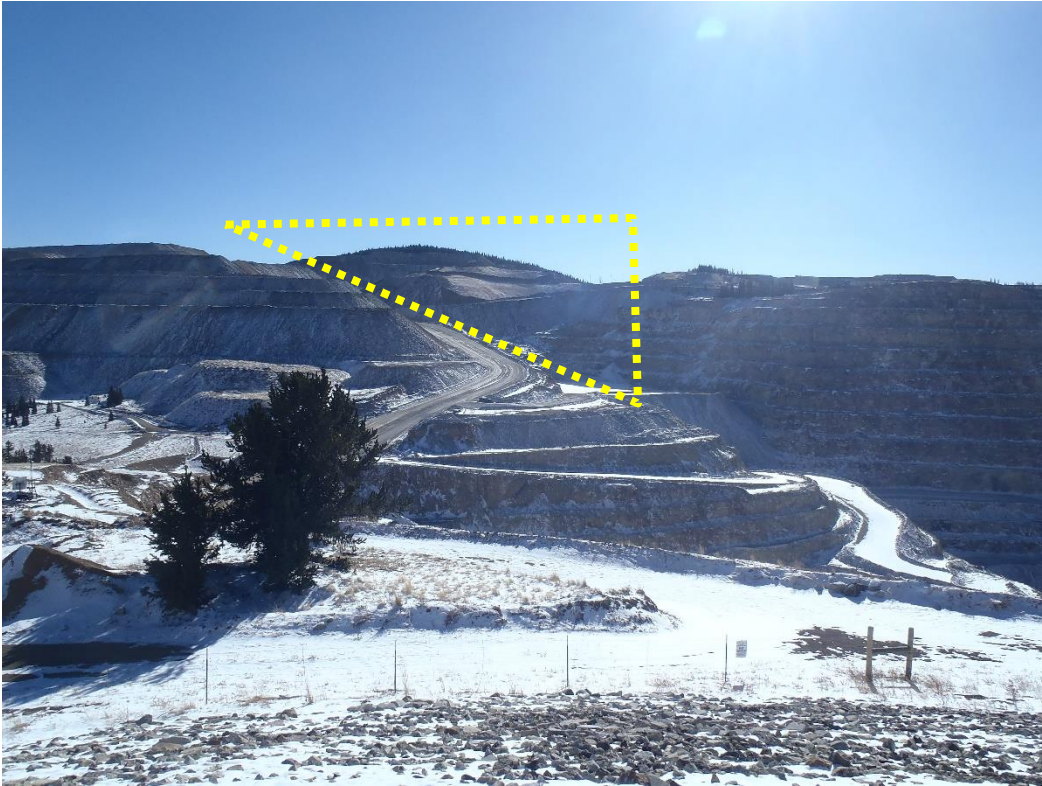
for the north end of the ECOSA (**Photo 9**) would proceed. The plan is to expand the footprint to the north and west such that no new affected area would be necessary.

Photo 9. View of proposed ECOSA expansion area (from east of WHEX pit, looking west).

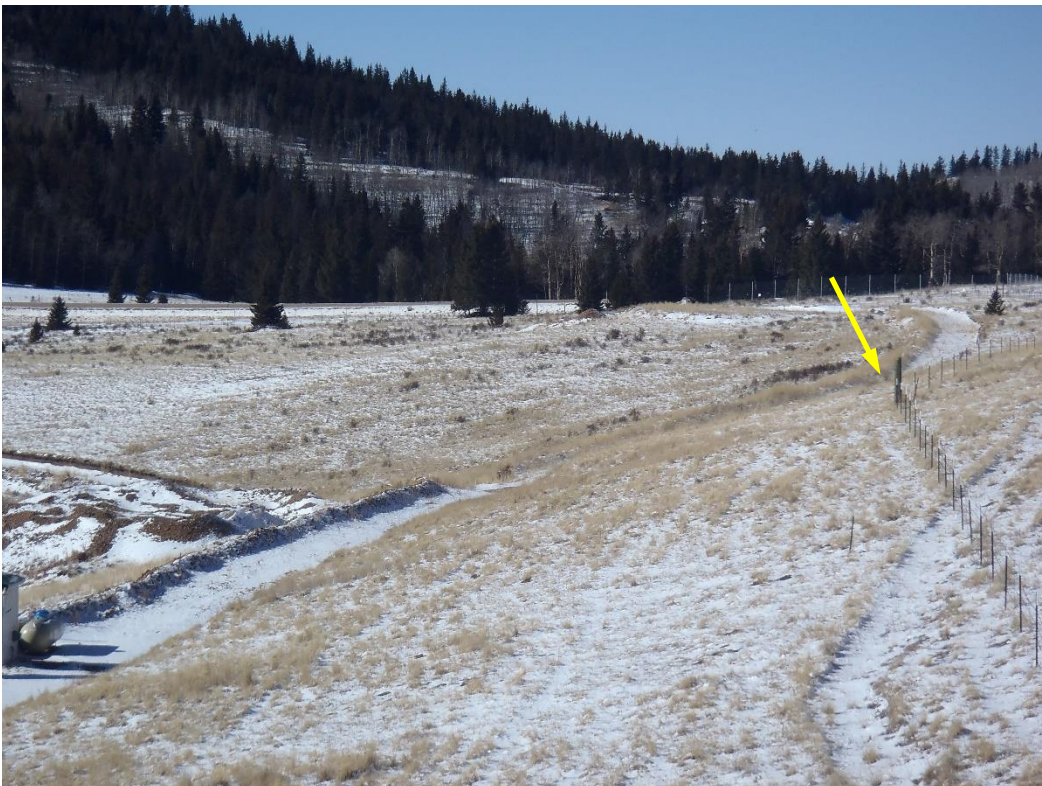
Wildlife Fencing: This inspector was able to observe the newly installed wildlife fencing on the east and north side of the WHEX pit (**Photo 10**) and in the vicinity of the intersection of Teller CR 821 and CR 82 near the Ironclad mine entrance (**Photo 11**)

Photo 10. Newly installed wildlife fencing NE of the WHEX pit.

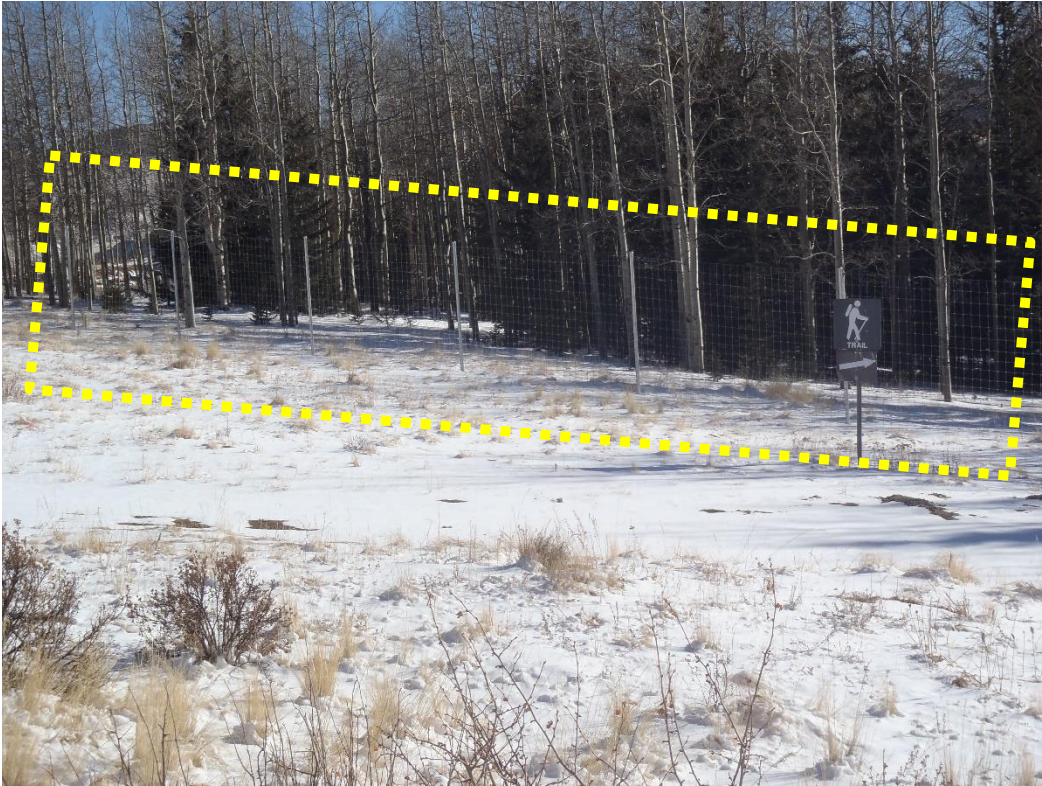
Photo 11. Newly installed wildlife fencing west of the Ironclad mine entrance (looking ESE).
