MINERALS PROGRAM INSPECTION REPORT
PHONE: (303) 866-3567

MINE NAME: Cugnini Gravel Pit	MINE/PROSPECTING ID#: M-1986-061	MINERAL: Sand and gravel	COUNTY: La Plata
INSPECTION TYPE: Monitoring	INSPECTOR(S): Lucas J. West	INSP. DATE: February 6, 2018	INSP. TIME: 09:00
OPERATOR: Oldcastle SW Group, Inc. dba Four Corners M	OPERATOR REPRESENTATIVE: Matt Carnahan	TYPE OF OPERATION: 112c - Construction Regular Operation	
REASON FOR INSPECTION: Normal I&E Program	BOND CALCULATION TYPE: Complete Bond	BOND AMOUNT: \$565,341.67	
DATE OF COMPLAINT: NA	POST INSP. CONTACTS: None	JOINT INSP. AGENCY: None	
WEATHER: Clear	INSPECTOR'S SIGNATURE:

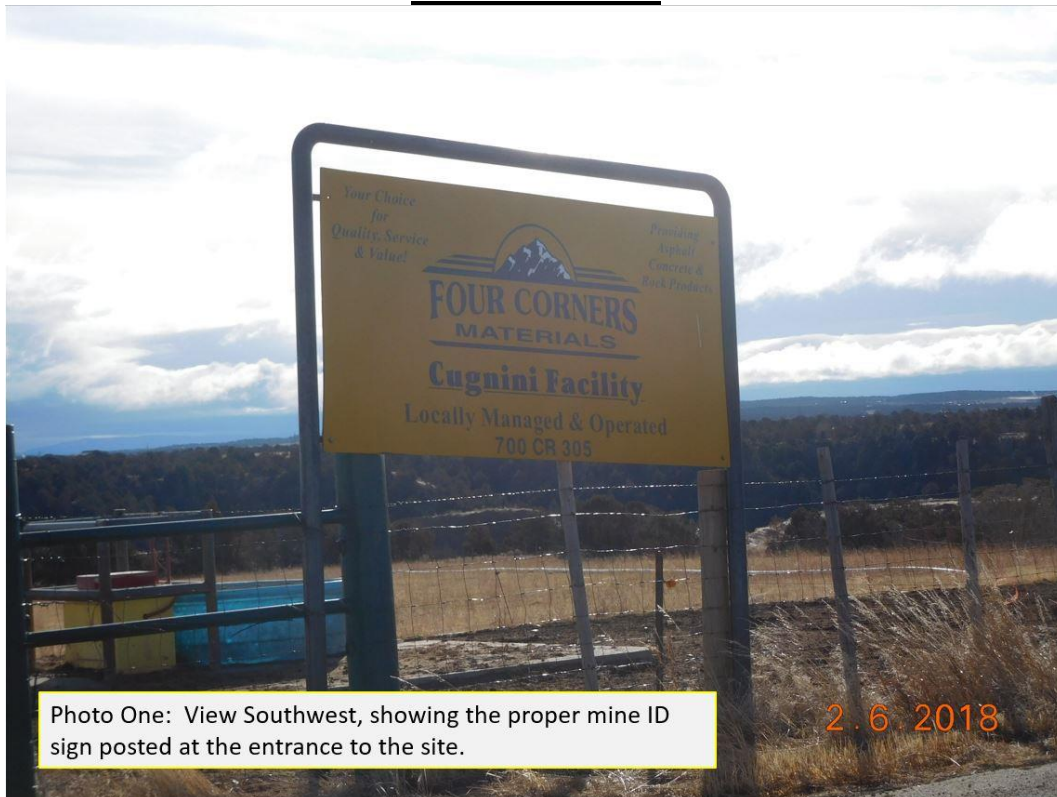
The proper Mine Identification Signage was posted at the entrance to the site and can be seen in Photo One and the permit boundary markers were clearly identified. The site was not active during the inspection and no equipment was on site. The site is intermittently operated and materials are periodically hauled from the consolidated stockpiles. The stockpiles that are observed on the pit floor are of various sizes, and all appear to be stable and in good condition. The topsoil stockpile was labeled and adequately vegetated to provide stability and cover. Examples of the stockpiles can be seen in Photos Two and Three. The pit floor is in good condition and free draining. Some areas are being used as storage for various items and debris, however all items being stored are done so in a neat and orderly fashion and is not considered a problem at this time.

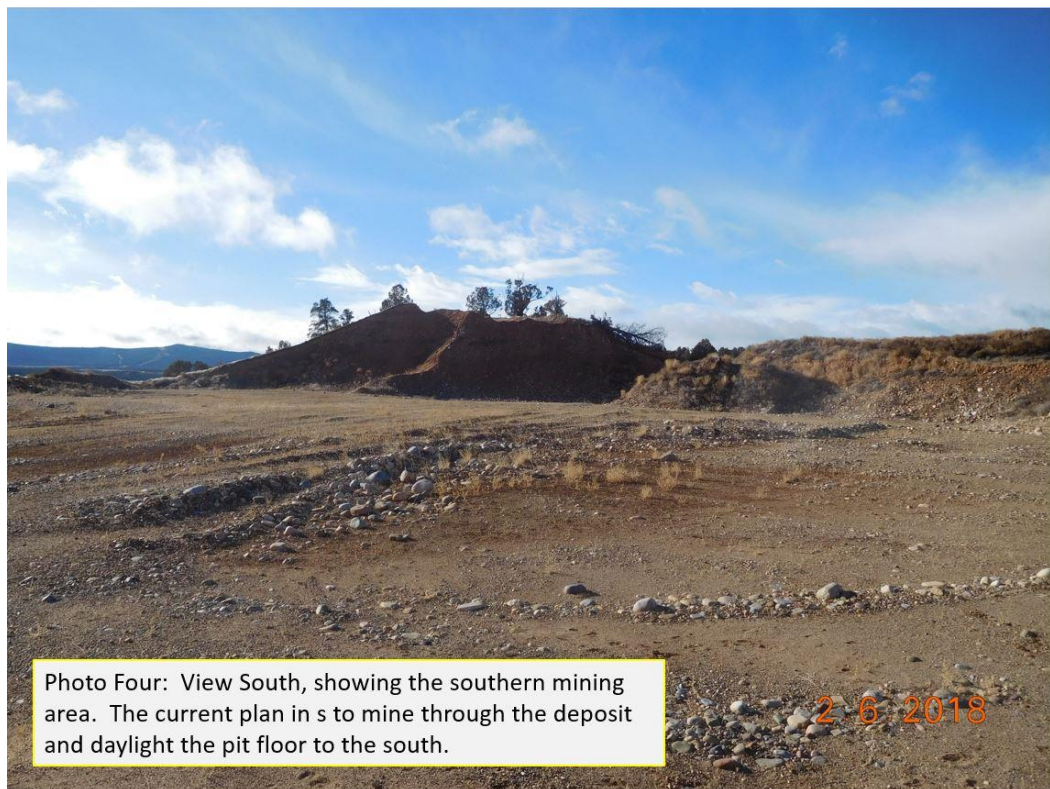
The active mining areas are in two separate areas of the pit, referred to as the North and South Mining areas. The southern mining area is currently located towards the edge of the disturbed area, consists of a small highwall and can be seen in Photo Four. The approved plan calls for daylighting the pit to the south. The Northern Mining area consists of a larger highwall, approximately 50 feet tall that can be seen in Photo Five. The northern mining area will be backfilled and reclaimed to a post mining land use of an irrigated center pivot field. Both of the mining areas appear to be stable and in good condition. The highwalls that exist show no signs of settling, slumping or erosional concerns.

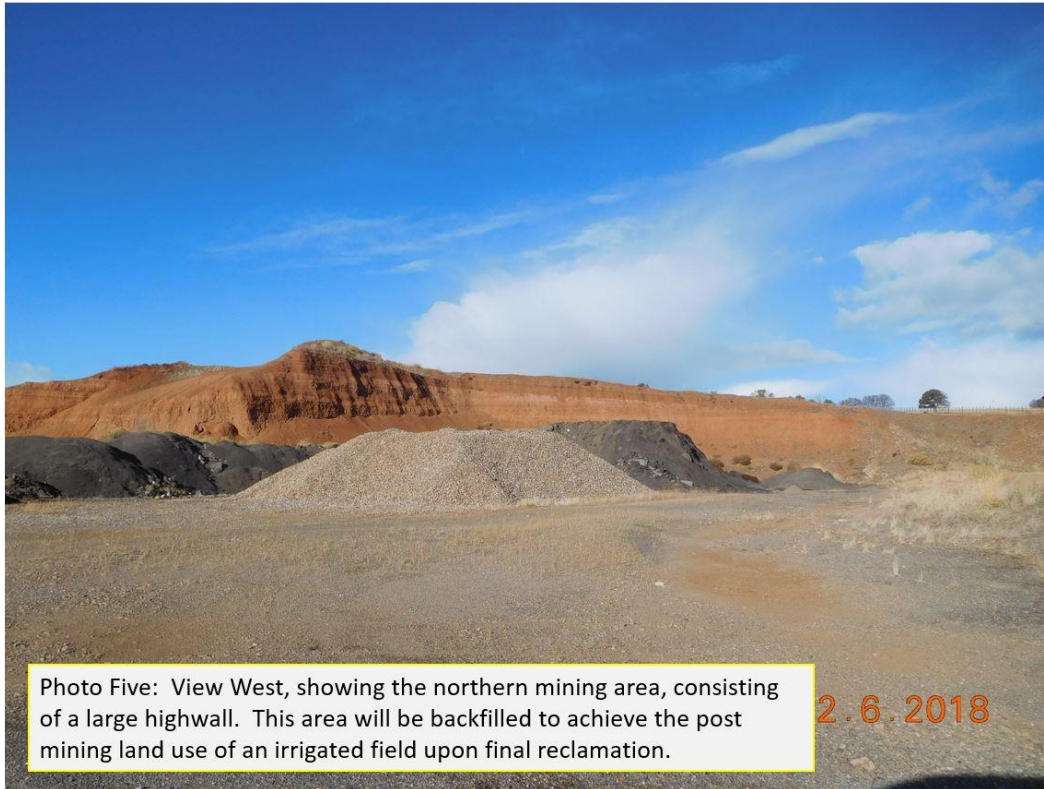
Photo Five: View West, showing the northern mining area, consisting of a large highwall. This area will be backfilled to achieve the post mining land use of an irrigated field upon final reclamation.
