MINERALS PROGRAM INSPECTION REPORT**PHONE: (303) 866-3567**

MINE NAME: Bayfield Pit No. 1	MINE/PROSPECTING ID#: M-1987-038	MINERAL: Sand and gravel	COUNTY: La Plata
INSPECTION TYPE: Monitoring	INSPECTOR(S): Lucas J. West	INSP. DATE: February 6, 2018	INSP. TIME: 10:30
OPERATOR: Oldcastle SW Group, Inc. dba Four Corners M	OPERATOR REPRESENTATIVE: Matt Carnahan	TYPE OF OPERATION: 112c - Construction Regular Operation	
REASON FOR INSPECTION: Normal I&E Program	BOND CALCULATION TYPE: Complete Bond	BOND AMOUNT: \$48,750.00	
DATE OF COMPLAINT: NA	POST INSP. CONTACTS: None	JOINT INSP. AGENCY: None	
WEATHER: Clear	INSPECTOR'S SIGNATURE:

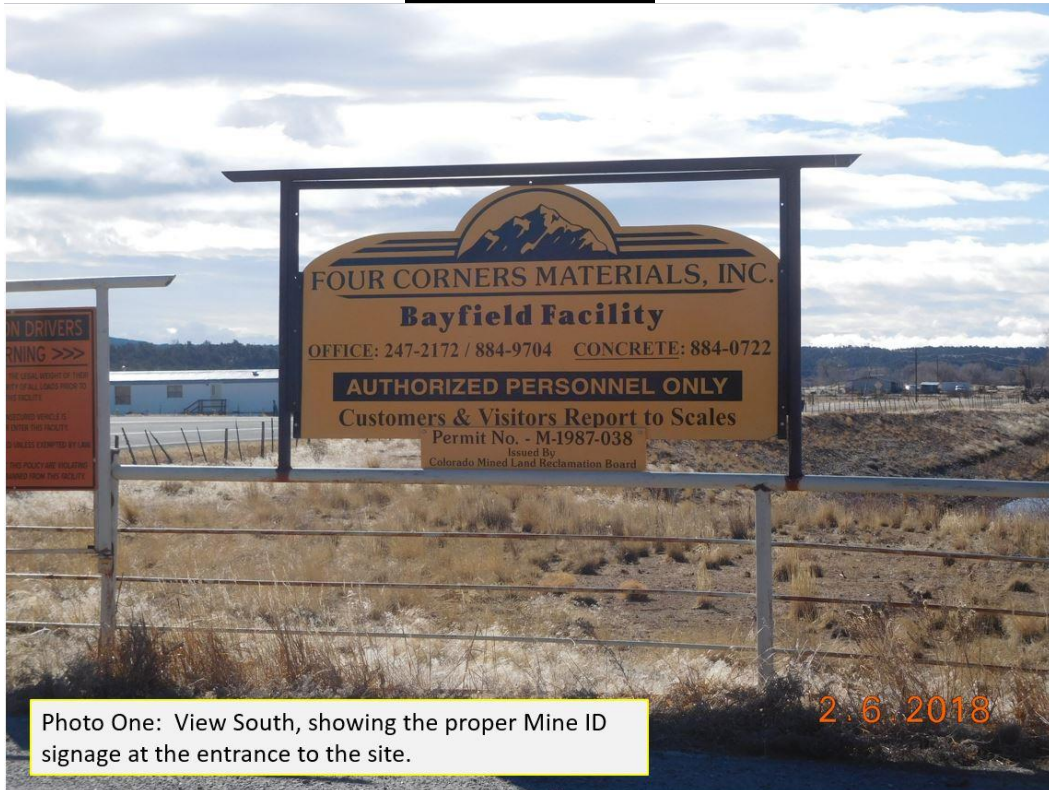
The proper mine identification signage was posted at the entrance to the site which can be seen in Photo One. The permit boundaries were also clearly marked by a series of T posts, fence lines and tree lines. The site was not active during the day of the inspection as it is operated seasonally with a majority of the activity taking place in the spring and summer. The site is being mined in a series of non-consecutive numbered phases. Phase 3 has been completely mined, and reclaimed to a large pond. The slopes on the banks of the pond have been graded and appear to be stable and in good condition. Vegetation around the pond is well established and is a mix of riparian and wetland species along the banks, and upland vegetation in other areas as specified by the reclamation plan. The pond areas and reclamation efforts can be seen in Photos Two and Three. Phases 1, 7, 5 and 6 have been mined out and are currently being utilized as stockpile and storage areas. The slopes around the edge of the phases which will eventually become banks of the ponds upon final reclamation have been relaxed to approximately a 3H: 1V configuration and are in good condition. Several stockpiles exist on the pit floor, and can be seen in Photos Four and Five. All stockpiles located on site are in good condition and show no signs of settling slumping or erosion. The topsoil stockpiles were observed, and are vegetated to provide stability and prevent erosion.
