**MINERALS PROGRAM INSPECTION REPORT**  
**PHONE: (303) 866-3567**

<b>MINE NAME:</b> Pit 29	<b>MINE/PROSPECTING ID#:</b> M-1980-183	<b>MINERAL:</b> Sand and gravel	<b>COUNTY:</b> Adams
<b>INSPECTION TYPE:</b> Monitoring	<b>INSPECTOR(S):</b> Jared L. Ebert	<b>INSP. DATE:</b> February 8, 2018	<b>INSP. TIME:</b> 10:30
<b>OPERATOR:</b> Brannan Sand and Gravel Company, L.L.C.	<b>OPERATOR REPRESENTATIVE:</b> Joshua Oliver	<b>TYPE OF OPERATION:</b> 112c - Construction Regular Operation	
<b>REASON FOR INSPECTION:</b> Normal I&E Program	<b>BOND CALCULATION TYPE:</b> Partial Bond	<b>BOND AMOUNT:</b> \$1,377,450.00	
<b>DATE OF COMPLAINT:</b> NA	<b>POST INSP. CONTACTS:</b> None	<b>JOINT INSP. AGENCY:</b> None	
<b>WEATHER:</b> Clear	<b>INSPECTOR'S SIGNATURE:</b>

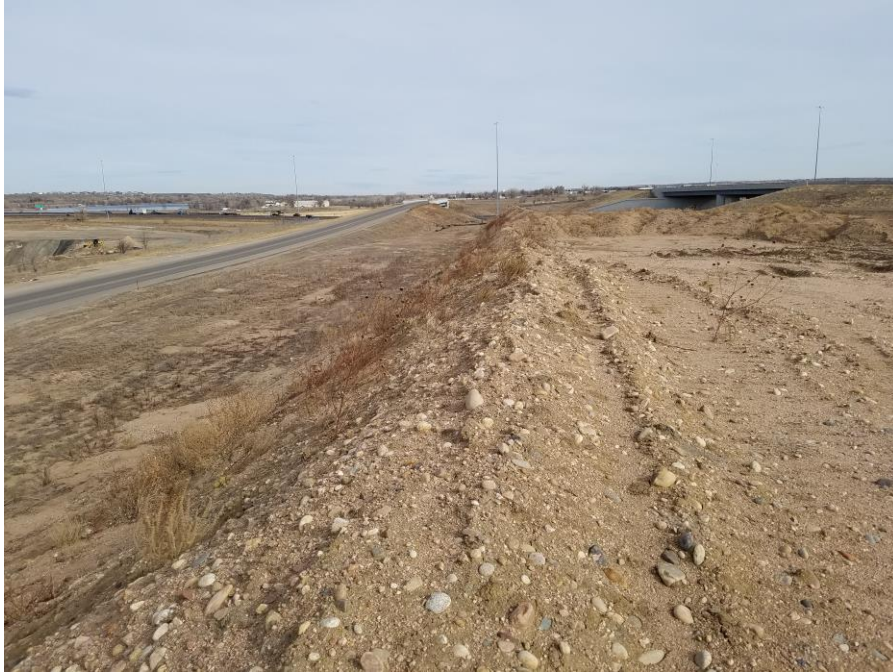
The Operator has a large pile of material stockpiled in Mining Area III at the north end of the site. Brannan is loading and hauling this material offsite for use in construction projects.

Figure 1. From the western end of Mining Area III looking north. From on top of stockpile.

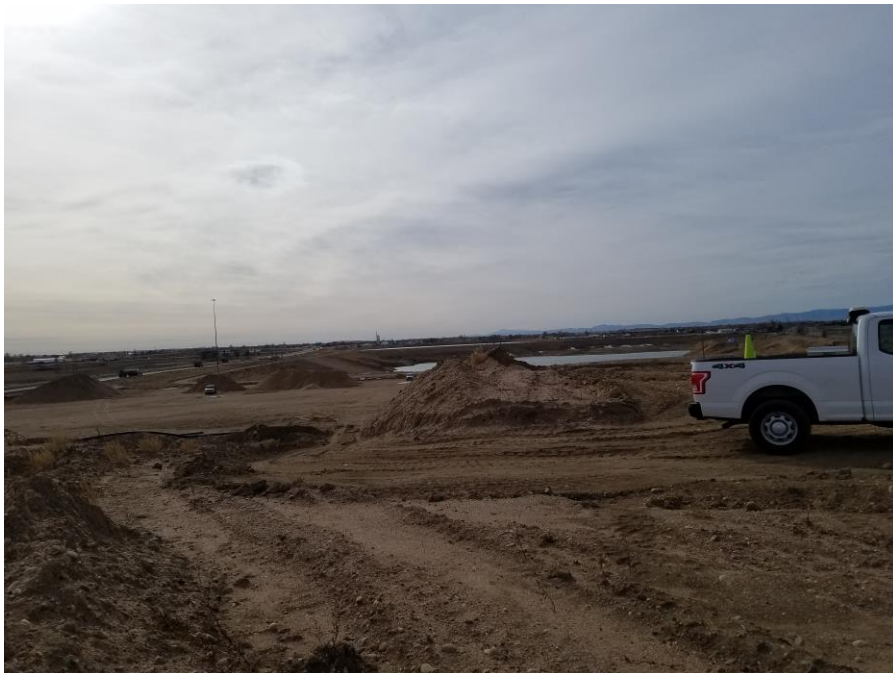
Figure 2. Mining Area III from near the center on stockpile looking north.

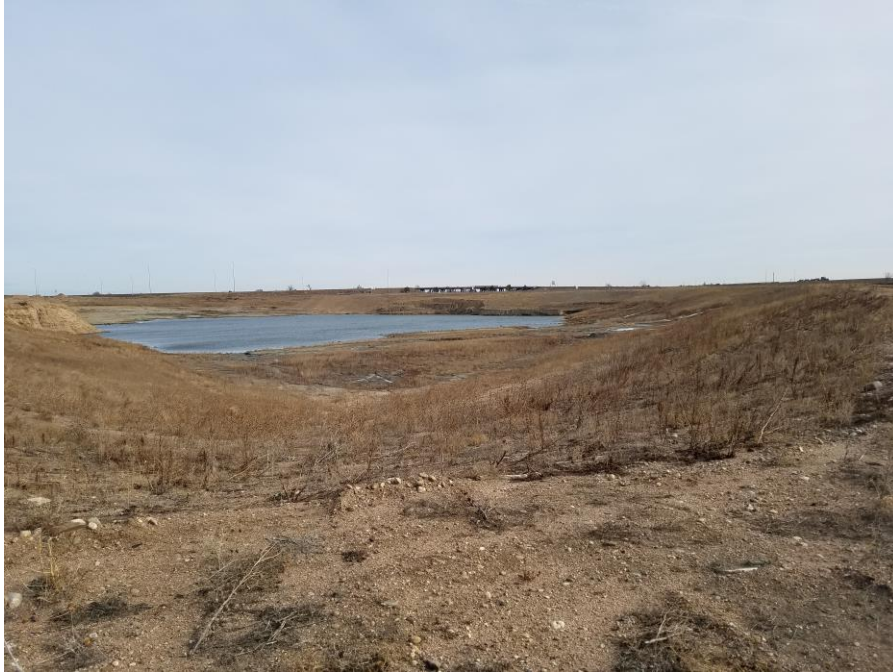
Mining Area II at the center of the site is being reclaimed as a water storage reservoir. According to Mr. Oliver, the slurry wall is leaking and the landowner is taking measures to repair the slurry wall. The pit is being dewatered. The majority of the slopes of the reservoir have been graded to a 3H:1V ratio or less. The slopes around the pump house located on the west side of the reservoir are steep, likely graded to a 1.5H:1V ratio. Near the southeast corner of this reservoir on the eastern reservoir slope and area estimated to be 150 to 200 feet in length has not been graded to the required 3H:1V slope. The slope is steep to near vertical at the base at this location. Mr. Oliver indicated they may need to bring in material to finish grading this area to the required slope.

**Figure 3. From the southwest corner of Mining Area II looking northeast.**

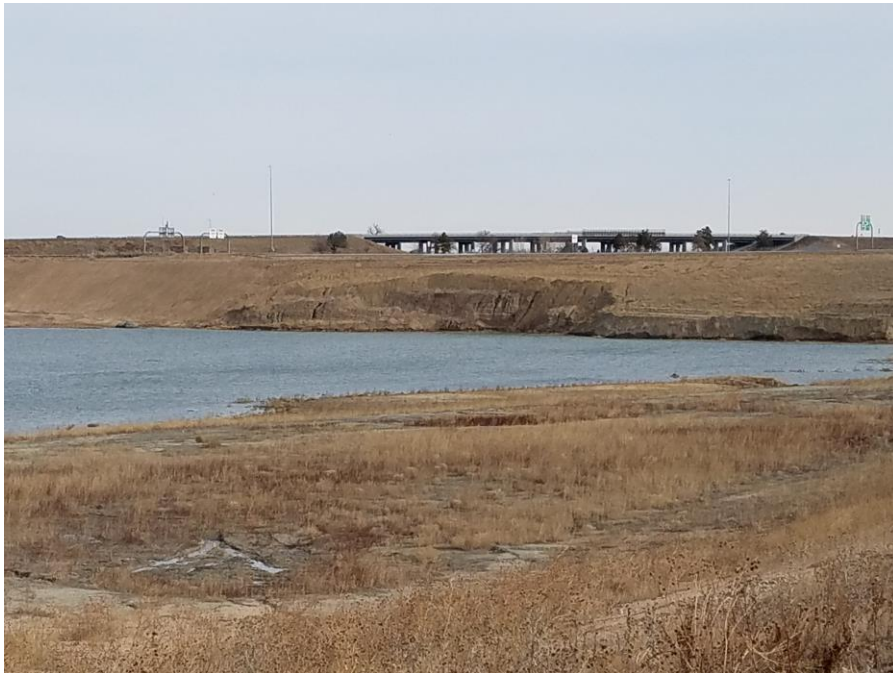
**Figure 4. Un-finished steep slope on east slope of Mining Area II.**

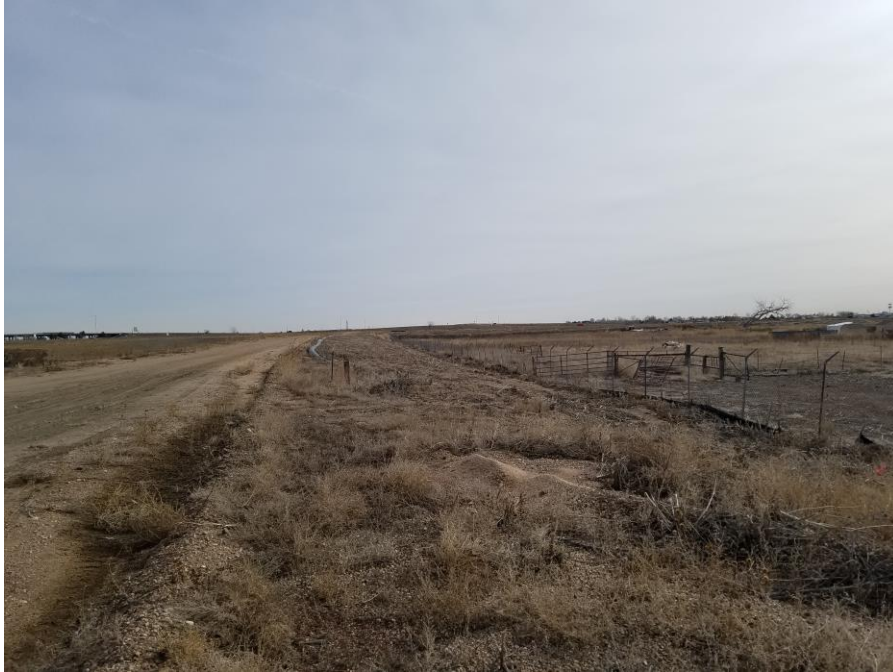
Brannan has installed a French drain at the southwest corner of Mining Area II to alleviate off-site flooding of the property south of this area. The southwest corner manhole was opened and observed. Water was flowing through the French drain and standing water was not observed on the property to the south.

Figure 5. Location of where French Drain was installed. From southwest corner looking east.

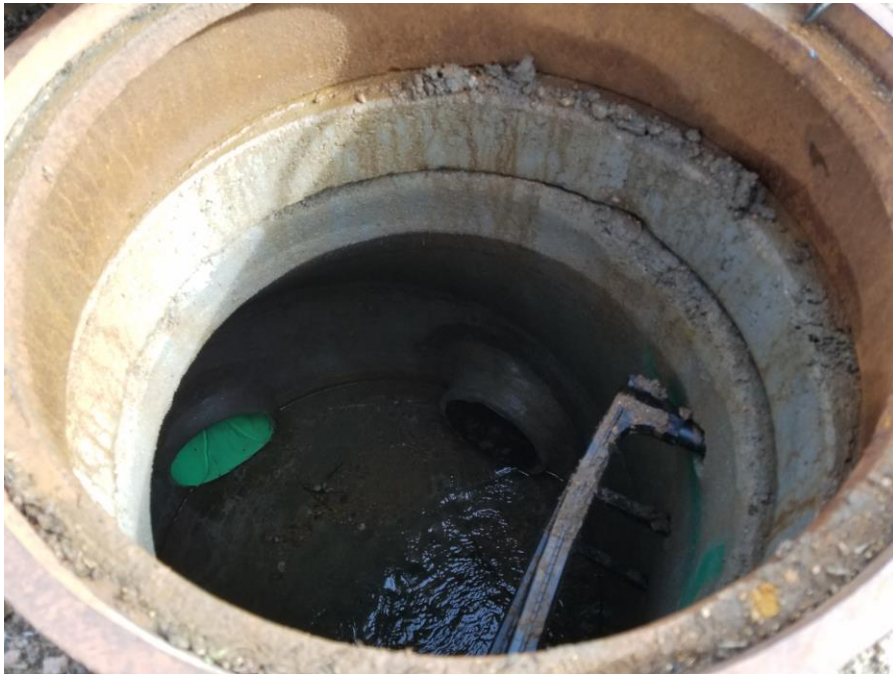
Figure 6. Manhole in southwest corner of French drain. Water flowing.

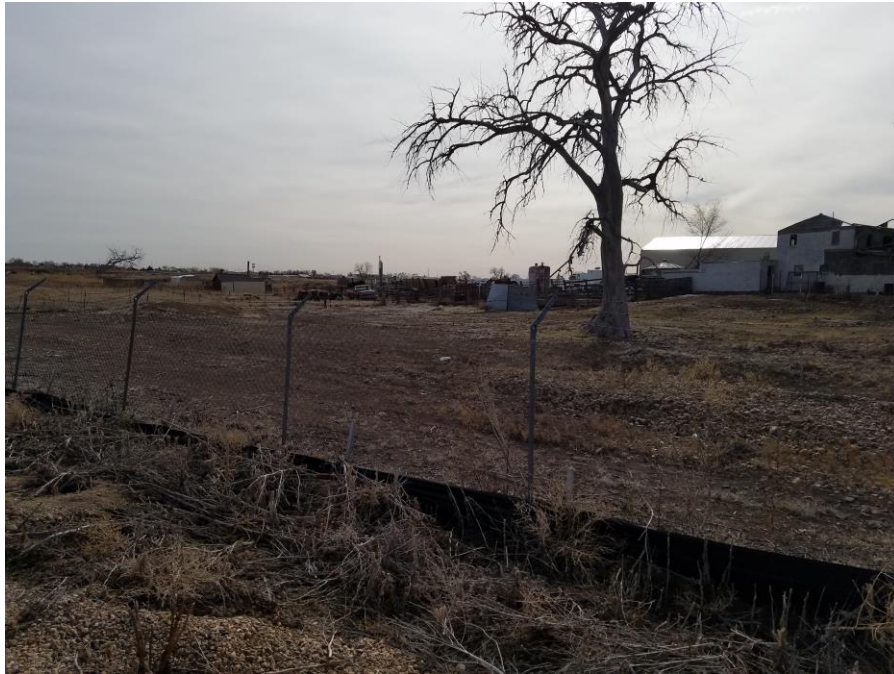
Figure 7. View of the property south of the French drain.

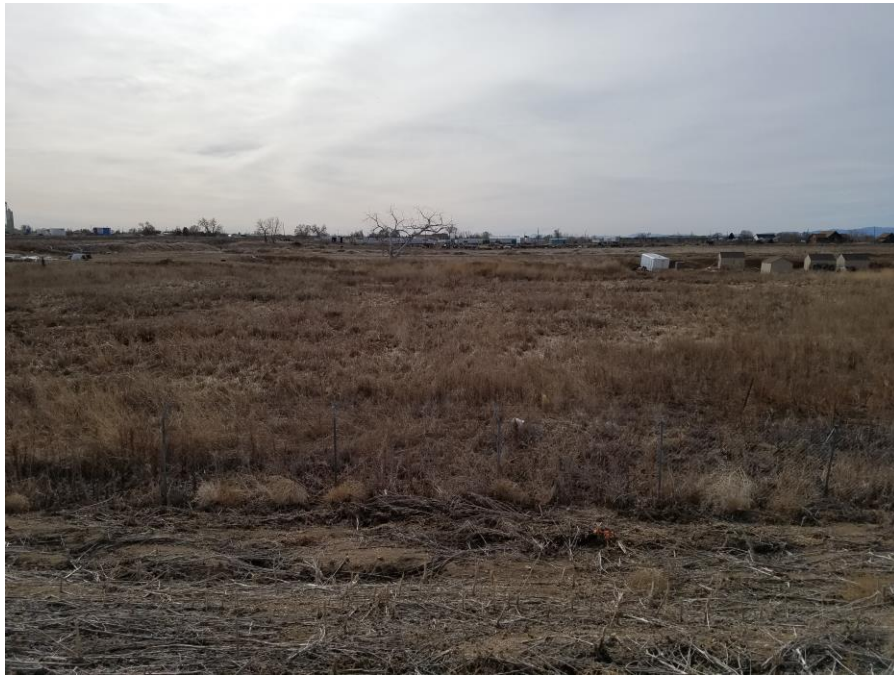
Figure 8. View of the property south of the French Drain.

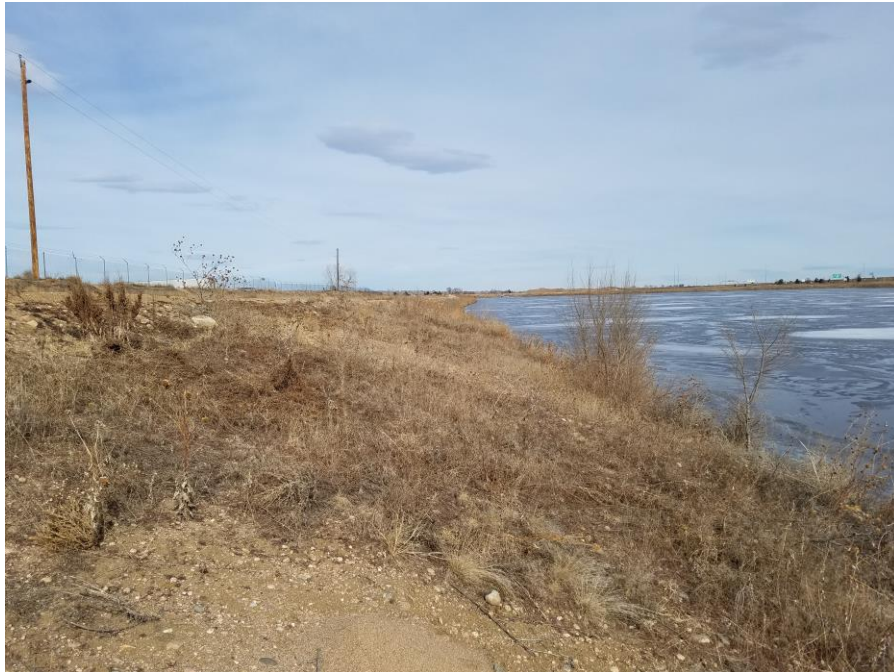
Largely, reclamation is complete in Mining Area I and the area is being utilized as a water storage reservoir. The vegetation above the waterline is fairly sparse consisting of annual weedy vegetation. Some willows and trees have volunteered and established along the southern pit slope. The vegetation established around the southern reservoir is not adequate for the site to be released at this time. This was discussed with Mr. Oliver. Brannan may want to consider conducting some soils test to determine if soil amendments may be necessary

**Figure 9. From the southwest corner of Mining Area I looking north.**

and may need to re-seed the site.

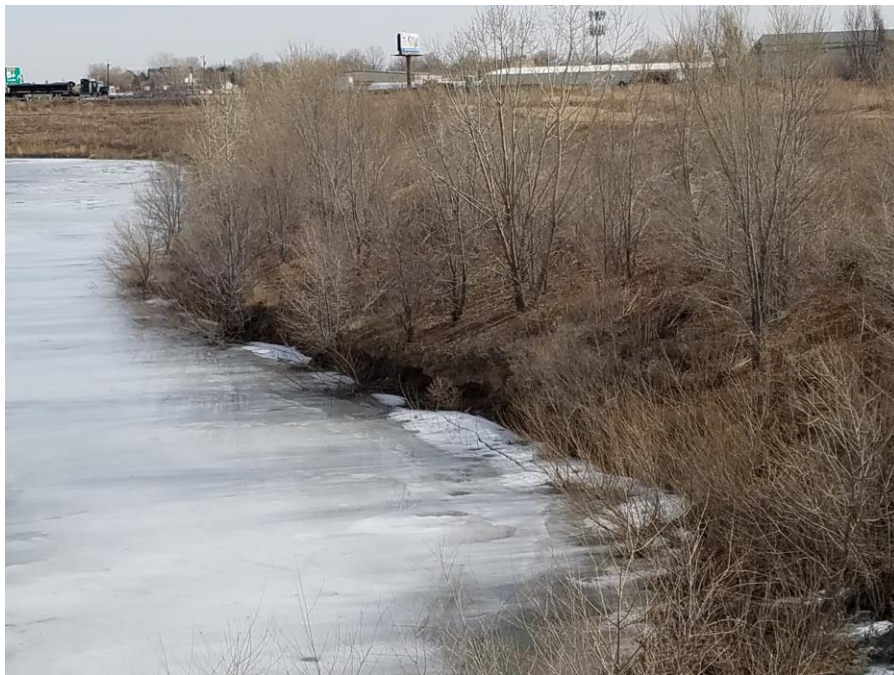
Mining Area I at the southern end of the site has been reclaimed as a water storage reservoir. The reservoir was holding water and the slopes above the waterline appeared stable with the exception of some bank cutting at the southern end of the lake. Rip-rap has not been placed on the reclaimed slopes.

**Figure 10. From the southwest corner of Mining Area I looking east. South slope, some bank cutting was observed.**

The current reclamation plan calls for rip-rapping the top-bank of the reservoirs. Mr. Oliver indicated that they may wish to revise the requirement and either eliminate the requirement or limit the location where rip-rap will be installed. Brannan will need to file a Technical Revision with the Division to revise this requirement along with providing justification for this revision. There are locations observed at the southern reservoir where some bank cutting was observed along the southern and eastern pit slopes. It is likely that rip-rap will need to be installed in these areas to stabilize the slopes from further erosion.

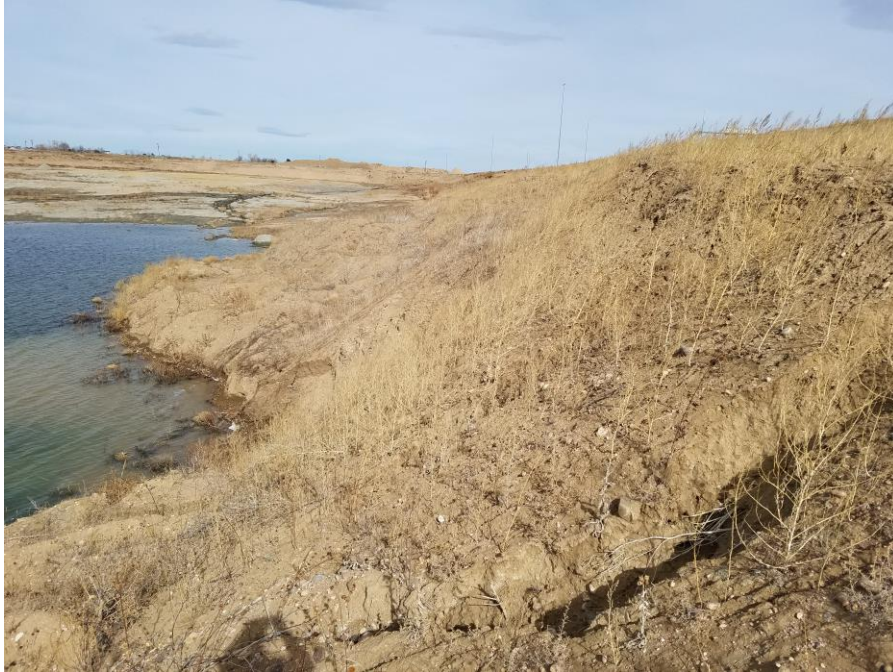
**Figure 11. Unfinished slope on the east side of Mining Area II.**
