MINERALS PROGRAM INSPECTION REPORT
PHONE: (303) 866-3567

MINE NAME: 31 Road Pit	MINE/PROSPECTING ID#: M-1987-178	MINERAL: Sand and gravel	COUNTY: Mesa
INSPECTION TYPE: Monitoring	INSPECTOR(S): Amy C. Yeldell	INSP. DATE: February 23, 2018	INSP. TIME: 10:45
OPERATOR: Parkerson Construction, Inc.	OPERATOR REPRESENTATIVE: Greg Monger	TYPE OF OPERATION: 112c - Construction Regular Operation	
REASON FOR INSPECTION: Normal I&E Program	BOND CALCULATION TYPE: Complete Bond	BOND AMOUNT: \$194,642.35	
DATE OF COMPLAINT: NA	POST INSP. CONTACTS: None	JOINT INSP. AGENCY: None	
WEATHER: Windy	INSPECTOR'S SIGNATURE:

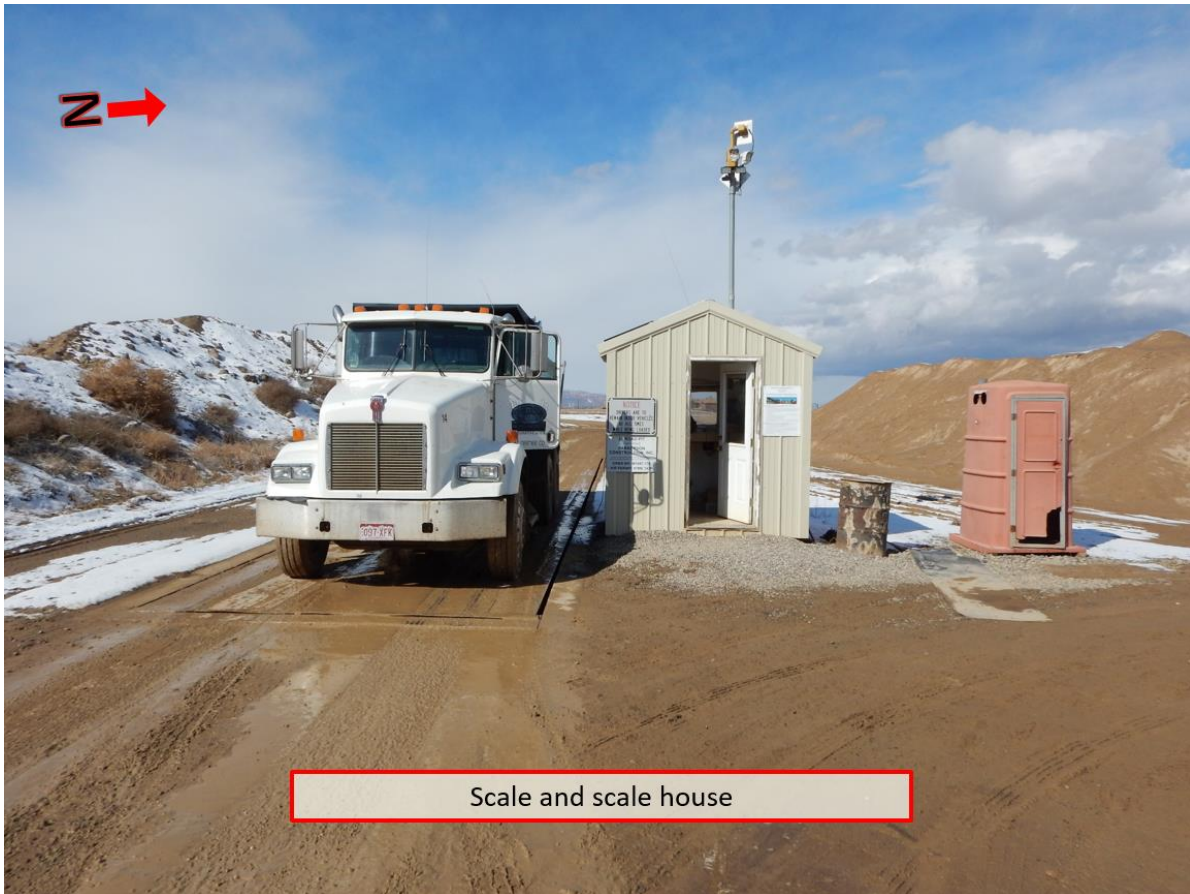
This site was active at the time of the inspection. Two plants and a loader were operating at the time of the inspection. The scale and scale house are located as you enter the pit floor. They were being used for the adjacent C Road Pit (M-2016-050). Additional trucks and equipment are neatly parked on the pit floor. Mining related supplies are neatly stored along the eastern boundary. The site is clean and free of trash and other miscellaneous debris.

Scale and scale house

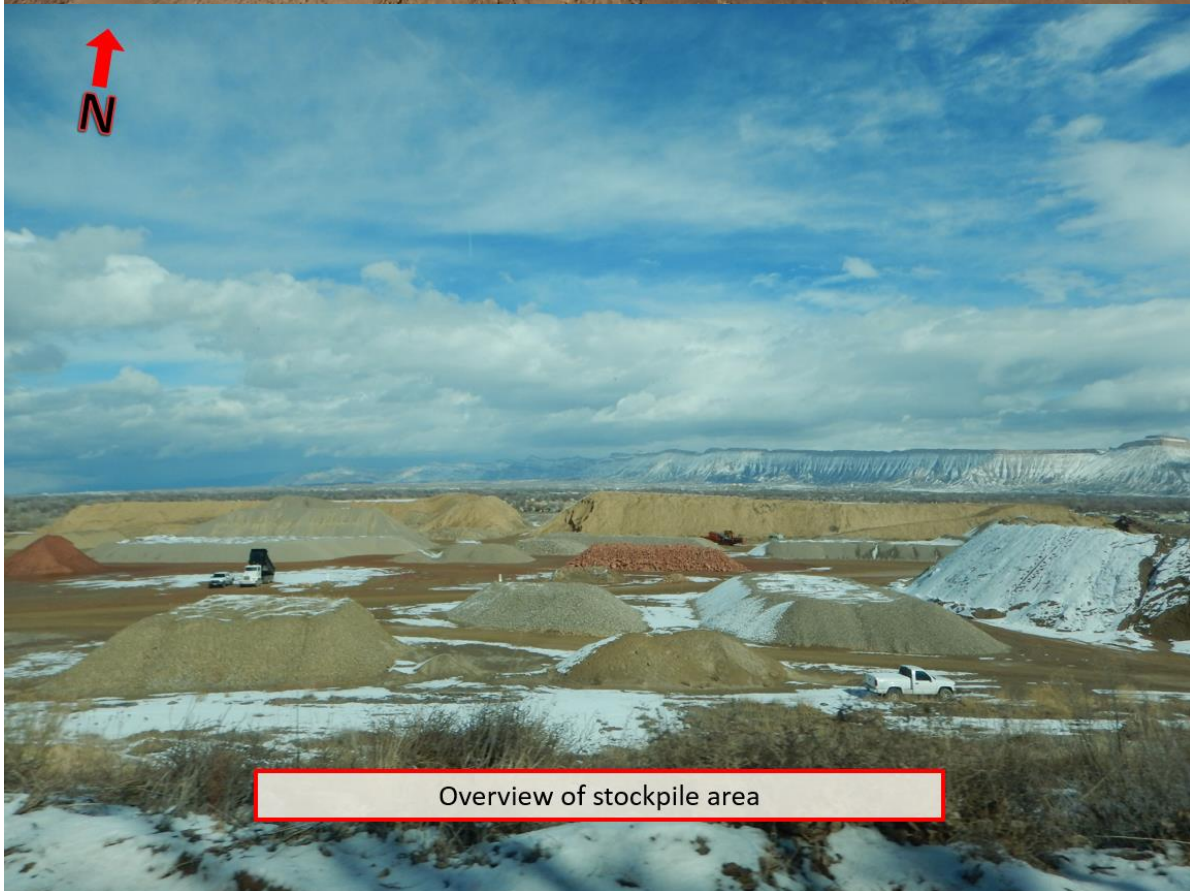
This site has a maximum disturbance of 40 acres. With the addition of the TR-3 area staff estimates that approximately 53 acres are currently affected. The pit has been excavated to a depth of approximately 20 feet. Highwalls are near vertical. Material naturally sloughs into a pile at the base of the highwall. Several stockpiles exist within the pit floor. Stockpiles are stored neatly according to size class. Stockpiles are stable and erosion free and sloped approximately 2:1.

Overview of stockpile area

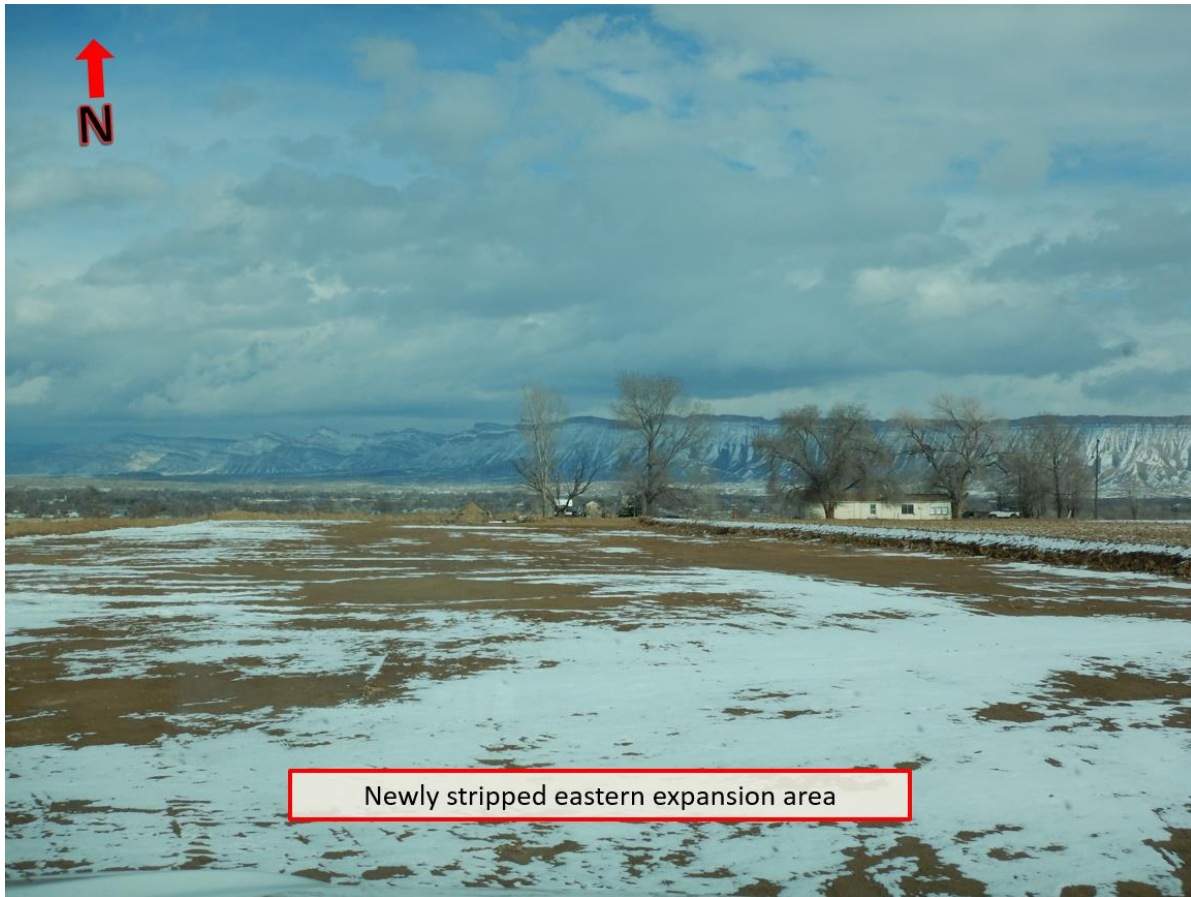
Mining is progressing towards the East. In late 2017 TR-3 allowed for an additional 95 feet to be mined. This area has been surveyed and stripped. As a reminder the operator is required to maintain a 200 foot buffer from the permit boundary to protect nearby structures. The topsoil from this area has been stockpiled in a berm along the southern boundary. The topsoil pile did not appear to be reseeded yet.

Newly stripped eastern expansion area

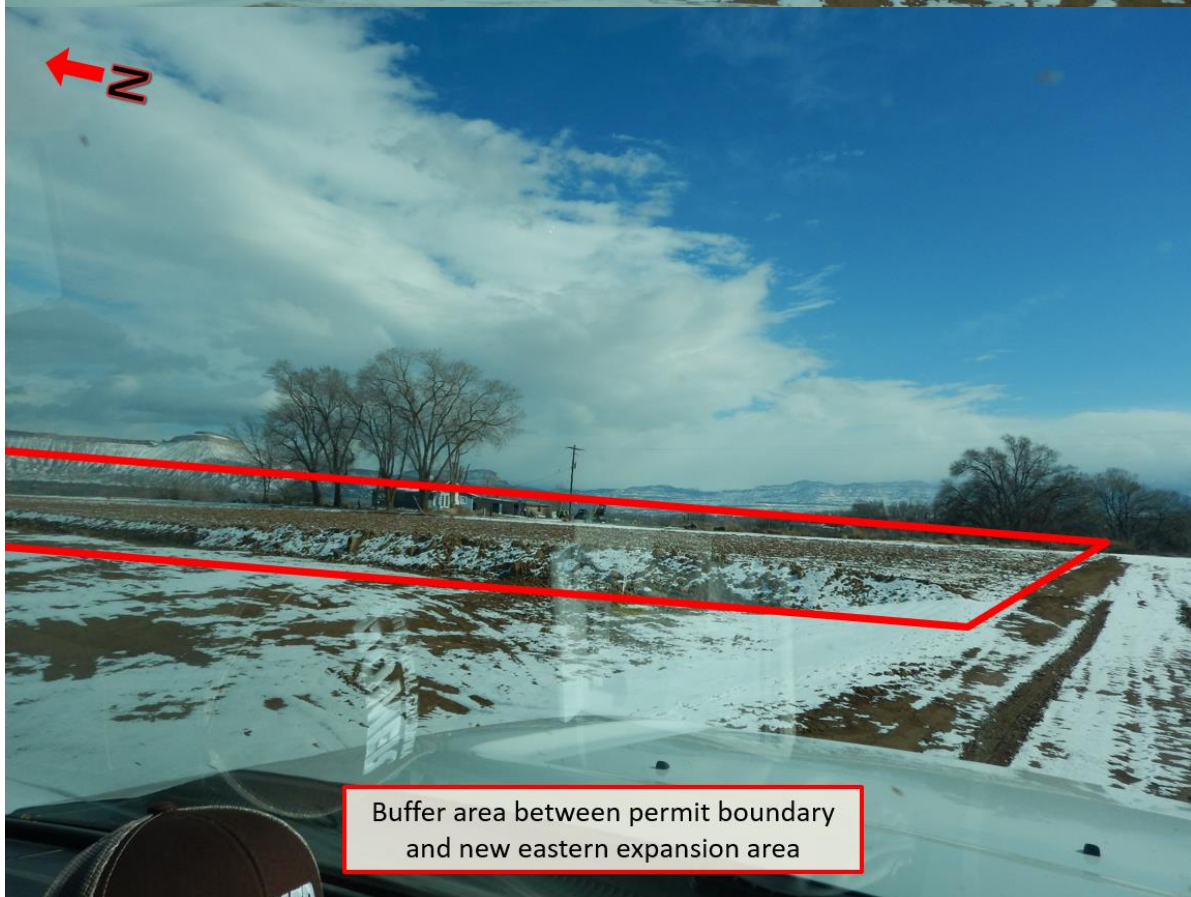
Buffer area between permit boundary
and new eastern expansion area
