MINERALS PROGRAM INSPECTION REPORT
PHONE: (303) 866-3567

MINE NAME: Table Mountain Quarry	MINE/PROSPECTING ID#: M-1999-004	MINERAL: Silica (quartz, quartzite)	COUNTY: Fremont
INSPECTION TYPE: Monitoring	INSPECTOR(S): Timothy A. Cazier, Amy Eschberger	INSP. DATE: January 29, 2018	INSP. TIME: 11:45
OPERATOR: Tezak Heavy Equipment Co. Inc.	OPERATOR REPRESENTATIVE: Randy DiLuzio	TYPE OF OPERATION: 112c - Construction Regular Operation	
REASON FOR INSPECTION: Priority	BOND CALCULATION TYPE: Partial	BOND AMOUNT: \$202,793.00	
DATE OF COMPLAINT: NA	POST INSP. CONTACTS: Colo. Land Board	JOINT INSP. AGENCY: Colo. Land Board	
WEATHER: Clear	INSPECTOR'S SIGNATURE:

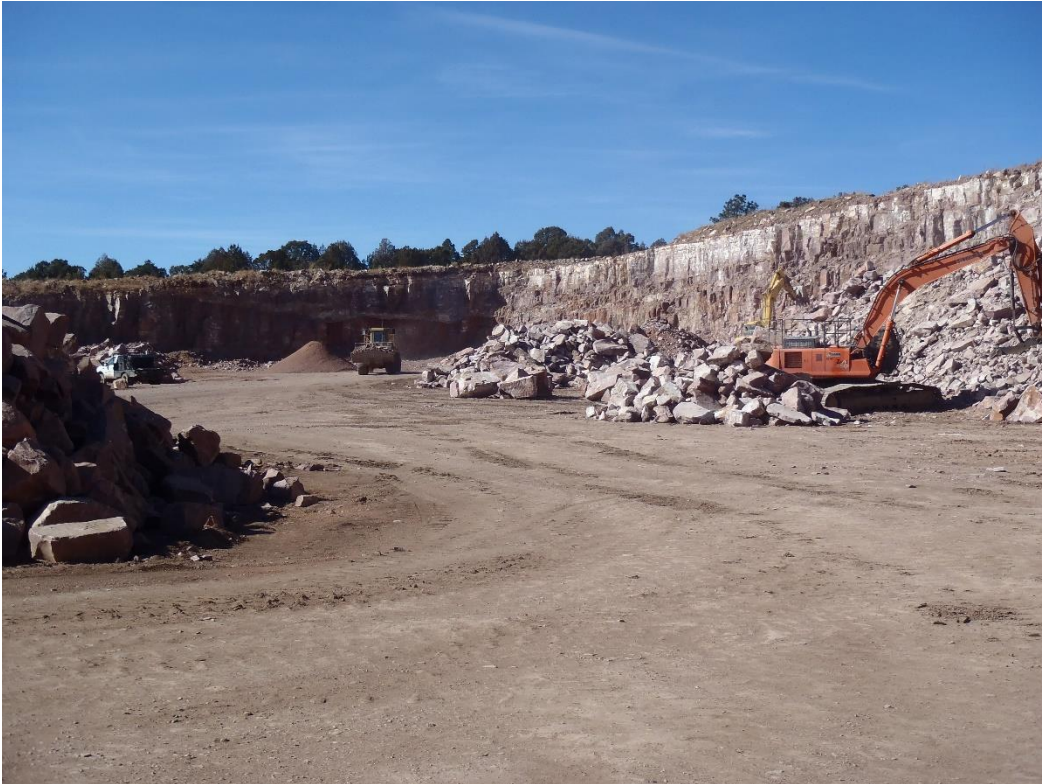
Highwalls were observed to be approximately 40 feet in height and appeared stable (see **Photo 3**). There is a permit stipulation (discussed below) limiting the highwall length to 2,000 feet. The current length of the highwall was estimated to be less than 1,300 feet. The Operator is currently mining in Area A. A previous Operator had begun mining in Area B.

Photo 3. Active east-west highwall (looking WNW).

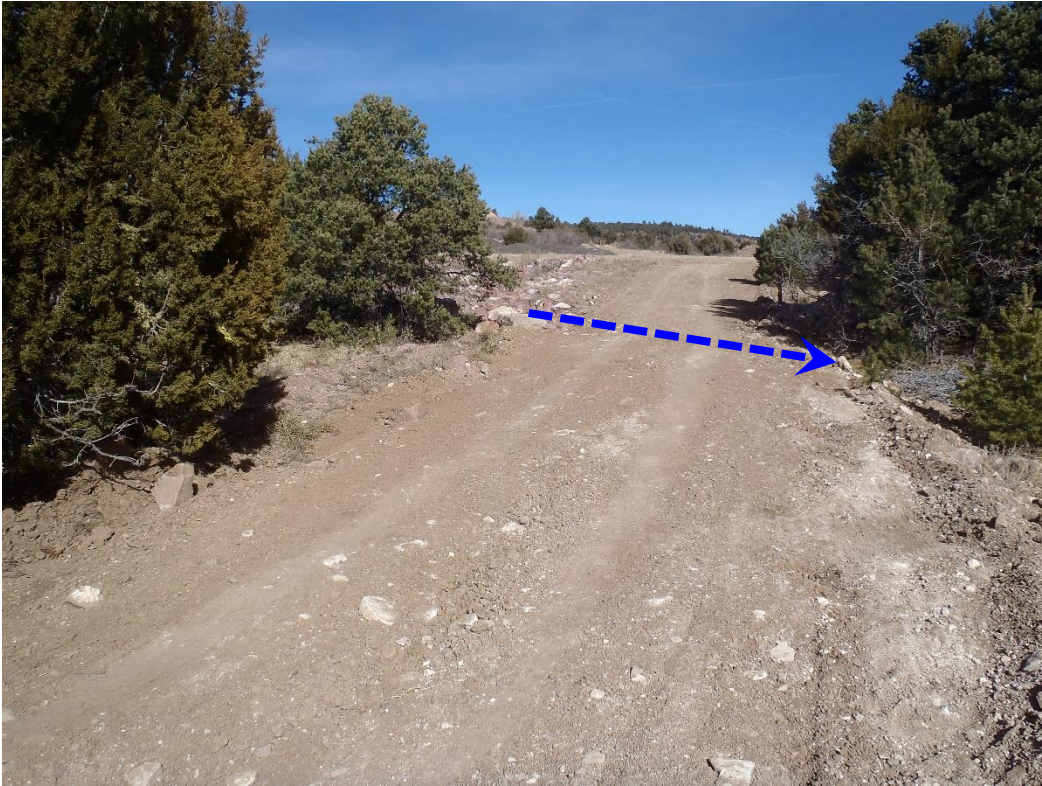
Stormwater MGT Plan: The Division's abandoned mine land (AML) group has a forfeited bond from a permit that preceded the current permit. TC Wait from AML visited the site in the summer of 2017 to assess what reclamation could be accomplished with the forfeited bond money. Her assessment included stormwater improvements to the outfall from the south sediment pond (see **Photos 7 and 8**). Some discussions with the Mr. DiLuzio during this inspection resulted in some improvements that might be made to the area where the outfall channel crosses the road running southward from the permit area. During the previous inspection, it appeared discharge from the sediment pond was primarily following the road. During this inspection, it appears most, if not all the discharge is running next to the road, rather than in it. It also appeared the discharge was directed towards natural channels. The Operator should coordinate with the Division's AML group prior to initiating any drainage improvement in this area.

Photo 7. Stormwater crossing along road south of sediment pond (looking north).

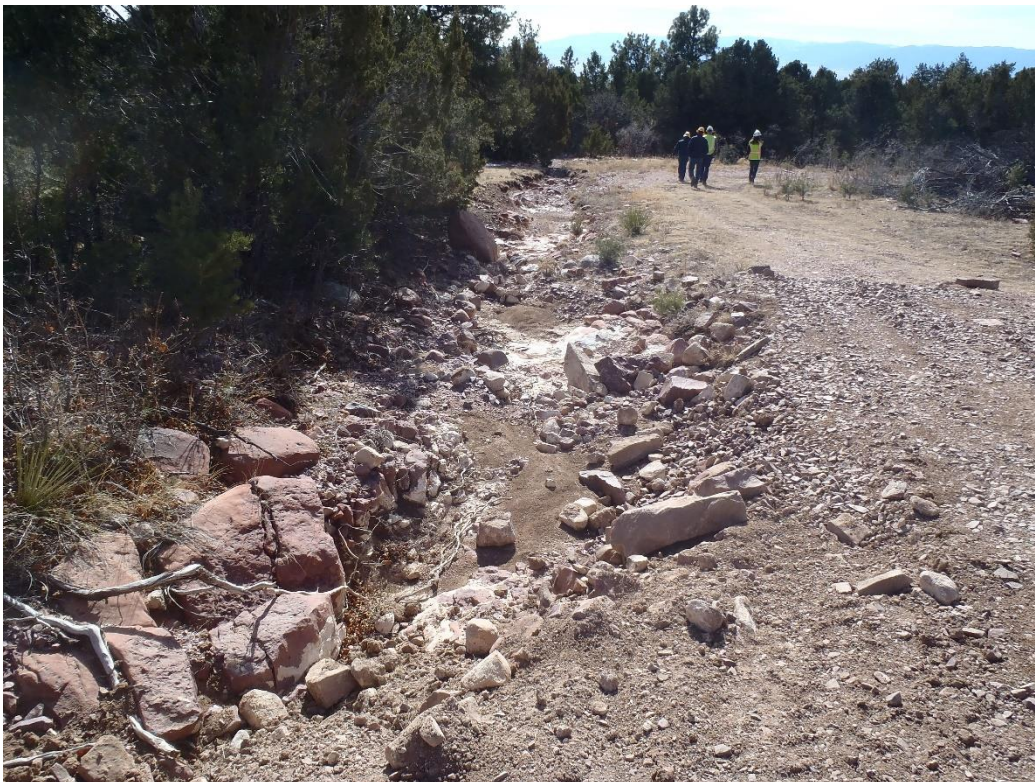
Photo 8. Stormwater channel along road south of sediment pond (looking south).
