MINERALS PROGRAM INSPECTION REPORT
PHONE: (303) 866-3567

MINE NAME: Menzer Quarry	MINE/PROSPECTING ID#: M-1976-009-HR	MINERAL: Granite, granite gneiss	COUNTY: El Paso
INSPECTION TYPE: Monitoring	INSPECTOR(S): Timothy A. Cazier	INSP. DATE: January 29, 2018	INSP. TIME: 14:15
OPERATOR: Schmidt Construction Company	OPERATOR REPRESENTATIVE: Dan Chavez, Mark Heifner	TYPE OF OPERATION: 112c - Construction Regular Operation	
REASON FOR INSPECTION: Priority	BOND CALCULATION TYPE: Partial Bond	BOND AMOUNT: \$456,000.00	
DATE OF COMPLAINT: NA	POST INSP. CONTACTS: None	JOINT INSP. AGENCY: None	
WEATHER: Clear	INSPECTOR'S SIGNATURE:

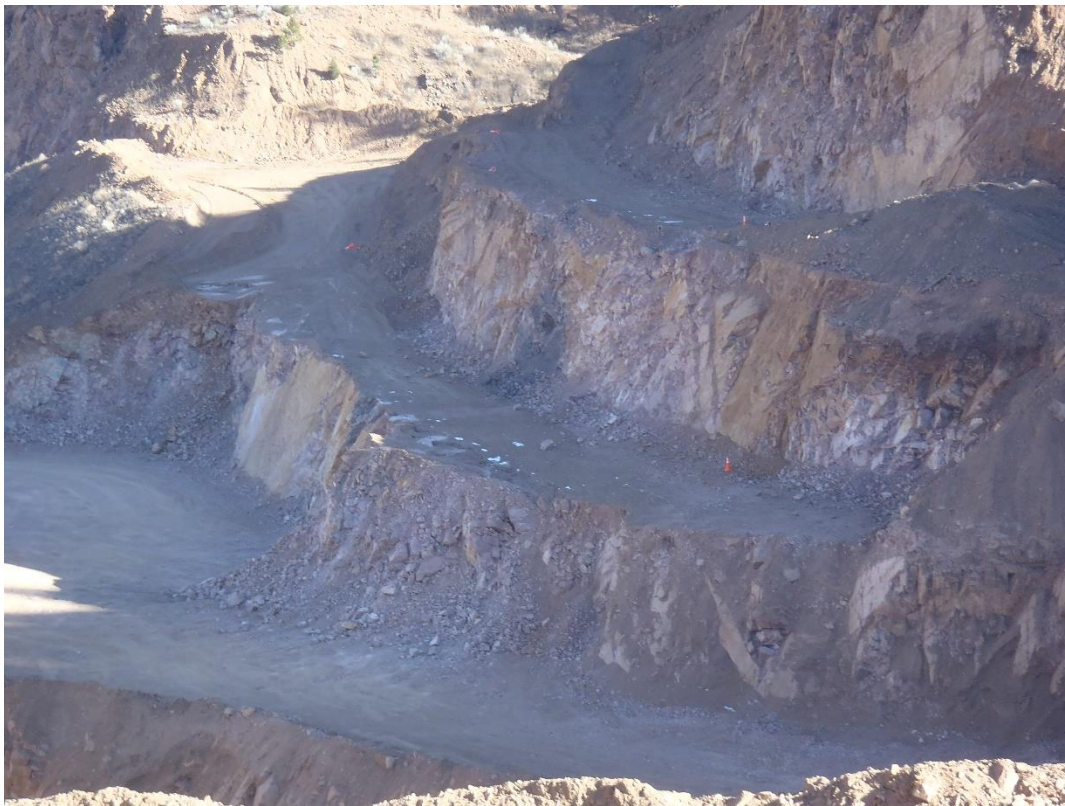
Backfilling and Grading: The highwalls are benched with 40-foot widths at 30 to 40 feet in height and backfilled with a blend of topsoil and fines. Sufficient backfill material appeared to be available.

Photo 1. Highwall (looking SE).

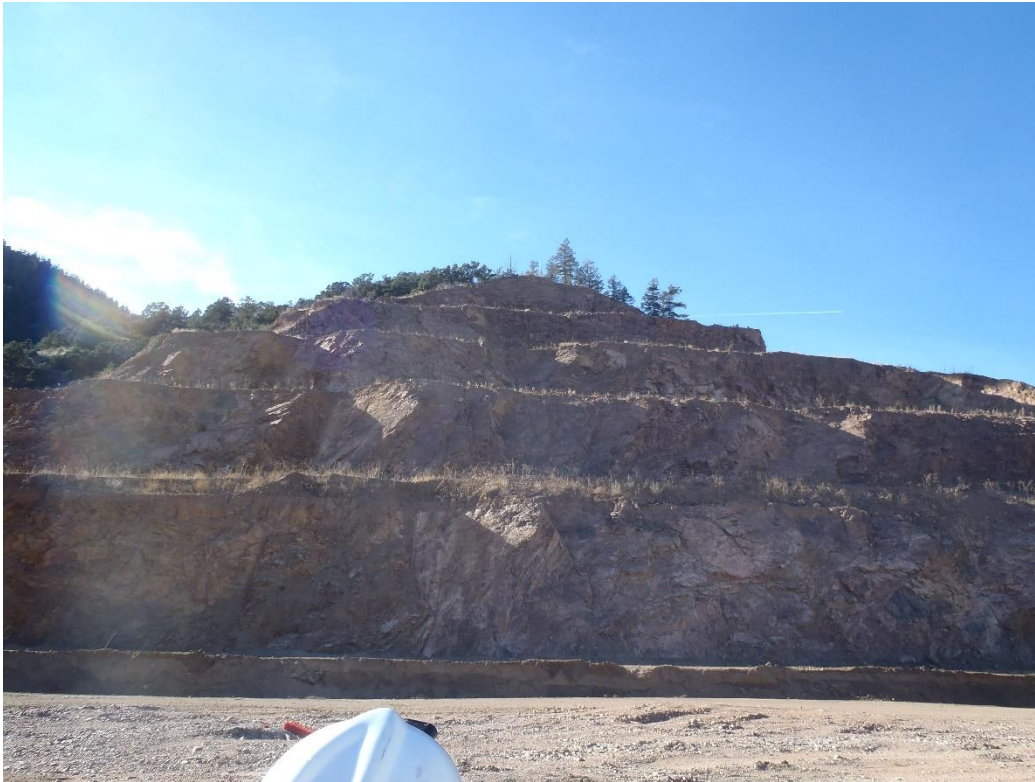
Photo 2. West highwall (looking west).

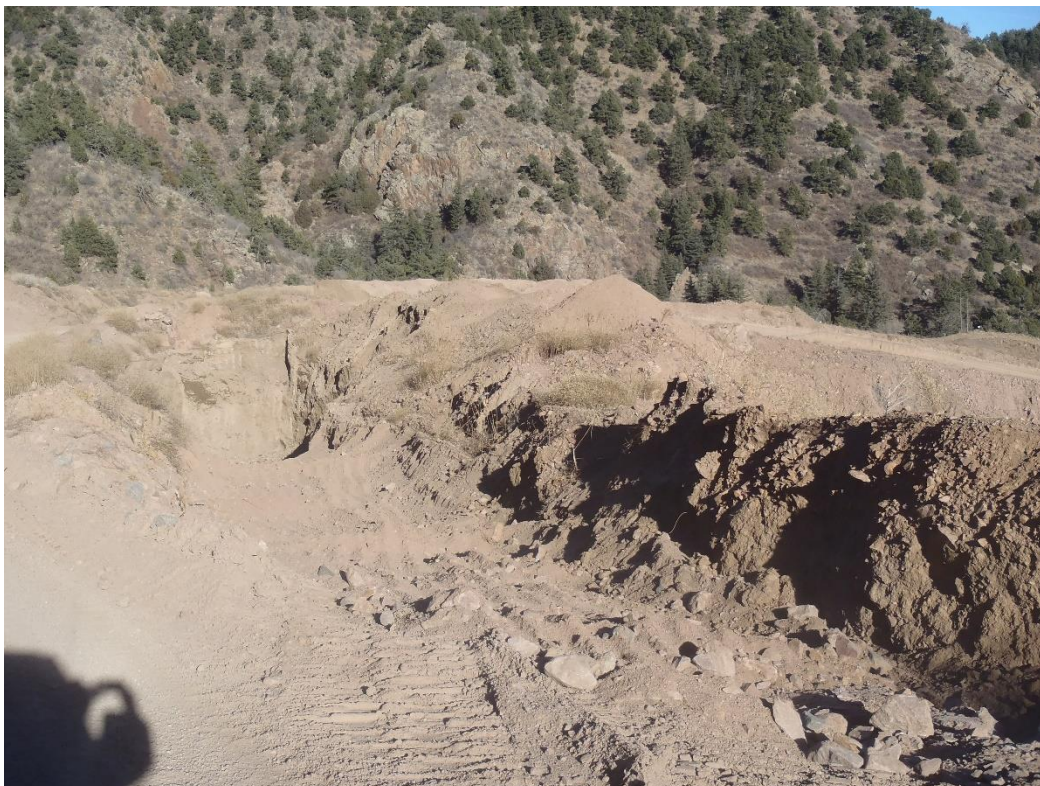
Sediment Control: The mine has several sediment traps positioned along the haul road (see **Photo 3**). No erosion problems were observed and no additional BMPs were needed at the time of the inspection. The main sediment pond on the east side of the permit area had been cleaned out since the previous inspection (see **Photo 4**).

Photo 3. Sediment trap along main haul road (looking NNE).

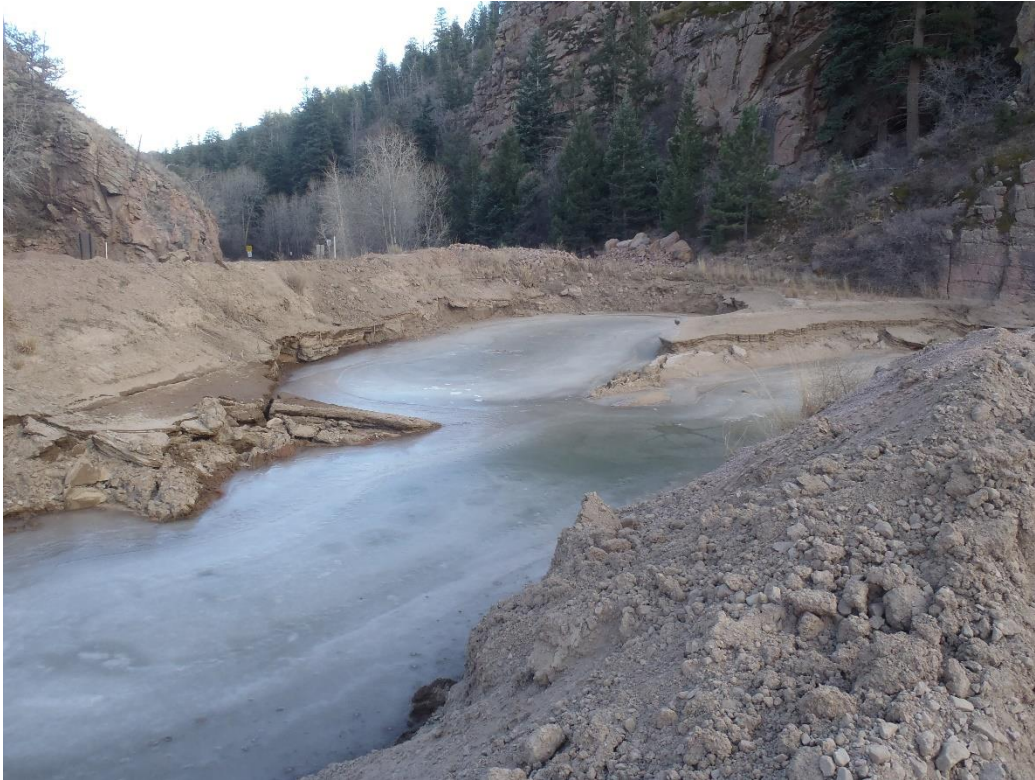
Photo 4. Sediment pond on east side (looking south).

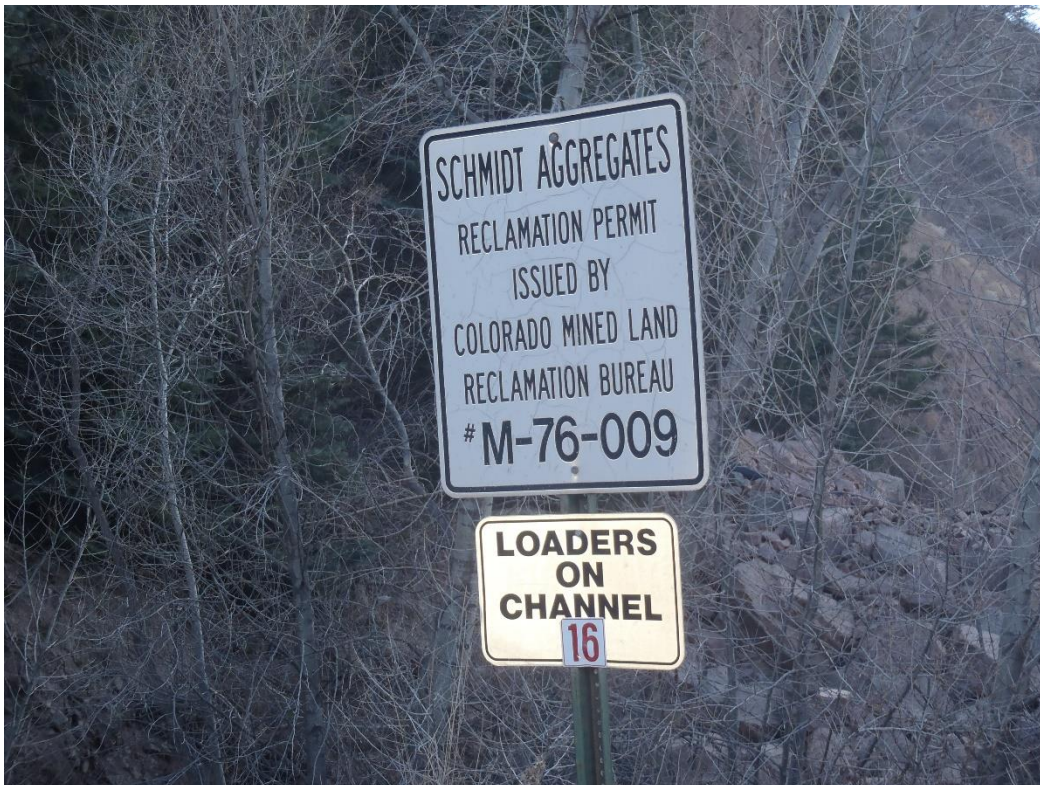
Signs and Markers: The permit sign was properly posted (see **Photo 5**) and boundary markers were observed to delineate the permit boundary (see **Photo 6**).

Photo 5. Permit sign at entrance (SW corner).

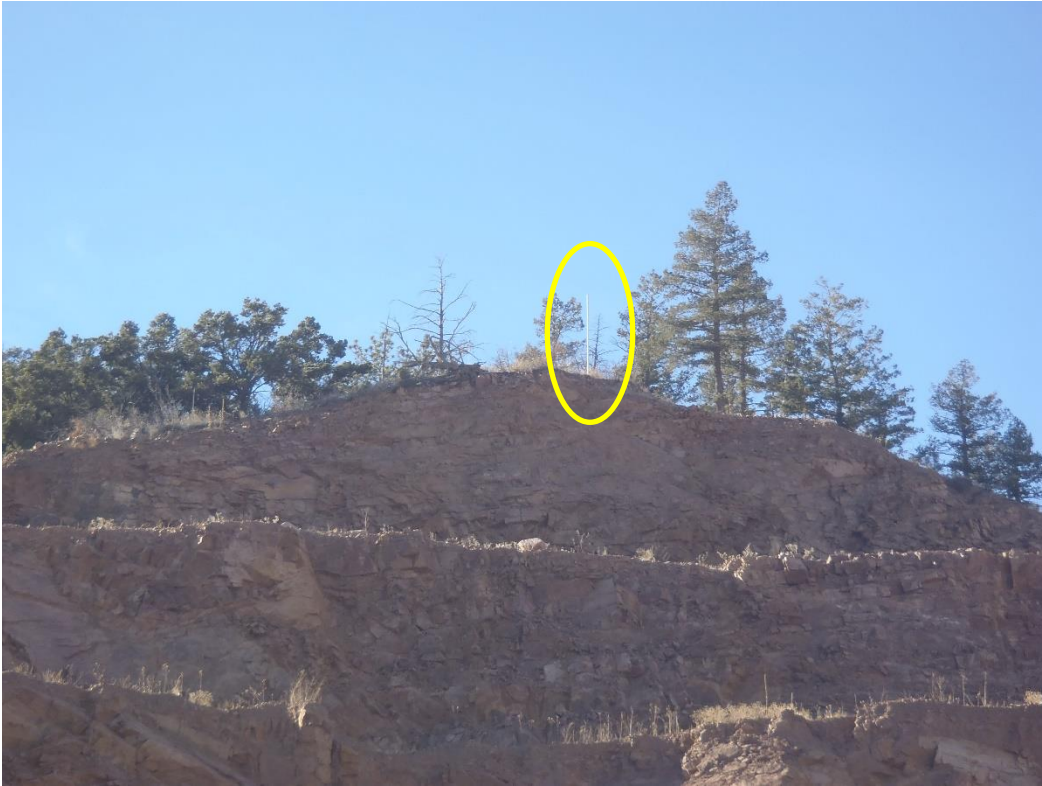
Photo 6. Typical permit boundary sign (west side highwall).
