MINERALS PROGRAM INSPECTION REPORT
PHONE: (303) 866-3567

MINE NAME: Table Mountain Quarry	MINE/PROSPECTING ID#: M-1999-004	MINERAL: Silica (quartz, quartzite)	COUNTY: Fremont
INSPECTION TYPE: Monitoring	INSPECTOR(S): Timothy A. Cazier, Amy Eschberger	INSP. DATE: January 29, 2018	INSP. TIME: 11:45
OPERATOR: Tezak Heavy Equipment Co. Inc.	OPERATOR REPRESENTATIVE: Randy DiLuzio	TYPE OF OPERATION: 112c - Construction Regular Operation	
REASON FOR INSPECTION: Priority	BOND CALCULATION TYPE: Partial	BOND AMOUNT: \$202,793.00	
DATE OF COMPLAINT: NA	POST INSP. CONTACTS: Colo. Land Board	JOINT INSP. AGENCY: Colo. Land Board	
WEATHER: Clear	INSPECTOR'S SIGNATURE:

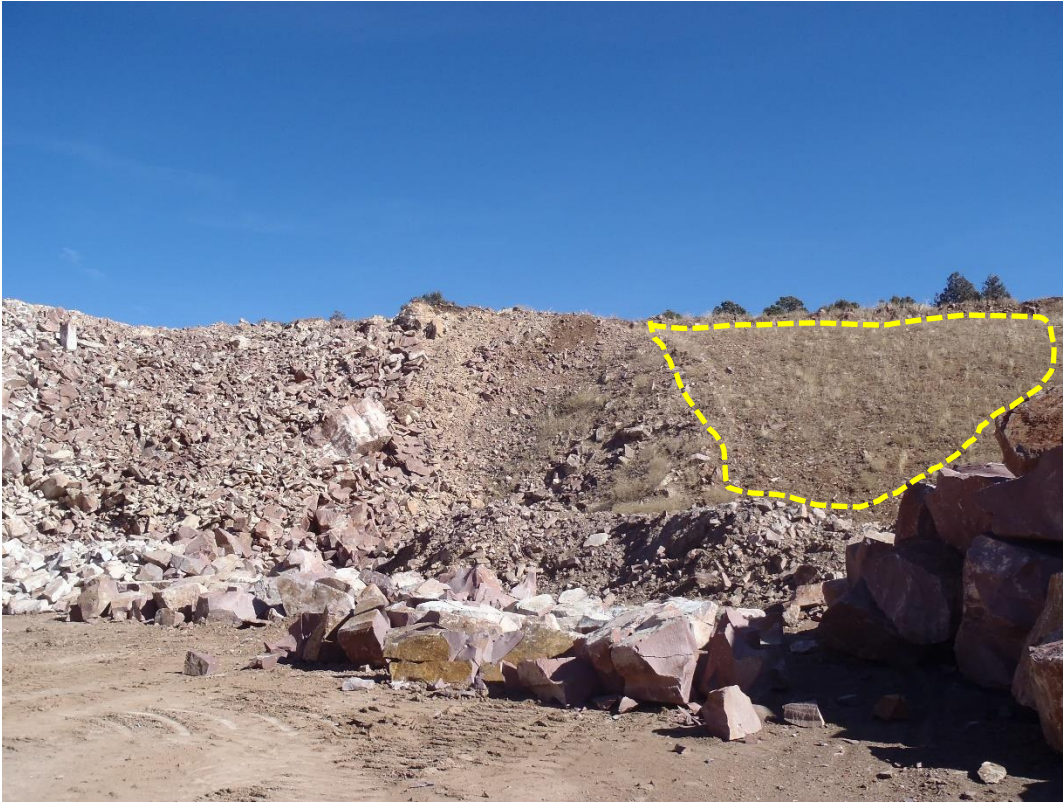
Revegetation: Revegetation had been initiated at both ends of the highwall in the backfilled areas of the highwall (see **Photos 1 and 2**). No noxious weeds were observed.

Photo 1. East highwall reclamation (looking east).

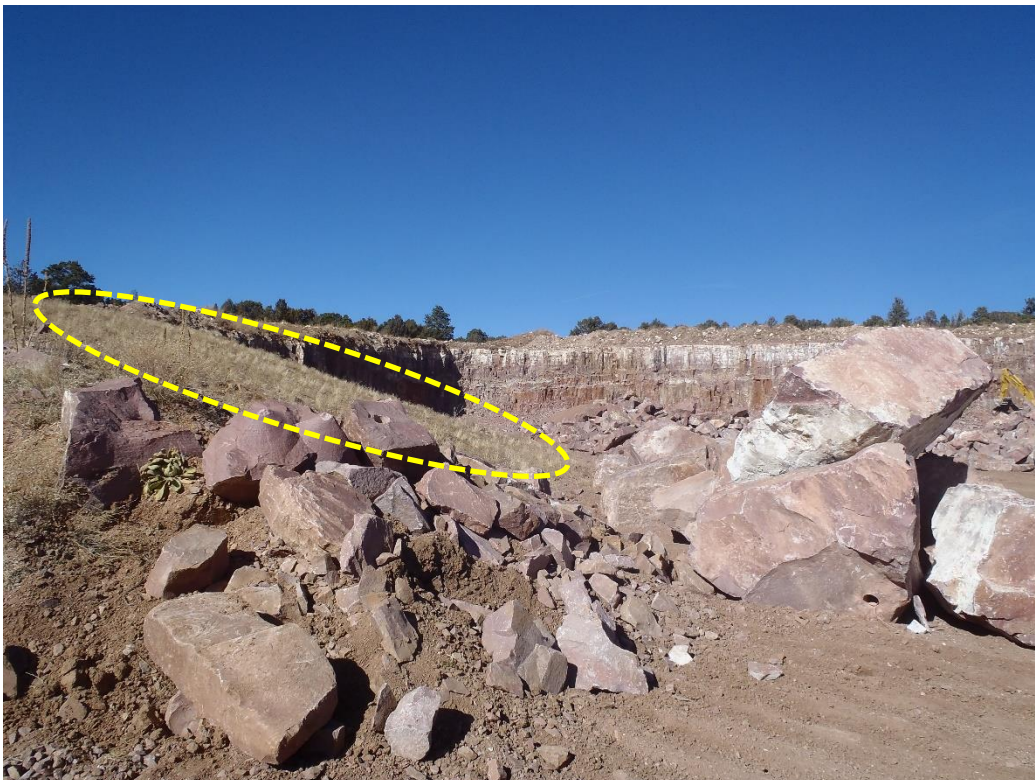
Photo 2. West highwall reclamation (looking NW).

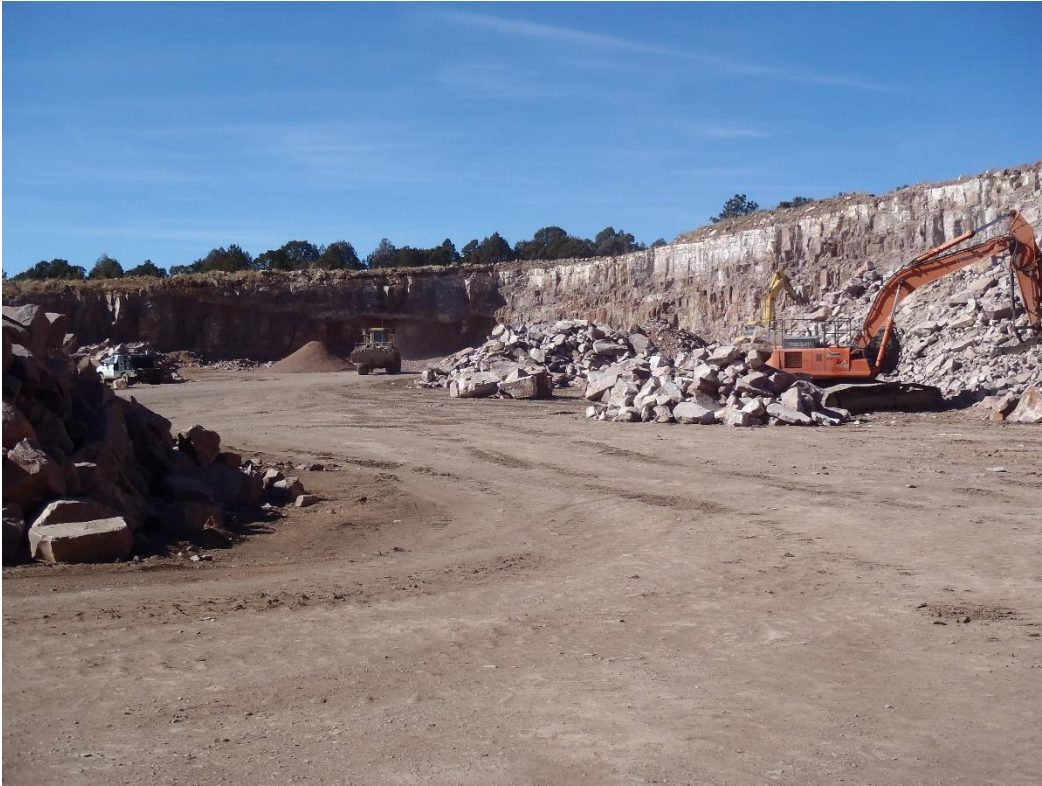
Highwalls were observed to be approximately 40 feet in height and appeared stable (see **Photo 3**). There is a permit stipulation (discussed below) limiting the highwall length to 2,000 feet. The current length of the highwall was estimated to be less than 1,300 feet. The Operator is currently mining in in Area A. A previous Operator had begun mining in Area B.

Photo 3. Active east-west highwall (looking WNW).

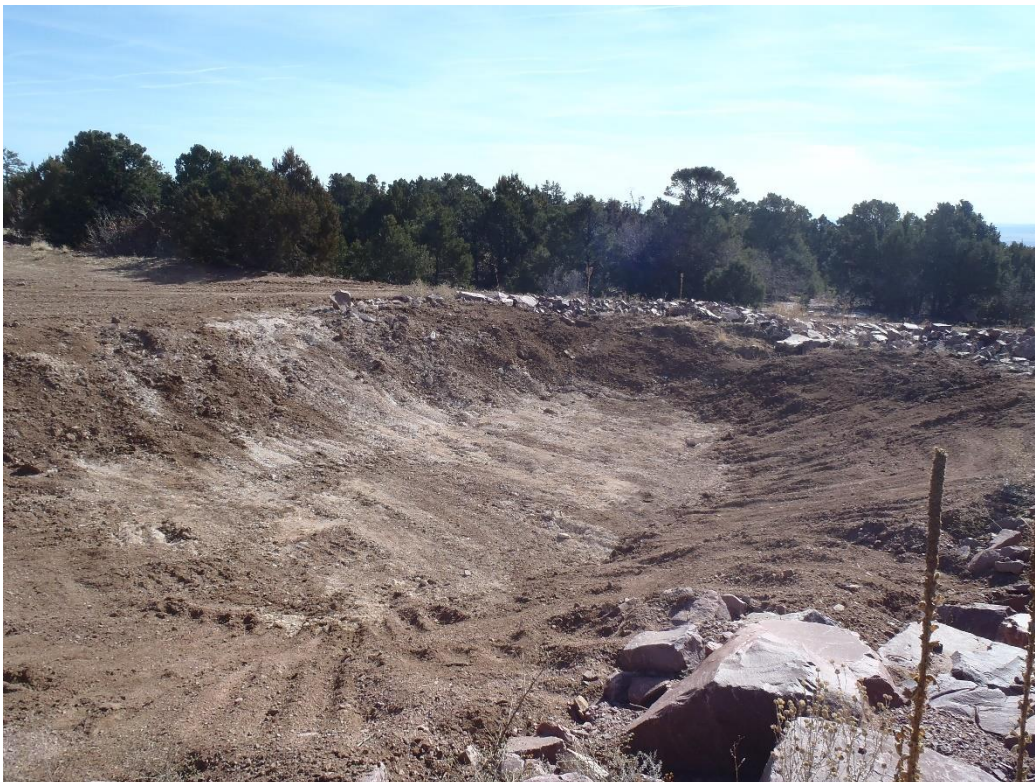
Sediment Control: The sediment pond on the south end of the site had been cleaned out since the previous inspection (see **Photo 4**). Discussions regarding stormwater control improvements are included in the Stormwater MGT Plan below. No erosion problems were observed and no BMPs were needed at the time of the inspection.

Photo 4. South sediment pond (looking SSE).

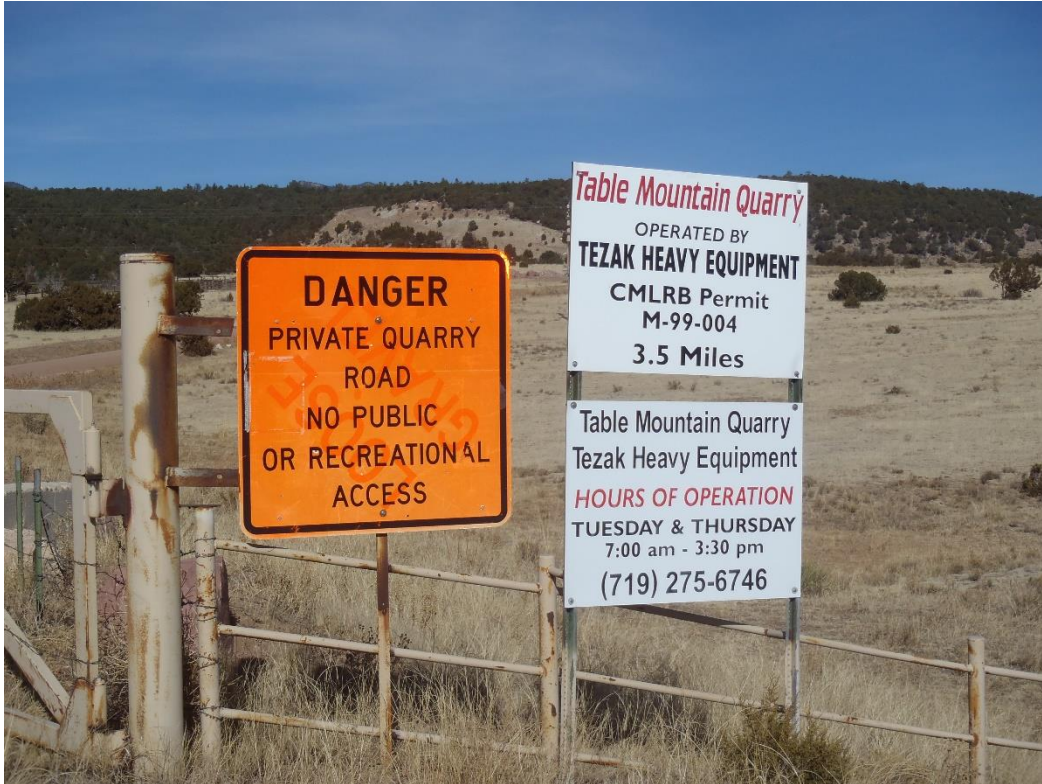
Signs and Markers: The permit sign was posted near the intersection of Hwy 115 and the mine access road (see **Photo 5**) at the time of the inspection. Boundaries are generally marked with T-posts (see **Photo 6**).

Photo 5. Permit sign near entrance.

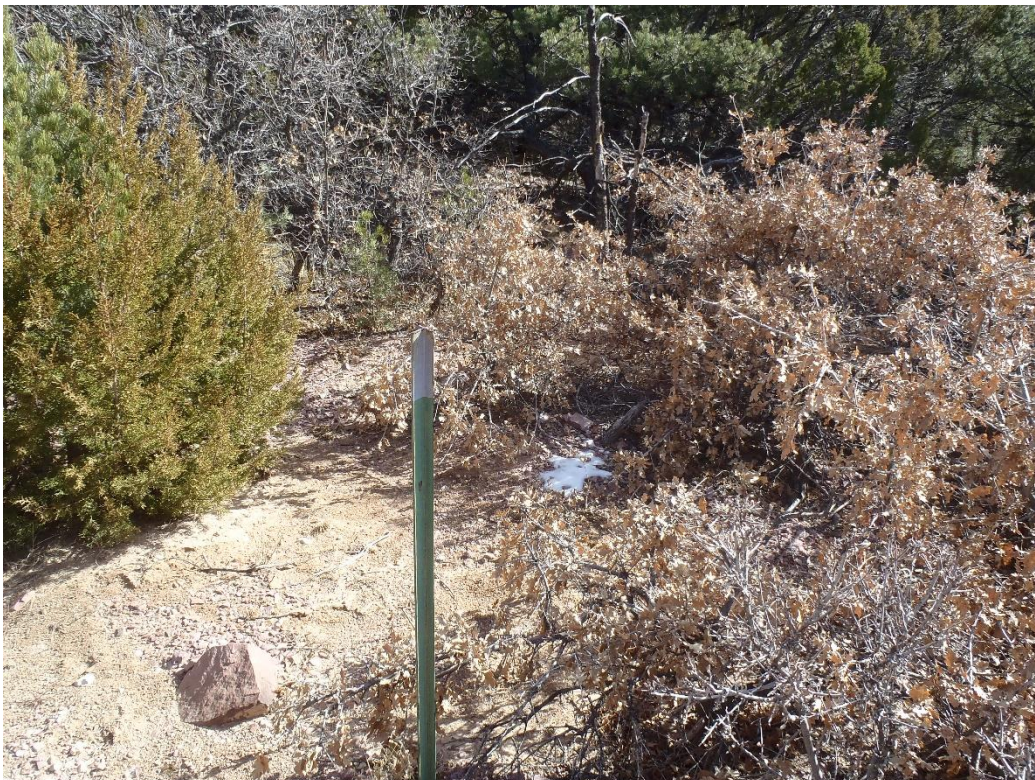
Photo 6. Typical T-post boundary marker.

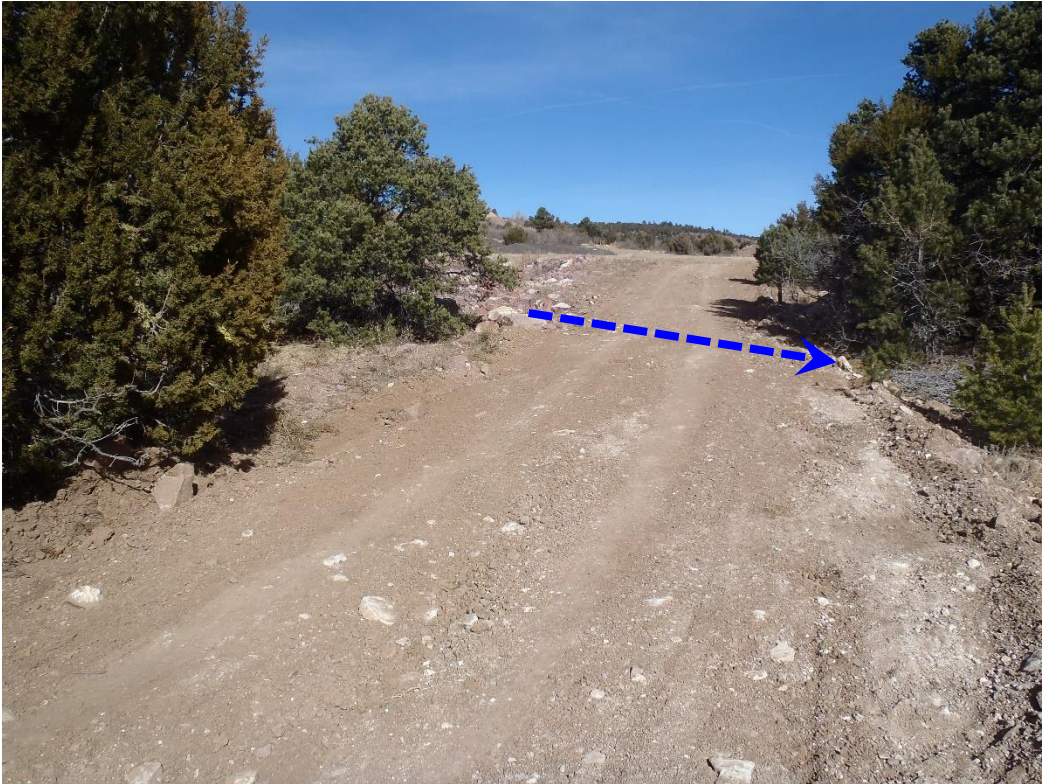
Photo 7. Stormwater crossing along road south of sediment pond (looking north).

Stormwater MGT Plan: The Division's abandoned mine land (AML) group has a forfeited bond from a permit that preceded the current permit. TC Wait from AML visited the site in the summer of 2017 to assess what reclamation could be accomplished with the forfeited bond money. Her assessment included stormwater improvements to the outfall from the south sediment pond (see **Photos 7 and 8**). Some discussions with the Mr. DiLuzio during this inspection resulted in some improvements that might be made to the area where the outfall channel crosses the road running southward from the permit area. During the previous inspection, it appeared discharge from the sediment pond was primarily following the road. During this inspection, it appears most, if not all the discharge is running next to the road, rather than in it. It also appeared the discharge was directed towards natural channels. The Operator should coordinate with the Division's AML group prior to initiating any drainage improvement in this area.

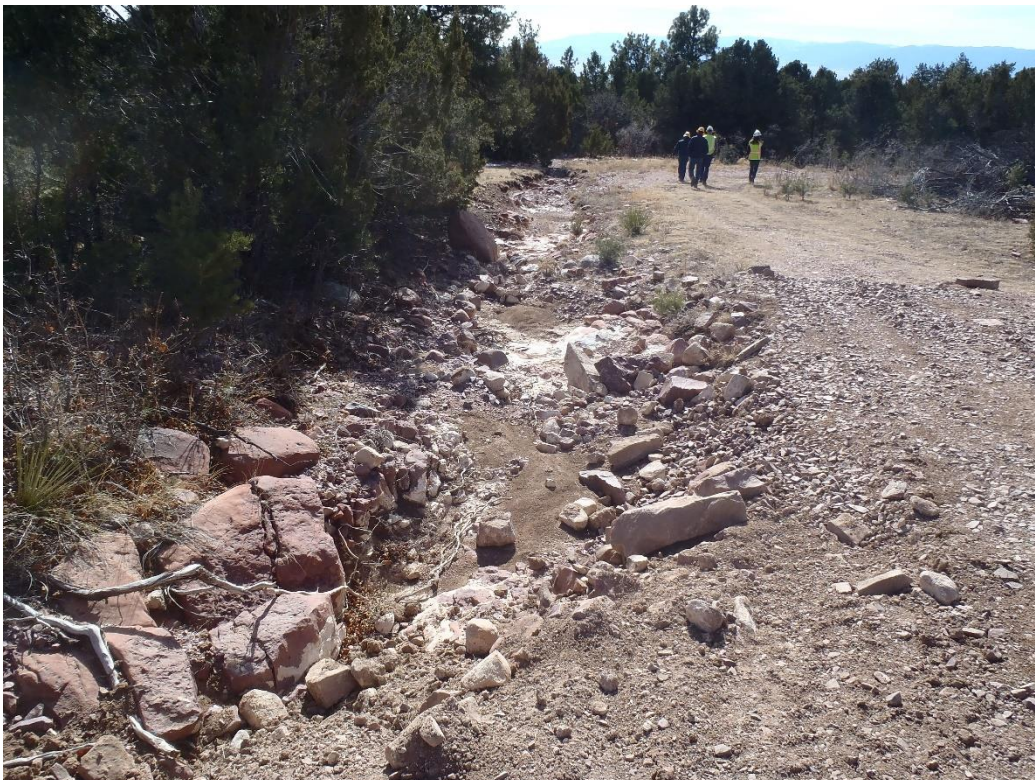
Photo 8. Stormwater channel along road south of sediment pond (looking south).

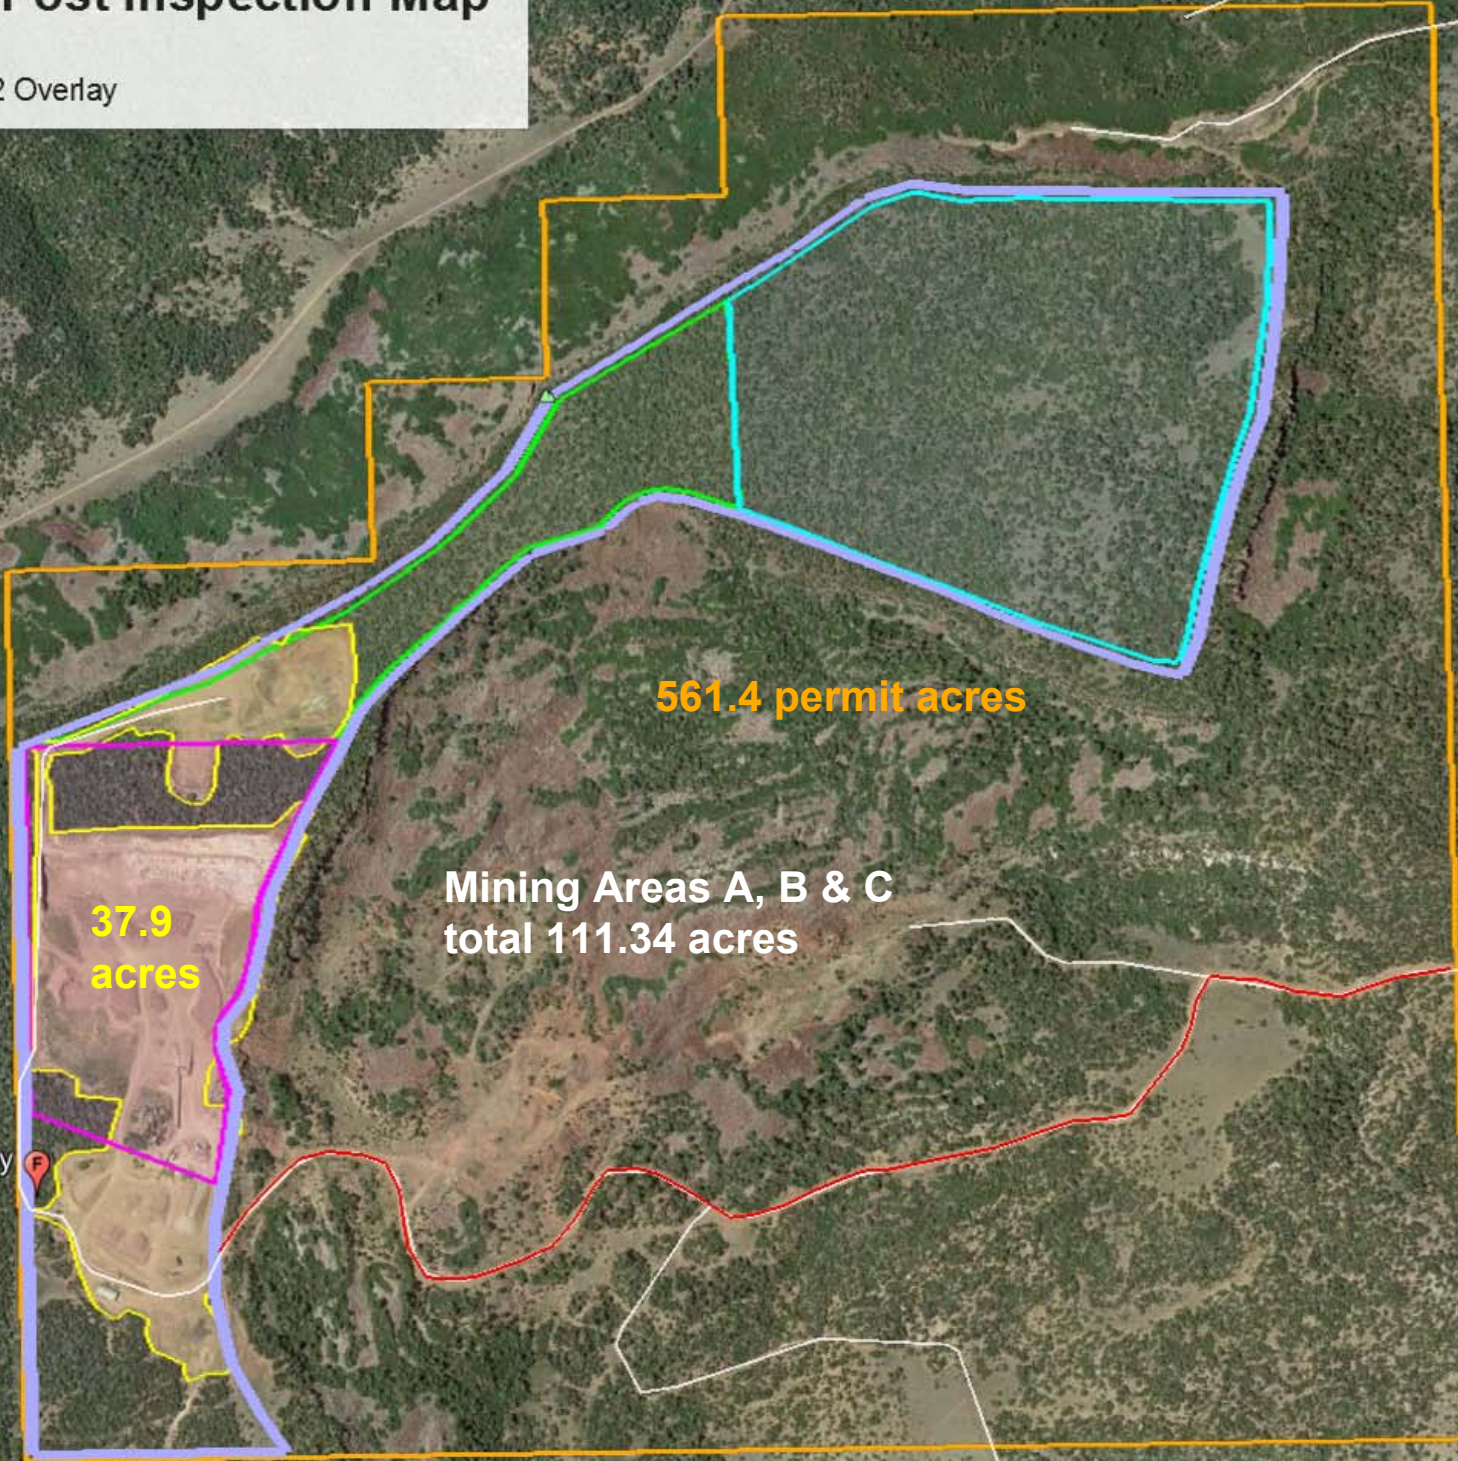
M-1999-004 1/29/2018 Post Inspection Map

Gen. Compliance with Mine Plan: The operation appeared to be in compliance with the approved mine plan. Google Earth was used to measure the disturbed area, which was estimated to be just under 38 acres (see **enclosed** post-inspection map). This is near the limit of the permit's maximum allowed disturbed area at one time. Based on the amendment 1 (AM-01) application and subsequent adequacy reviews, it appears the maximum allowed disturbed area at any given time is 38.2 acres. The concurrent reclamation on the south end of the east and west highwalls in Area A (see **Photos 1** and **2**) might offset the disturbed area total if a release were requested. The Permittee should consider a revision to the permit, or requesting releases of reclaimed areas so the affected area does not exceed the current maximum allowed area of 38.2 acres.

37.9
acres
