MINERALS PROGRAM INSPECTION REPORT
PHONE: (303) 866-3567

MINE NAME: Hitch Rack Ranch	MINE/PROSPECTING ID#: P-2017-008	MINERAL: Granite, granite gneiss	COUNTY: El Paso
INSPECTION TYPE: Monitoring	INSPECTOR(S): Timothy A. Cazier, Amy Eschberger	INSP. DATE: January 30, 2018	INSP. TIME: 13:00
OPERATOR: Transit Mix Concrete Co.	OPERATOR REPRESENTATIVE: Brandon Heser	TYPE OF OPERATION: ME – Mineral Exploration	
REASON FOR INSPECTION: Priority	BOND CALCULATION TYPE: None	BOND AMOUNT: \$4,000.00	
DATE OF COMPLAINT: NA	POST INSP. CONTACTS: None	JOINT INSP. AGENCY: None	
WEATHER: Cloudy	INSPECTOR'S SIGNATURE:

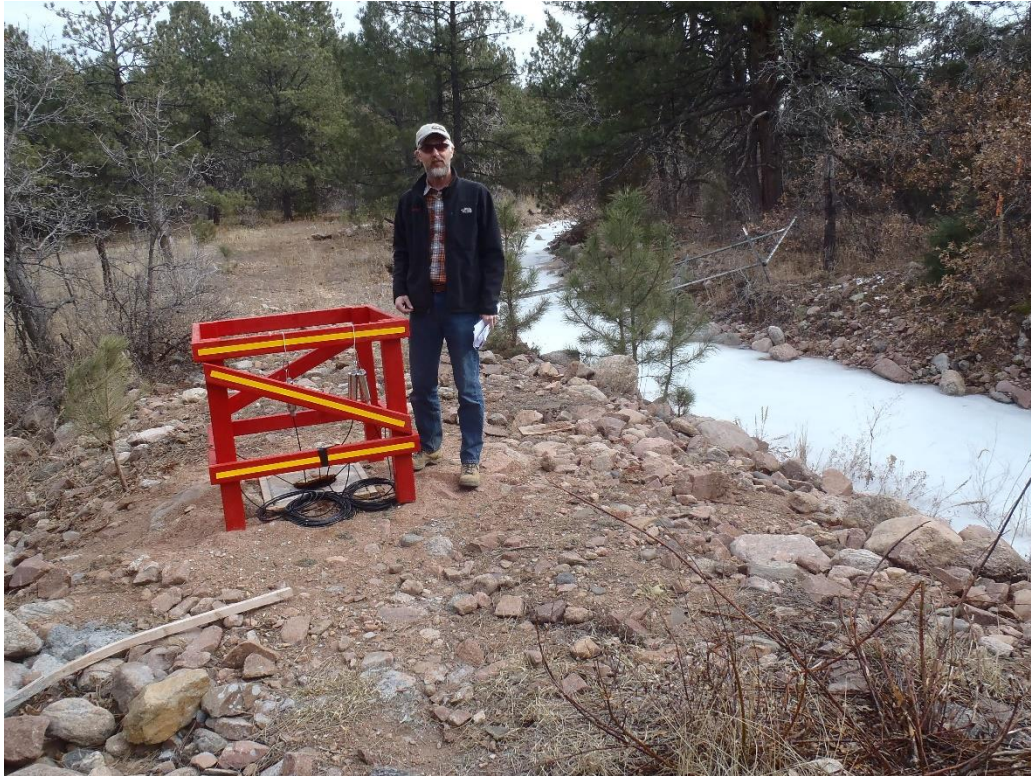
Hydrologic Balance: The following four monitoring wells were observed during this inspection: MW-7 (a.k.a. LTC-GW-7), MW-6 (a.k.a. LTC-GW-6), MW-2 (a.k.a. LTC-GW-2), and MW-1 (a.k.a. LTC-GW-1) (see **Photos 1 through 4**) and GPS coordinates of each were collected using a handheld Trimble Juno 3B (see **enclosed post-inspection map**). Monitoring wells MW-1, -2, and -7 were completed with continuous monitoring well tubing (see **Photo 5**). MW-6 was completed without the continuous monitoring well tubing (see **Photo 6**).

Photo 1. MW-7 (looking east).

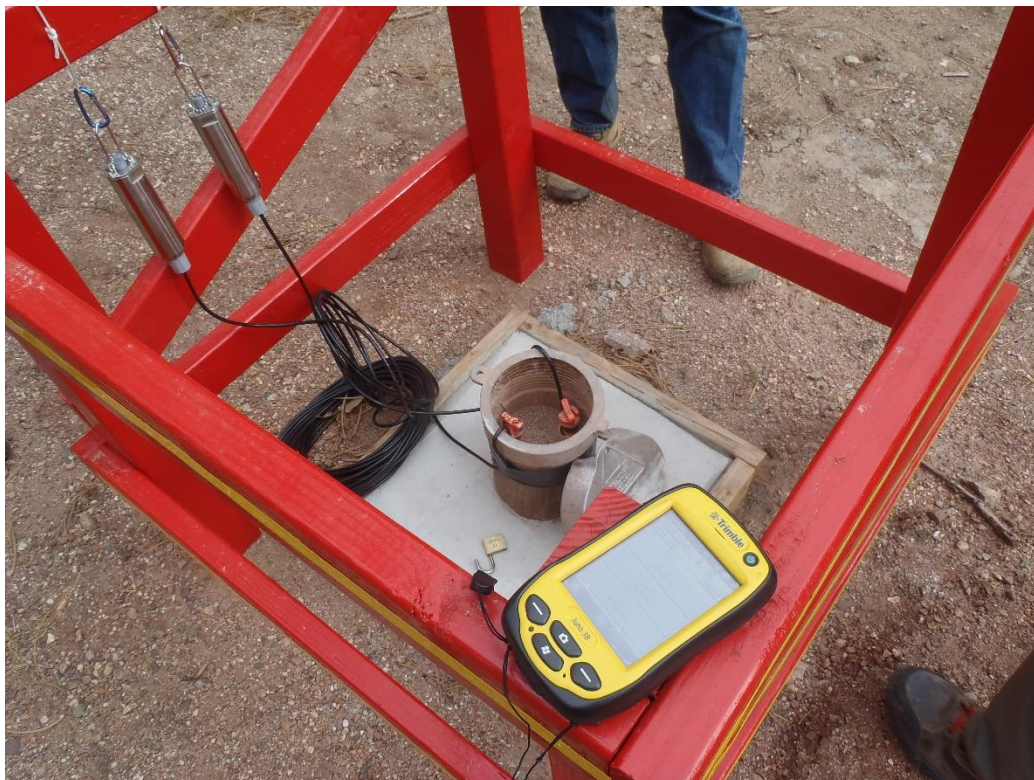
Photo 2. MW-6.

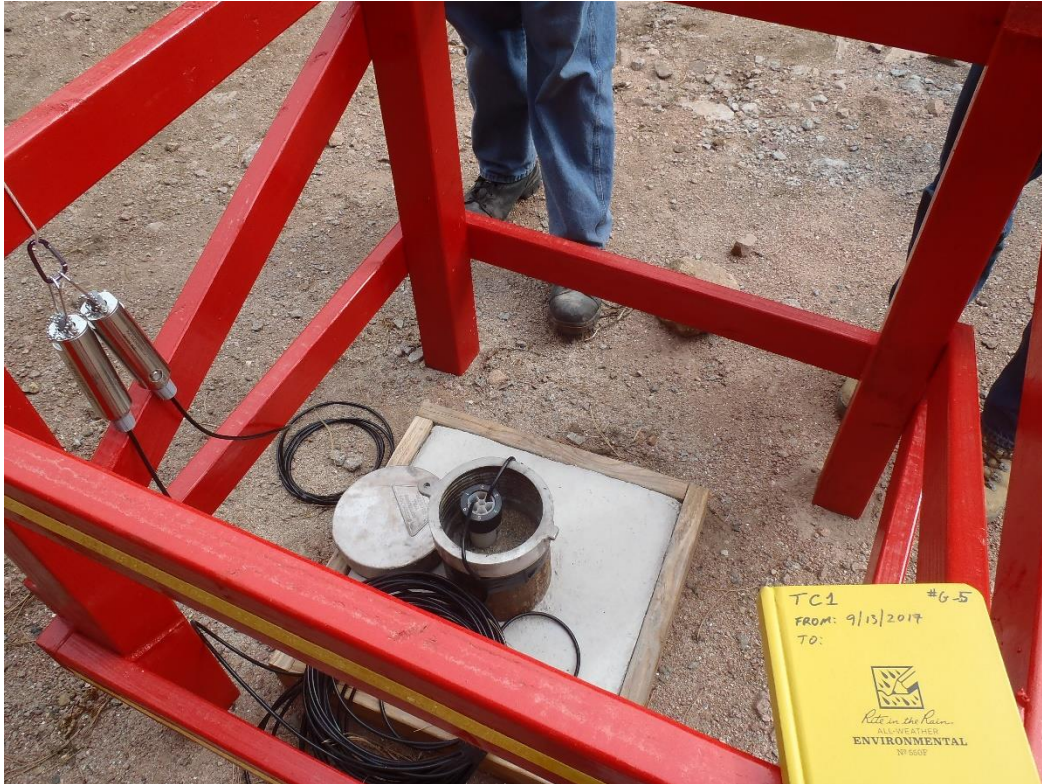
Photo 3. MW-2.

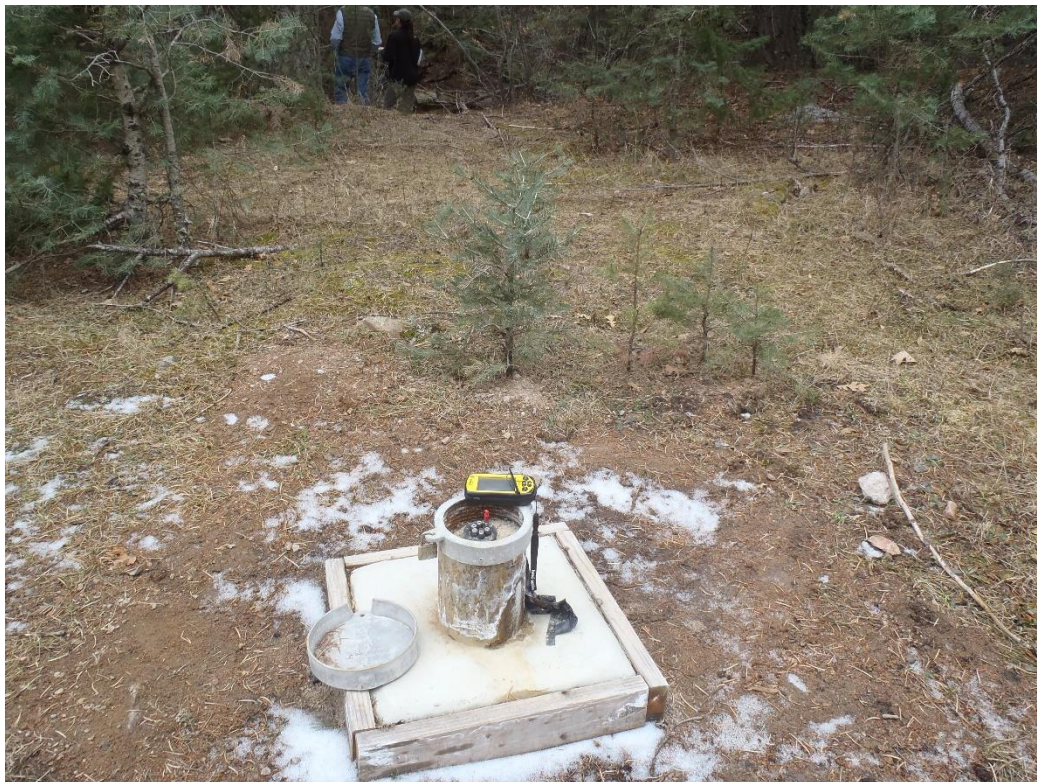
Photo 4. MW-1 (looking south).

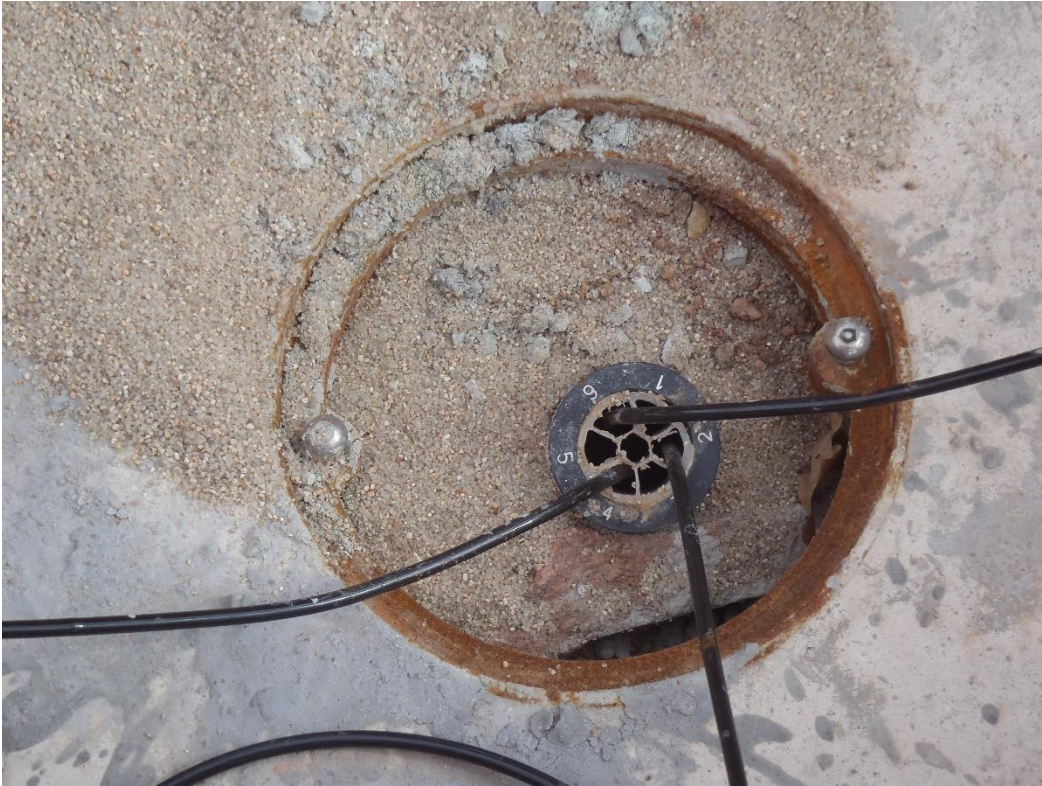
Photo 5. Continuous monitoring well tubing (MW-7).

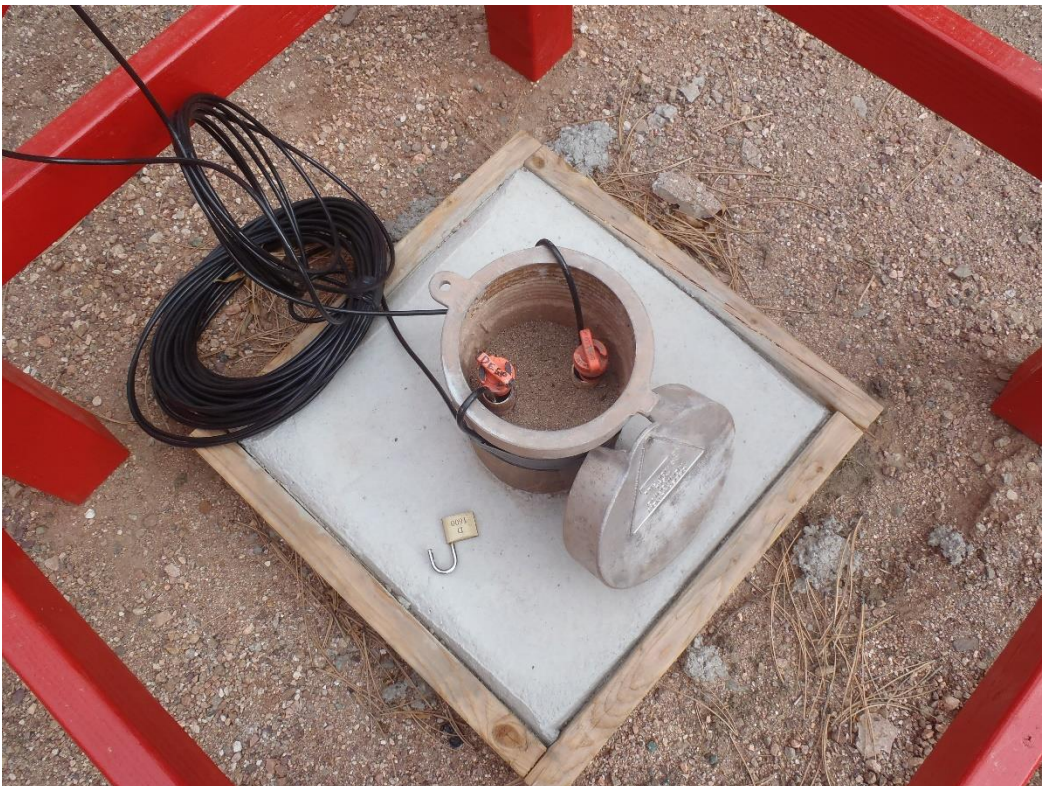
Photo 6. Standard completion (MW-6).
