Bureau of Land Management Colorado River Valley Field Office Minerals Inspection Report

General Information	
Date	3/7/2018
Project Name	Mid-Continent Limestone Quarry
Operator	RMR Aggregates, Inc.
Serial Number	COC-074205
Project Classification	Plan of Operations
Project Location	T5S R89W Sec36, Garfield County
Inspection Purpose	Regular site inspection (per 43 CFR 3809.600 (a))
Time Period Onsite	2.5 hours
Attendees	Jessica Lopez Pearce, BLM Geologist
	Bobby Wagner, RMR Aggregates, Inc. Director of Operations
	Justin Olin, RMR Aggregates, Inc. Mine Superintendent

Summary

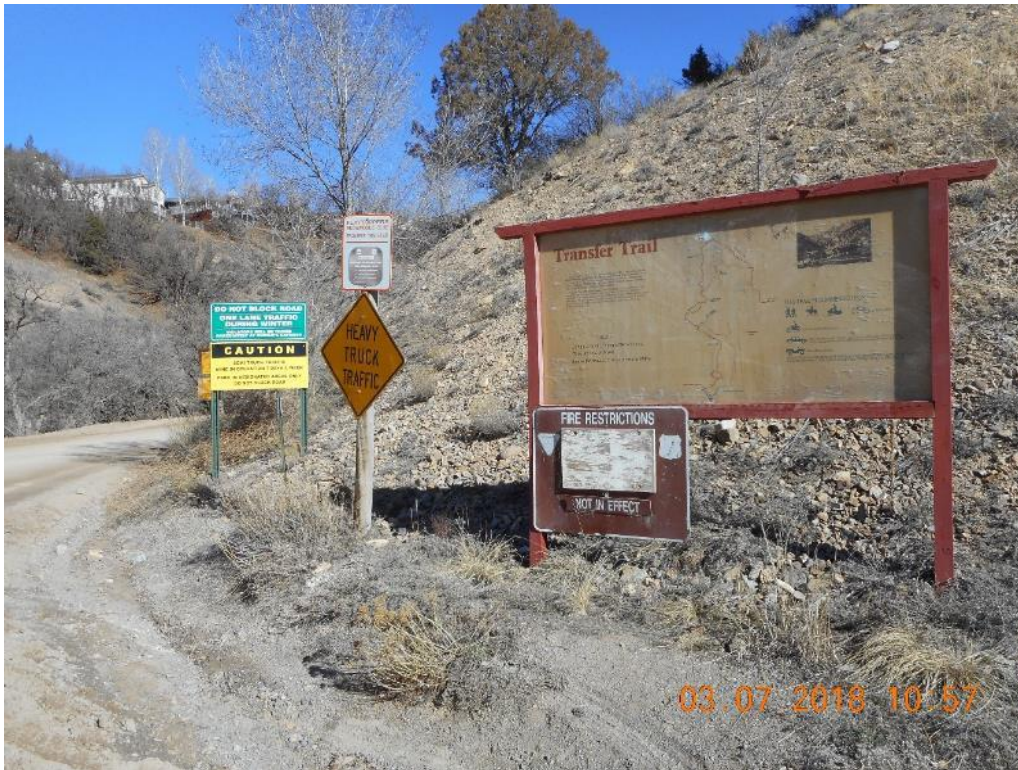
I began my inspection on the access road to the quarry. At the intersection of Traver Trail and Transfer Trail, I observed a yellow and black sign that stated: "Caution. Semi Truck Traffic. Mine in Operation 7 Days A Week. Park in Designated Areas Only. Do Not Block Road." As I drove up Transfer Trail to the quarry, I observed six "Heavy Truck Traffic" signs at various points along the road. Per the January 14, 2011 BLM letter related to parking and access on Transfer Trail: "CalX will install a metal sign at the intersection of Transfer Trail Road and Traver Trail Road. The sign will be approximately 2 feet by 4 feet in size and will read: Caution, Semi Truck Traffic, Mine in Operation 7 Days a Week, Park in Designated Areas Only, Do Not Block Road." The 2011 letter further states: "CalX will install "Heavy Truck Traffic" signs at multiple points along Transfer Trail Road." These requirements have been fulfilled.

Photo 1. A “Heavy Truck Traffic” sign and the required caution signage is present at the intersection of Traver Trail and Transfer Trail.

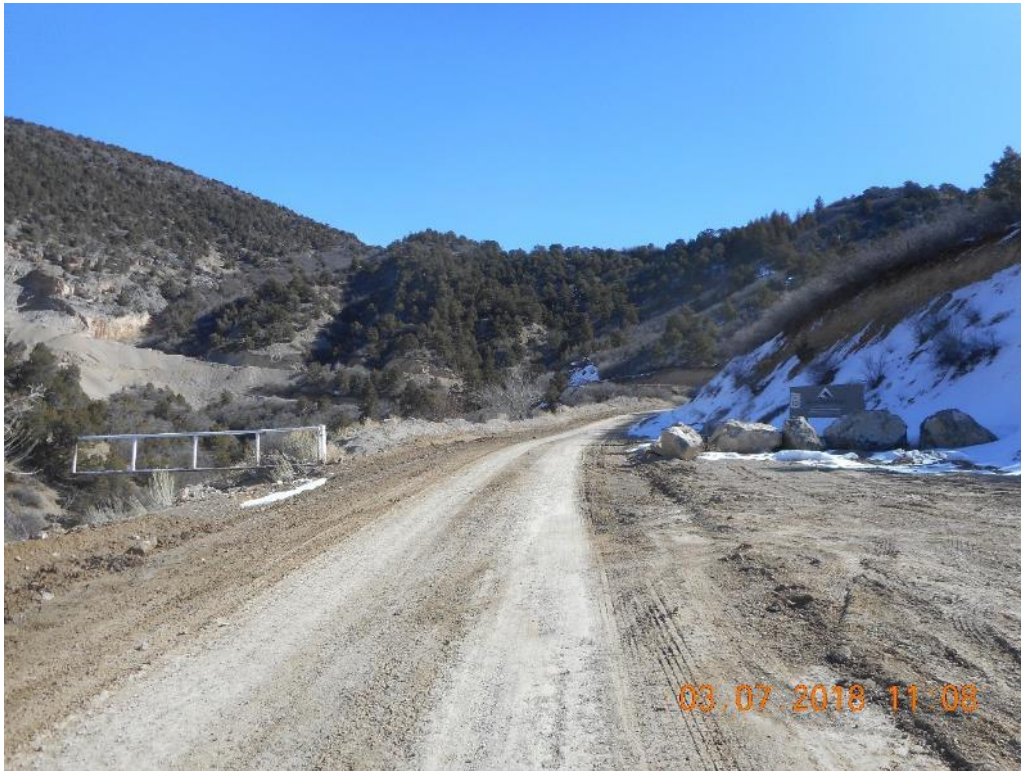
At the entrance gate to the operation, I observed a RMR Aggregates sign and an open gate. Only the west side of the gate was installed; the east side of the gate was lying on the ground. The gate, a scale shack, and a scale were approved under 43 CFR 3809 in a BLM letter dated November 20, 1986 which states: "The installation of a gate, scales, and scale shack is approved subject to item 3b(3) of the reclamation plan submitted by Mid-Continent Resources, Inc." The sign and gate were recently granted an occupancy authorization under 43 CFR

Photo 2. At entrance gate, looking northeast to gate and RMR sign.

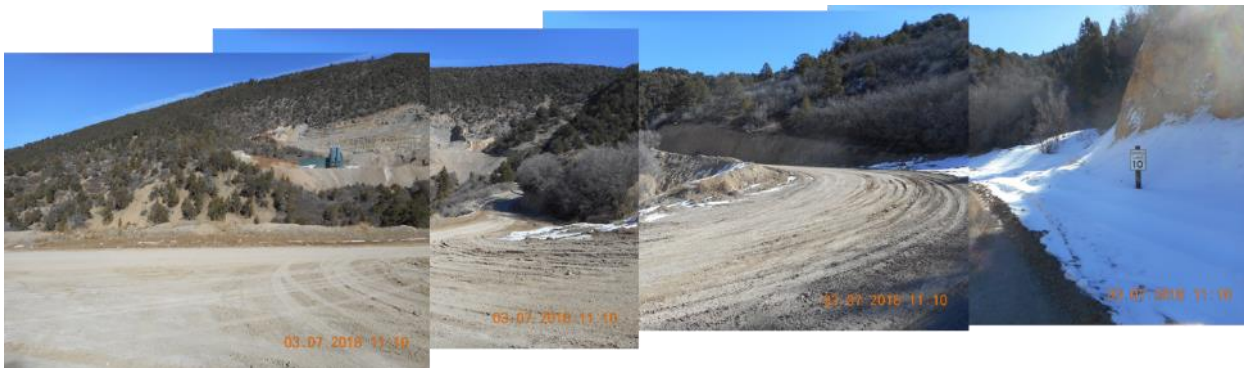
Photo 3. Looking north to Lower Road and Middle Road junction photopoint.

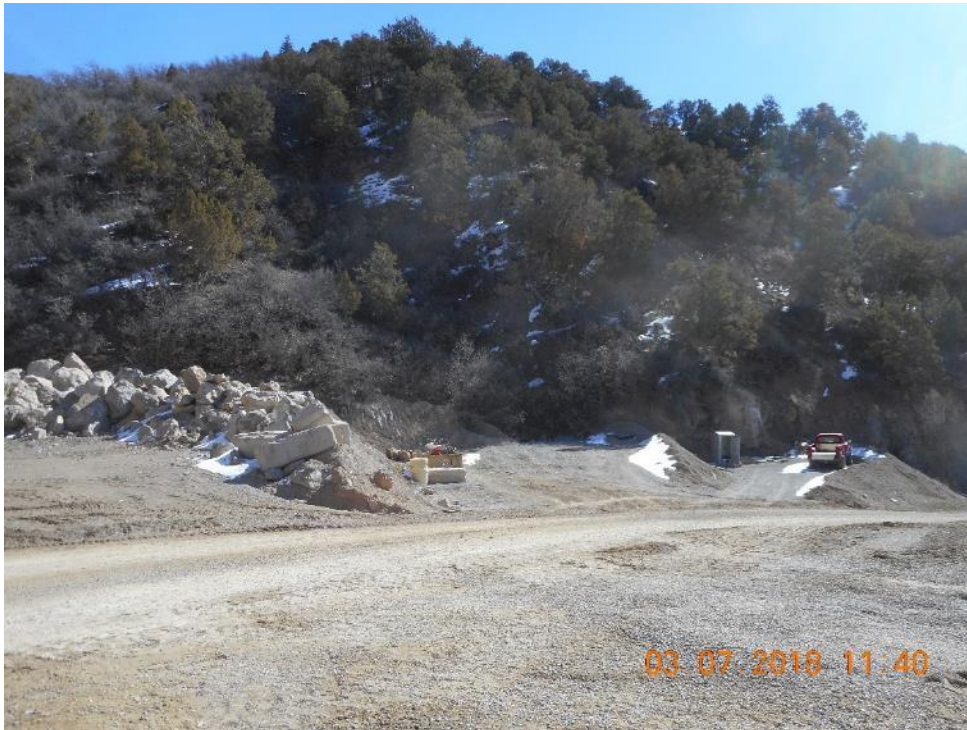
While walking up to the east side of the production bench, I observed three small benches or landings. The lowest landing contained vehicle parking and a small metal shed. The shed contained plastic containers of hydraulic oil and diesel exhaust fluid. These items require secondary containment. The 2015 CRVFO RMP – Appendix K BMPs state: "MIN-7: Project materials which could be a hazard to public health, safety or resource value will be stored in appropriate secondary containment. No oil or lubricants will be drained onto the ground surface." Additionally, per BMP MIN-50: "Standard secondary containment shall hold 110% of the capacity of the largest single tank it contains and be impervious to any oil, glycol, produced water, or other toxic fluid for 72 hours. Earthen berms must be compacted and of fine material that will prevent seepage of any spill to surrounding area." While I was on-site, Justin contacted a quarry employee to retrieve the containers and put them within secondary containment. The middle landing contained a large diesel tank with secondary containment and storage. The upper landing contained boulder storage.

Photo 4. Looking eastward at the upper (left), middle (center), and lower (right) small landings on the east side of the production bench.

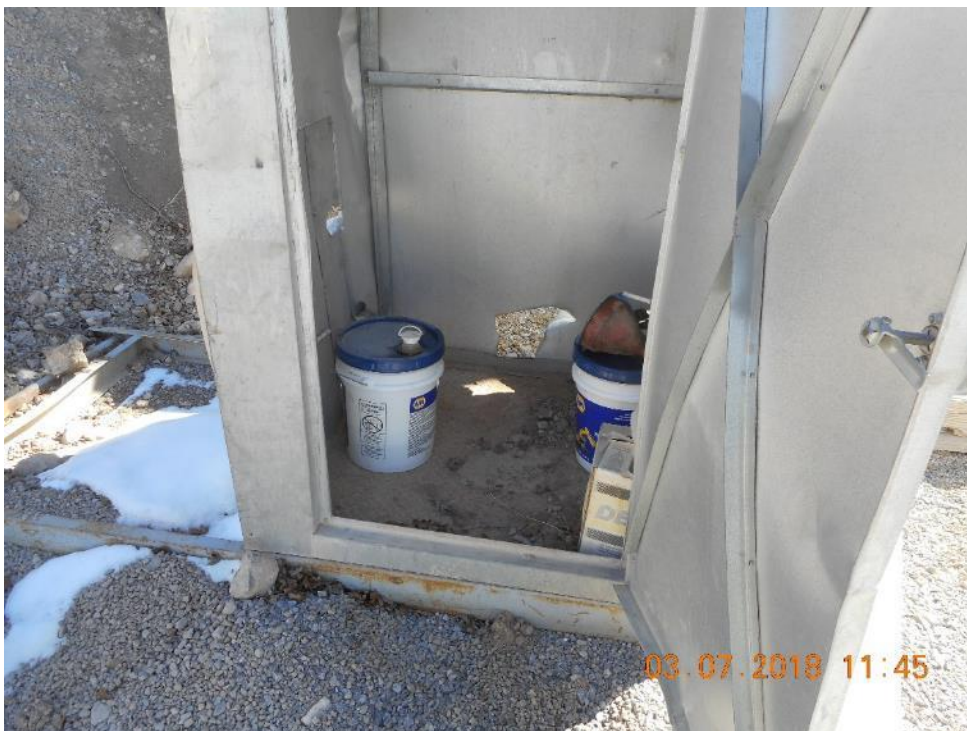
Photo 5. Inadequate secondary containment inside small storage shed on the lower small landing.

- While all secondary containment of petroleum-based and hazardous material issues were resolved during my site visit, RMR must remain vigilant in secondary containment requirements.
- Redesign the quarry highwall and mine benches to conform with the 1982 Plan of Operations and 1989 Plan of Operations modification or include an updated mining plan and mine bench design in a proposed Plan of Operations modification to reflect the current mine operations.
- Regrade topsoil stockpile to the 4:1 slope as stated in the 1989 Plan of Operations modification (Amendment 1) or include the current topsoil conditions in a proposed Plan of Operations modification.
- RMR must submit a surface drainage plan (or stormwater management plan) with any proposed Plan of Operations modification.

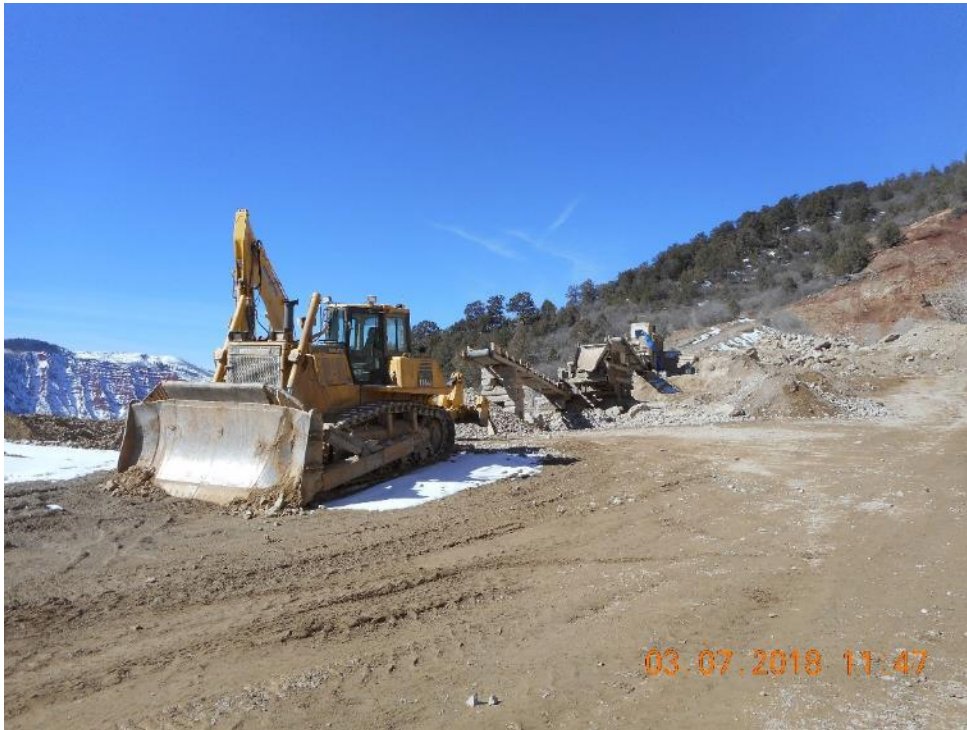
Equipment on the production bench consisted of a dozer, and excavator, a grizzly, and a crusher. The crusher was not operating during my visit due to a broken belt.

Photo 6. Looking west on production bench to dozer, excavator, and crusher.

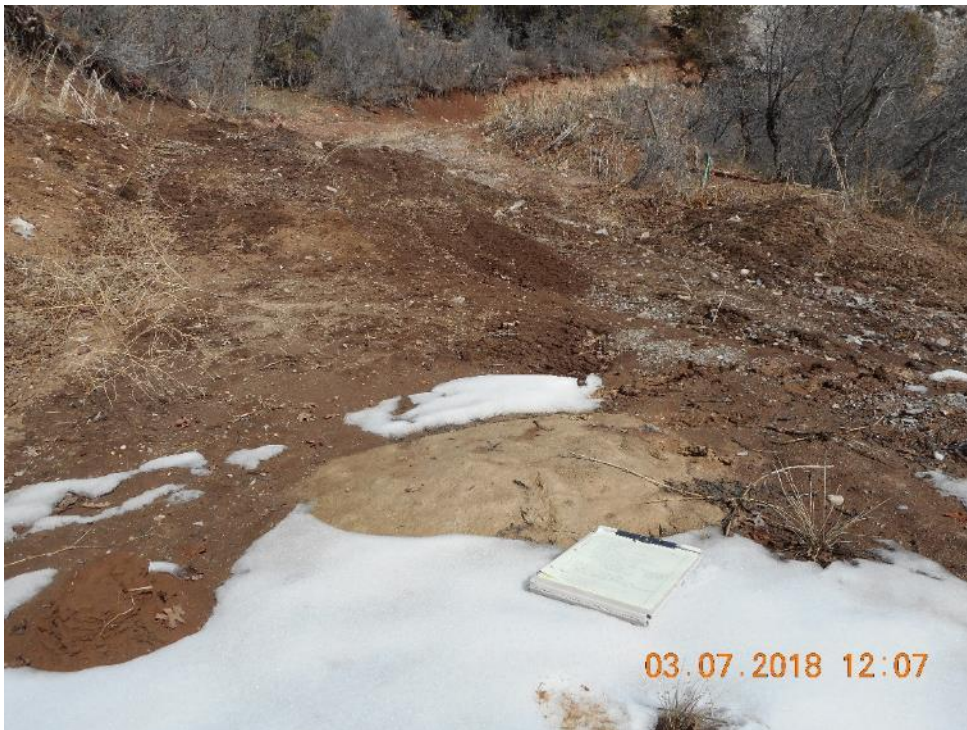
During this inspection, I visited two of the reclaimed 2016 exploratory drill holes; drill holes #5 and 6. Surface evidence of the remaining four holes (drill holes #1, 2, 3, and 4) had been obliterated by subsequent blasting operations. Drill hole #6, located on the western access to the upper mine benches, had some moisture-related material swelling at the surface but no other evidence of surface disturbance. Drill hole #5, located on the access to the upper-most mine bench, had a larger volume of cuttings remaining on the surface. All six drill holes were located within existing disturbance. RMR stated that water was not encountered during drilling operations for any of the six holes.

Photo 7. Looking north to drill hole #6. Clipboard for scale.

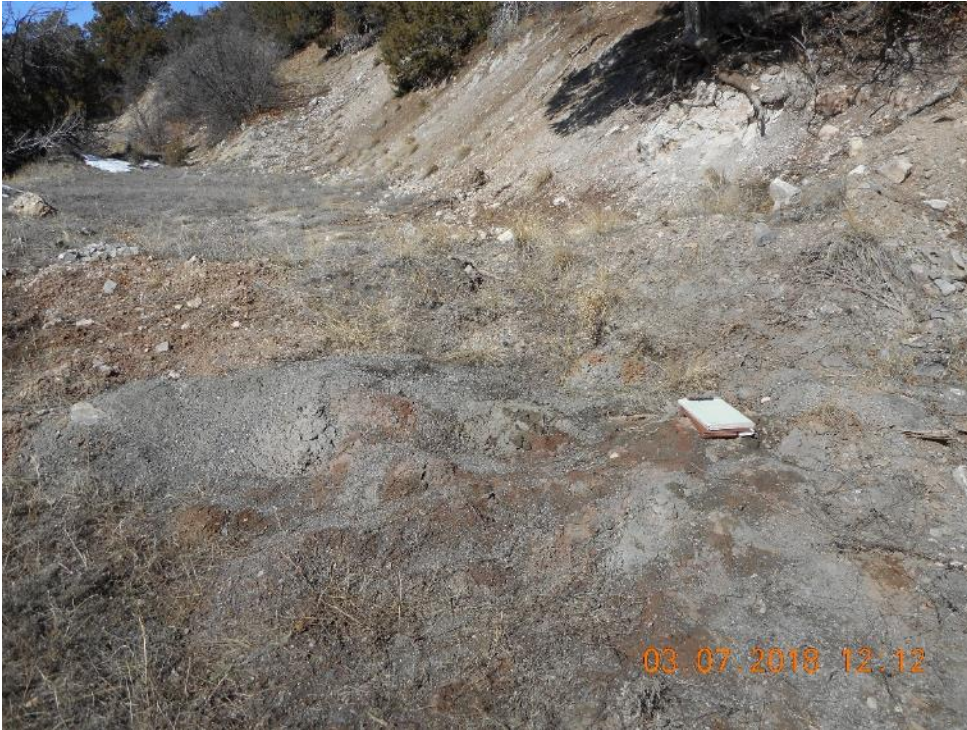
Photo 8. Looking west to drill hole #5. Clipboard for scale.

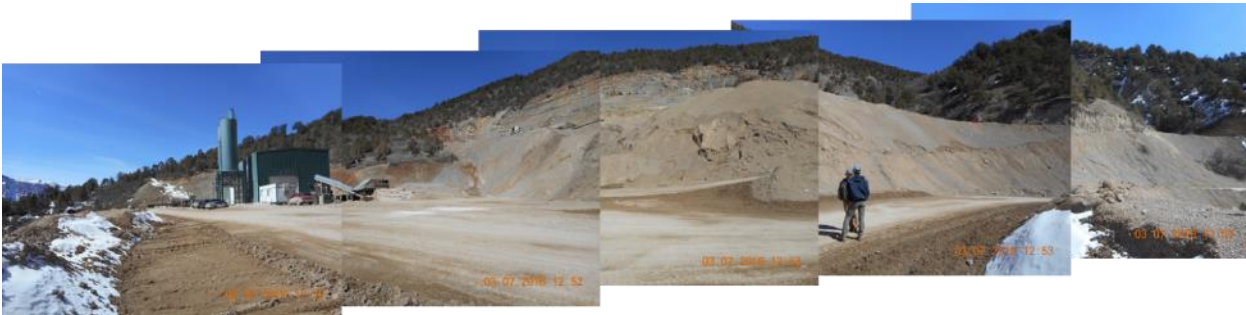
Photo 9. Looking north from central mill bench photo point

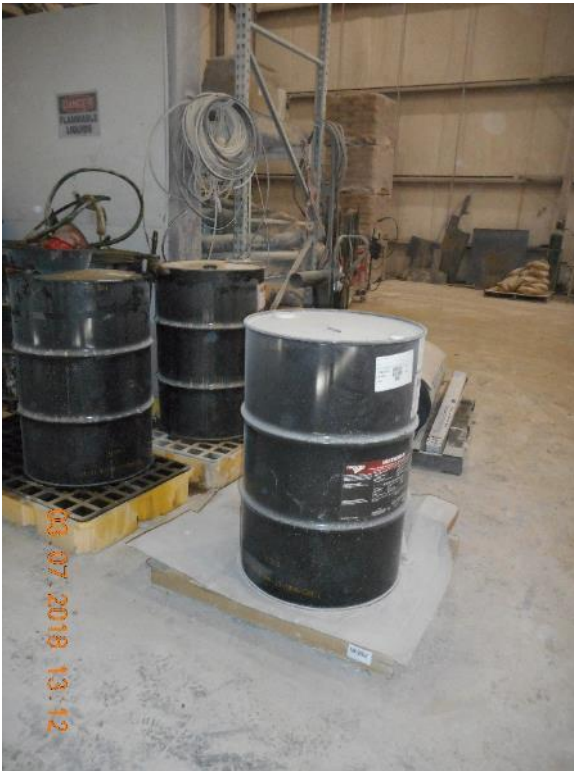
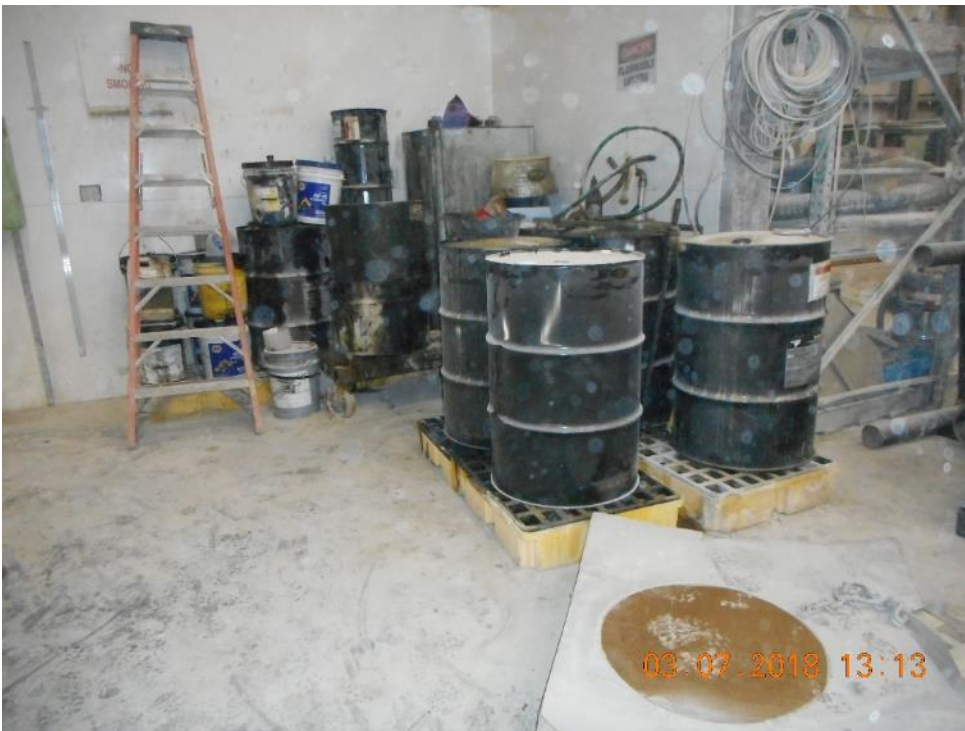
Issues were noted and addressed within the mill building. When we first entered the east side of the mill building, the mill was operating. However, Justin and Bobby noted a damaged conveyor belt from the secondary crusher to the mill and subsequently powered it down to make repairs. On the west side of the mill building interior, I observed a 50-gallon tank of hydraulic oil outside of secondary containment. Justin and Bobby moved the barrel onto a spill pallet while I was present. Other containers of lubricants were stored on spill pallets. The 2015 CRVFO RMP – Appendix K BMPs state: “MIN-7: Project materials which could be a hazard to public health, safety or resource value will be stored in appropriate secondary containment. No oil or lubricants will be drained onto the ground surface.” The mill facility was approved in BLM correspondence dated June 15, 2009. Per 43 CFR 3809.420 (b) (13): “During all operations, the operator shall maintain his or her structures, equipment, and other facilities in a safe and orderly manner.”

Photo 10a. Before: 55-gallon barrel of hydraulic oil without secondary containment inside the mill building.

Photo 10b. After: 55-gallon drum of hydraulic oil on spill pallet inside the mill building.

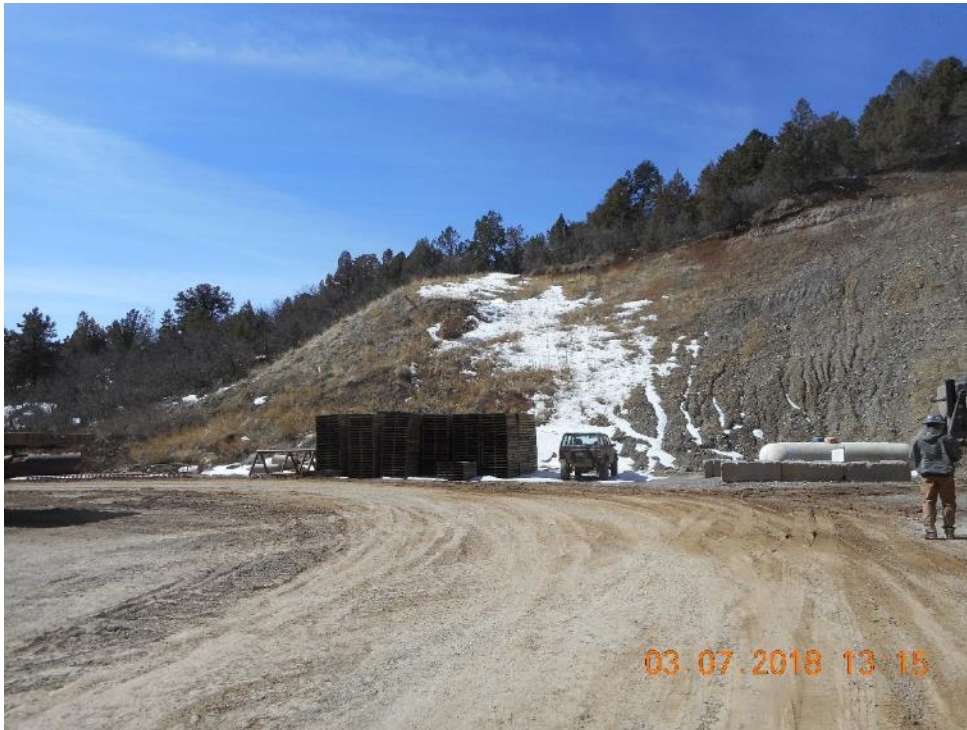
In the boneyard west of the mill facility, I observed scrap metal, stacked pallets, a portable restroom, tires, hazardous material storage, and various supplies. I observed a highway diesel tank within a metal trough, which served as secondary containment. There was also three large trailers, a personal vehicle, and two propane tanks behind concrete barriers.

Topsoil is stored on the far western side of the mill bench. The patches of mullein noted during my previous inspection had been sprayed during Native Habitat’s fall 2017 visit. As in past inspections, the soil stockpile

appeared to be at approximately 2:1 slope and the quantity inadequate for future site reclamation. According to the stipulations included in BLM's approval of the Plan of Operations modification dated July 21, 1989: "The stored topsoil will be graded to a slope of approximately 4:1 to prevent erosion and to facilitate seeding and establishment of grasses."

Photo 11. Looking west to boneyard and topsoil stockpile on the mill bench.

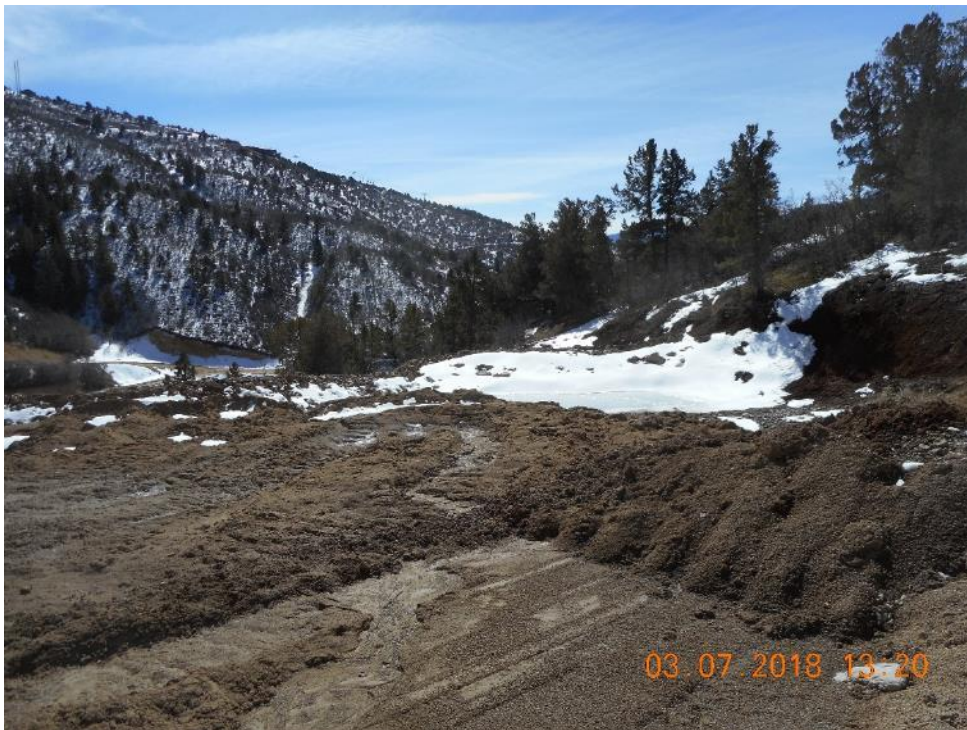
A stormwater retention pond was located on the southwestern side of the mill bench. The retention pond contained snow and water during my visit. RMR had also cleaned and/or improved three other sediment control structures related to the operation. A stormwater detention and spillway structure halfway along the lower road had been improved. A spillway at the gate had been improved. Additionally, the stormwater detention and spillway structure at the intersection of the unnamed drainage and Transfer Trail switchbacks had been cleaned and improved. These structures are important aspects of the operation; however, they are only briefly addressed in the 1982 Plan of Operations and 1989 Plan of Operations modification:

Photo 12. Looking south from mill bench at sediment control structure.

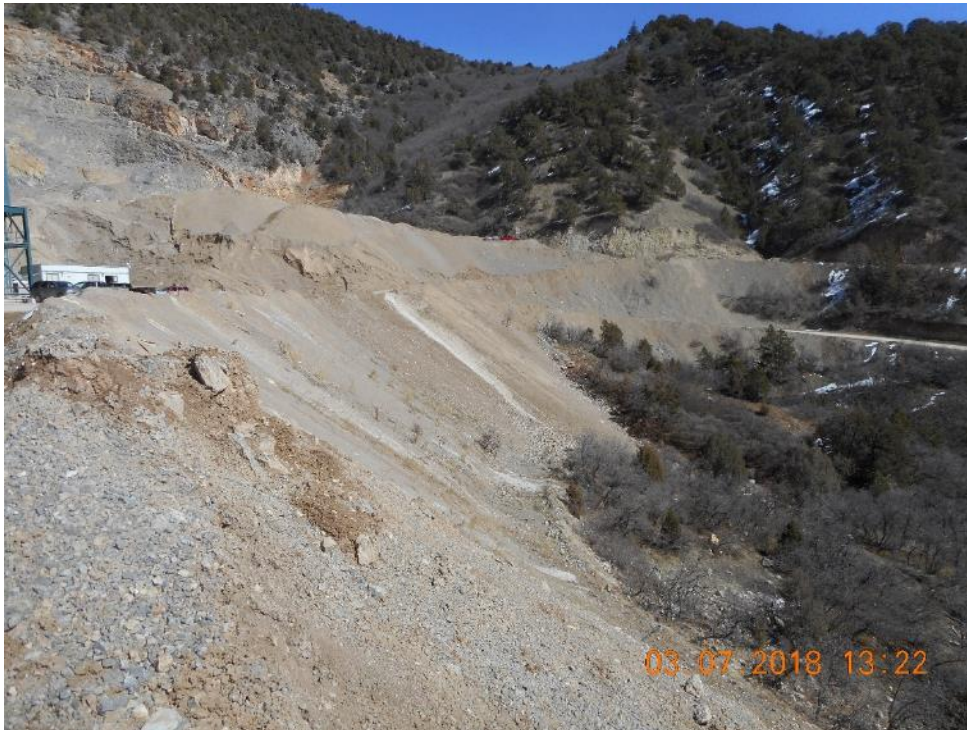
Photo 13. Looking east from the southwest corner of the mill bench.
