**COLORADO DIVISION OF RECLAMATION, MINING AND SAFETY**  
**MINERALS PROGRAM INSPECTION REPORT**  
**PHONE: (303) 866-3567**

| <b>MINE NAME:</b><br>Cresson Project | <b>MINE/PROSPECTING ID#:</b><br>M-1980-244 | <b>MINERAL:</b><br>Gold | <b>COUNTY:</b><br>Teller |
| <b>INSPECTION TYPE:</b><br>Monitoring | <b>INSPECTOR(S):</b><br>Elliott R. Russell | <b>INSP. DATE:</b><br>February 27, 2018 | <b>INSP. TIME:</b><br>10:30 |

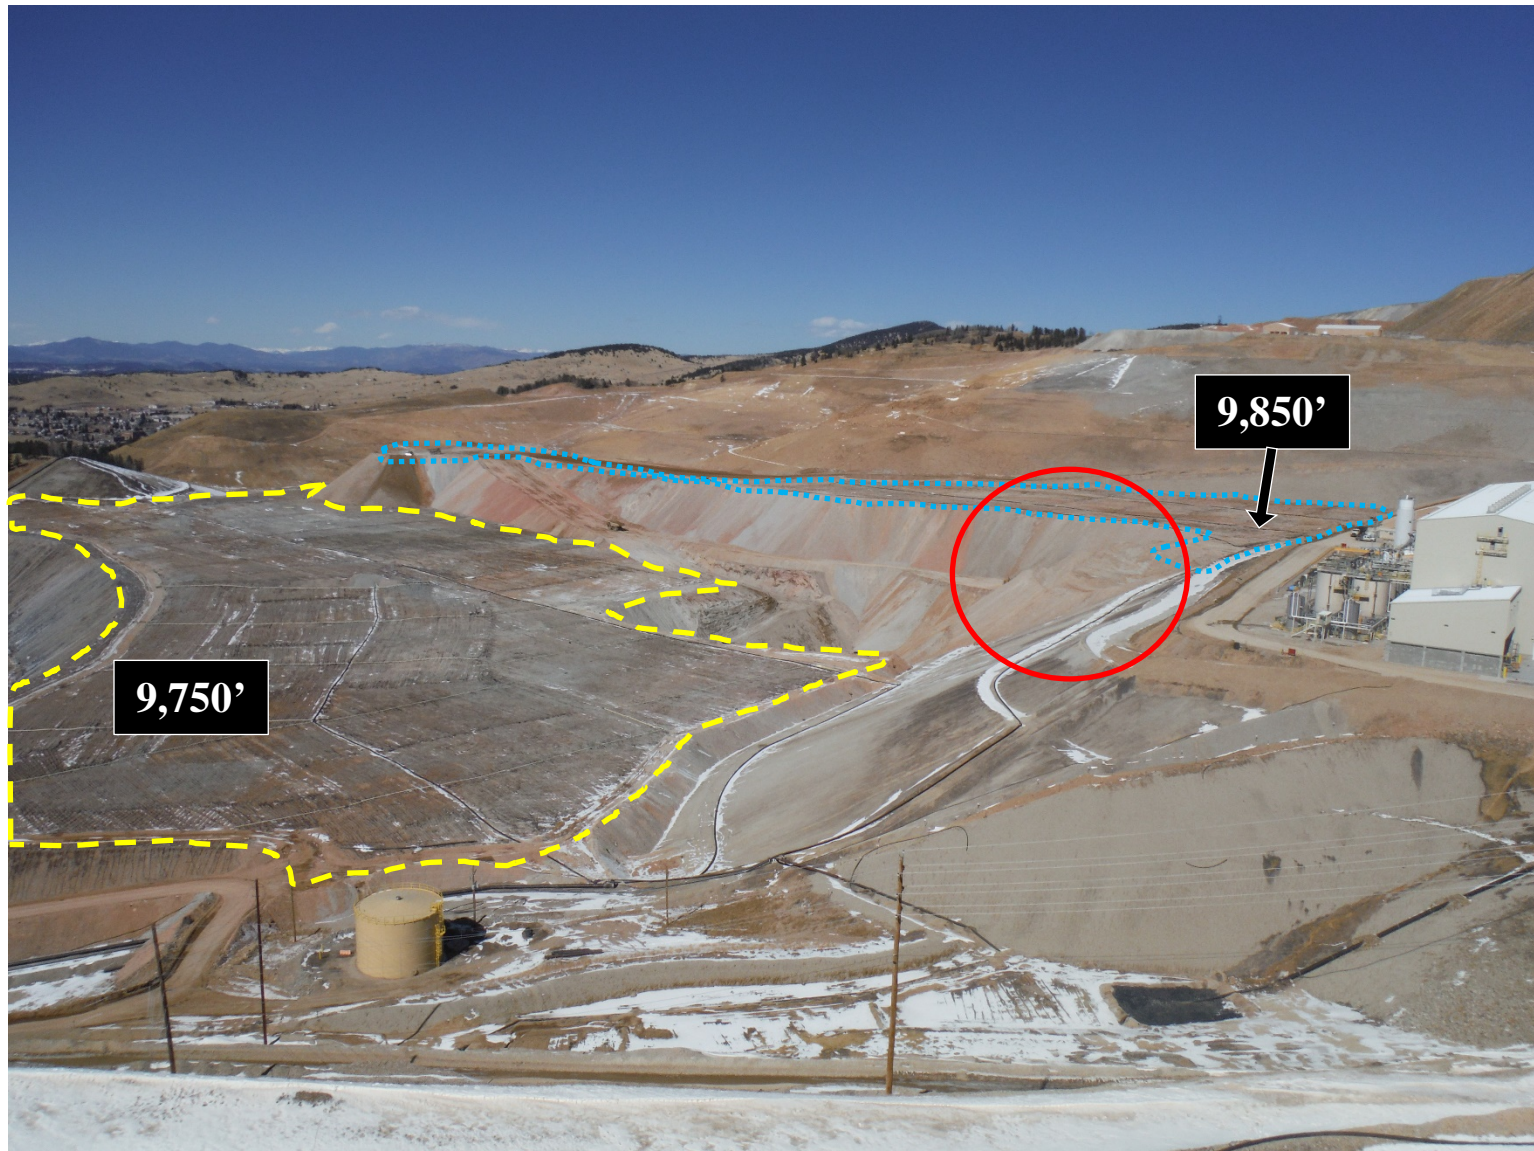
The Division observed the Squaw Gulch Valley Leach Facility (SGVLF) from a lookout point at approximately 10,100 feet, which is located between the Squaw Gulch and the Arequa Gulch Valley Leach Facilities (**Photos 1 and 2**). The Division observed a front-end loader loading haul trucks with stacked ore from an area within the SGVLF near the High Grade Mill (HGM) platform. The front-end loader was located on the 9,750 lift of the heap leach pad. The stacked ore was being removed and hauled approximately 2,000 feet northwest and up to the 9,850 lift of the SGVLF. Crushed ore is hauled and placed in the SGVLF; so, the observed front-end loader removing already placed ore in the SGVLF is not a typical activity observed at the facility. The Division inquired about the observed activities with Mr. Bills and Ms. Steward, however they were unfamiliar with the situation involving the front-end loader. The Division requested that Mr. Bills and Ms. Steward locate CC&V personnel who could explain the unusual activity occurring in the SGVLF and also to get closer to the front-end loader activity for further observations.

**Photo 1.** Overview of the SGVLF, top of 9,750 lift outlined in dashed yellow, top of 9,850 lift outlined in dotted blue, area of front-end loader activity circled in red; looking northwest.

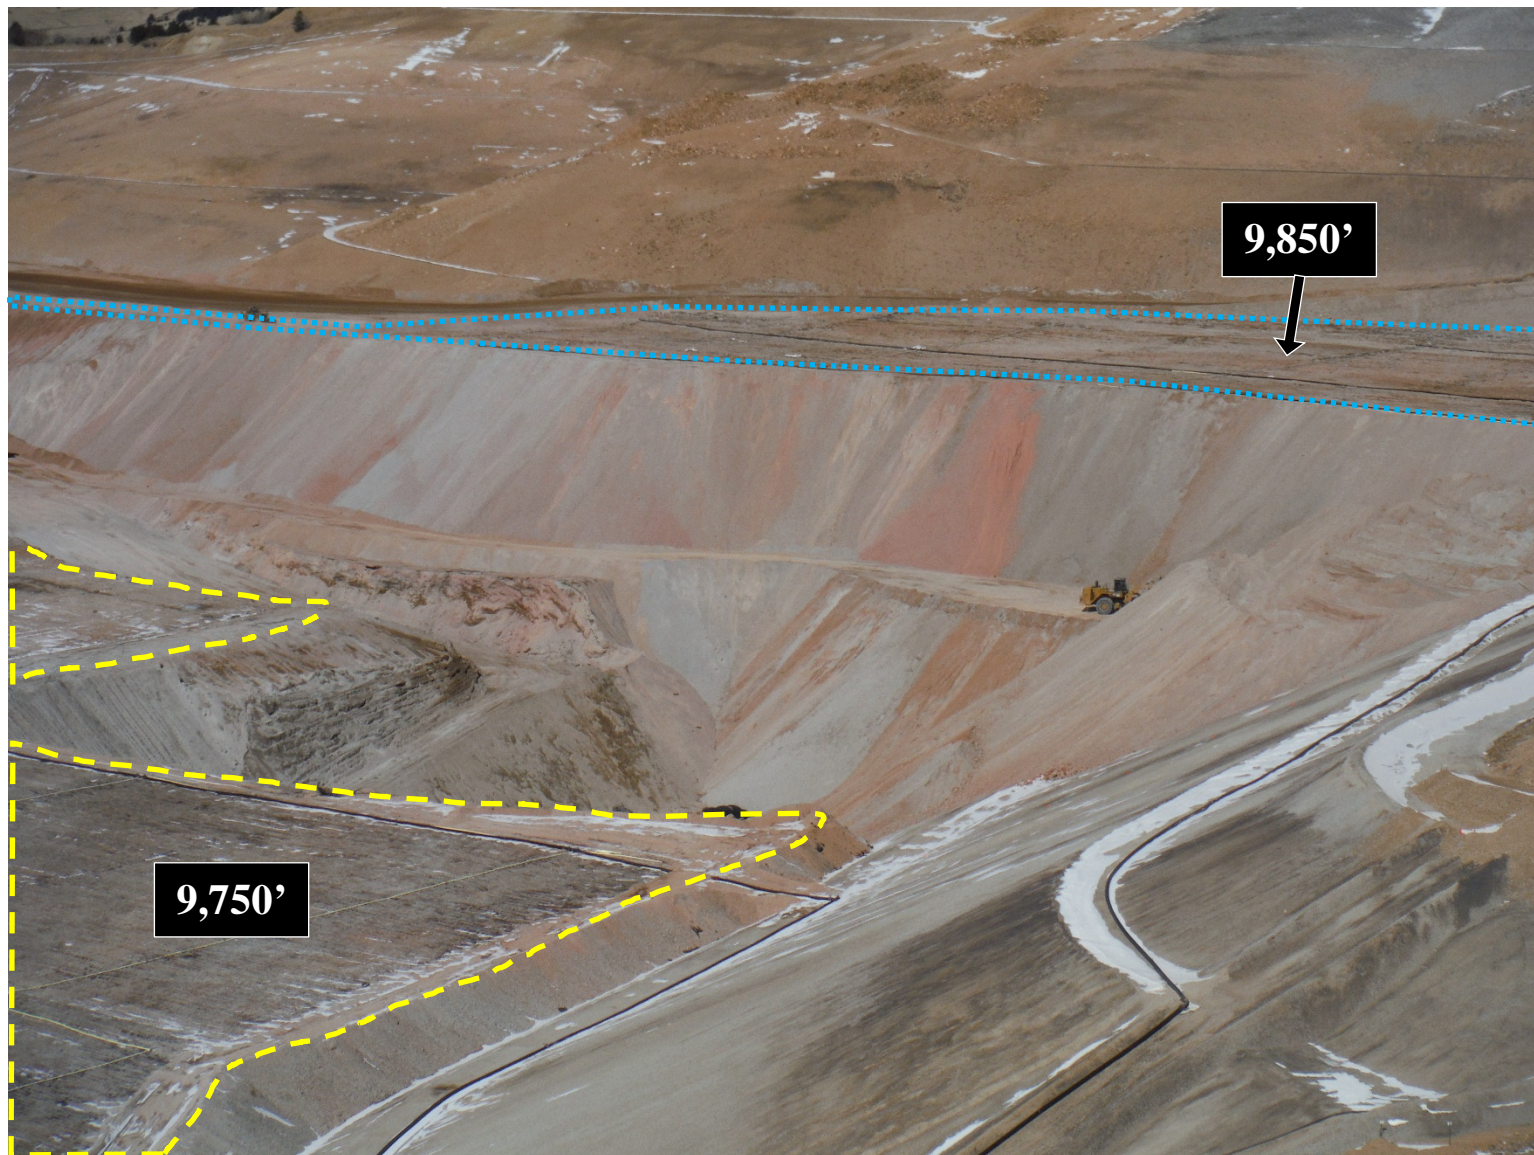
**Photo 2.** Close up of front-end loader activity in the SGVLF, top of 9,750 lift outlined in dashed yellow, top of 9,850 lift outlined in dotted blue; looking north.

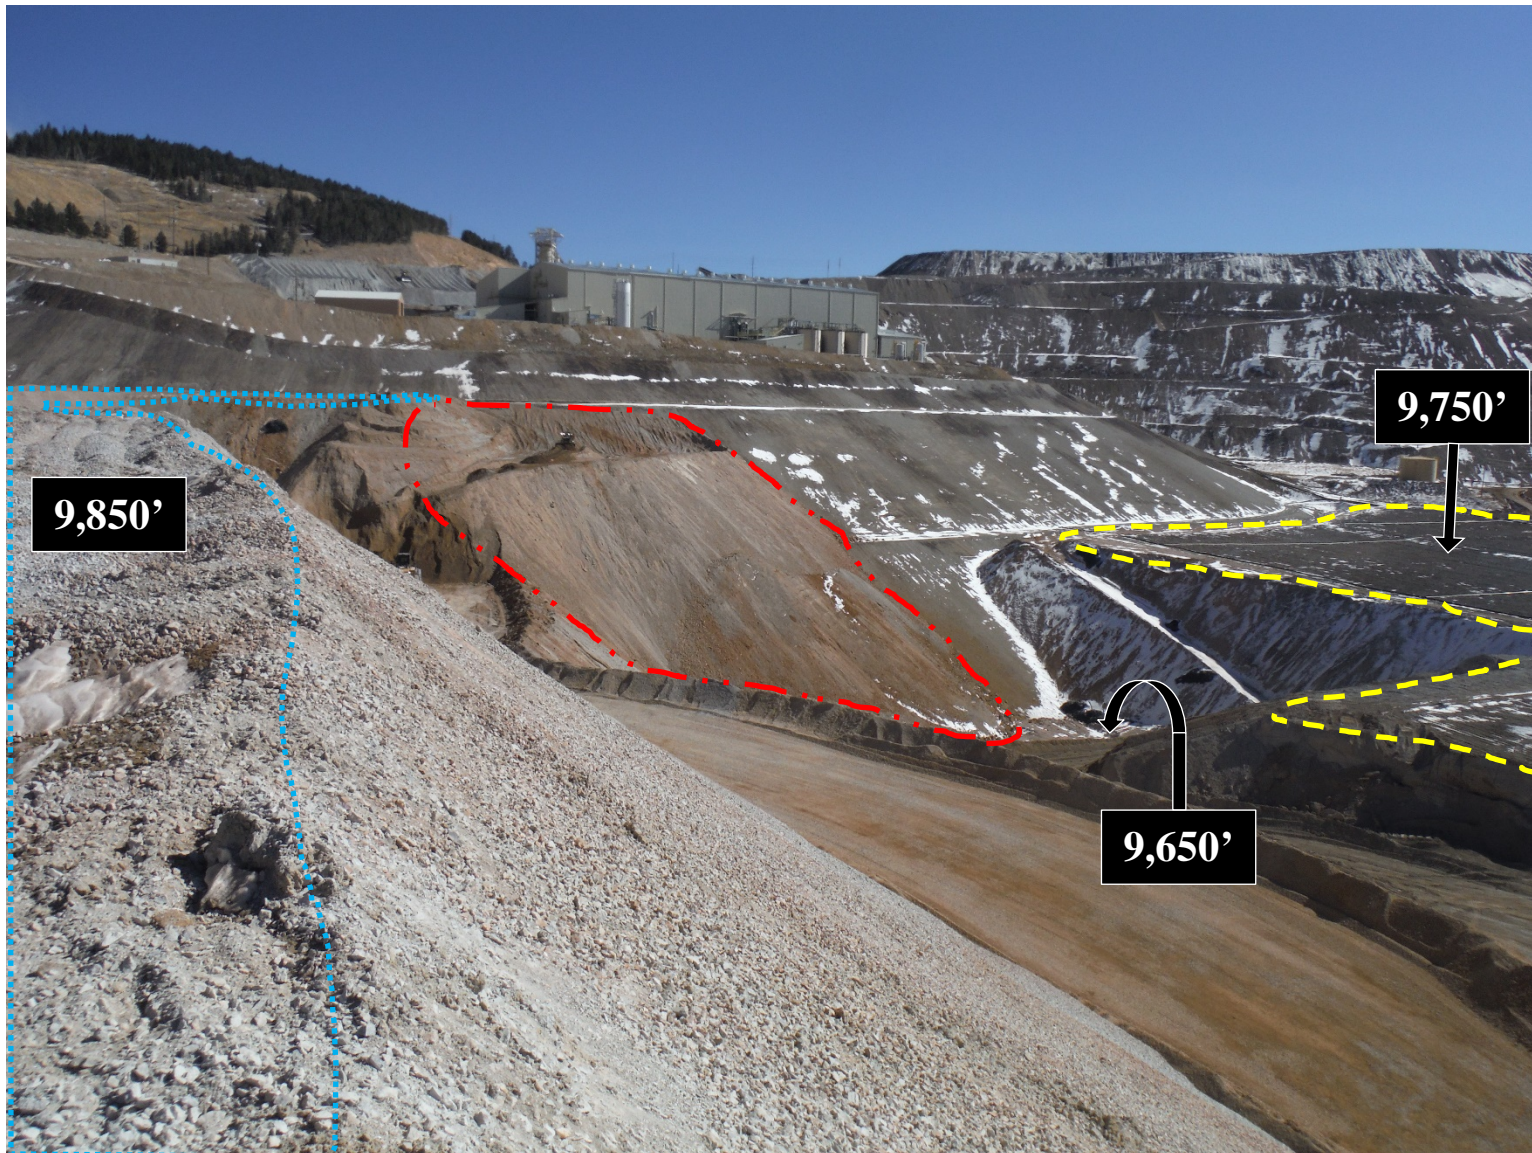
**POSSIBLE VIOLATION 1:** Non-crushed ore (run-of-mine) was dumped in 200-foot lifts from the 9,850 lift, with steep side slopes onto down-sloping ground, and contacting the Drain Cover Fill for the geomembrane liner within the Squaw Gulch Valley Leach Facility. Additionally, crushed ore was dumped onto the Drain Cover Fill from the approximate 10,050 lift, approximately 200 feet above the active lift and out of sequence with the construction schedule of the permit for the Squaw Gulch Valley Leach Facility. The above mentioned activities are not authorized by the permit. The Operator has failed to follow the approved plan to stack ore in the Squaw Gulch Valley Leach Facility. Pursuant to C.R.S. 34-32-124(1), this is a possible violation for failure to comply with conditions of an order, permit, or regulation.

The Division was accompanied by Dylan Roberts into the SGVLF to inspect the area of the slope failure. Mr. Roberts stated to the Division that the slope failure had occurred sometime before the beginning of the year. The Division was informed the slope failure occurred when CC&V dumped ore from the 9,850 lift down to the 9,650 lift (**Photo 3**). Lifts in the SGVLF are permitted to be 100 feet high. In the area of the slope failure, the dump was approximately 200 feet high as a portion of the 9,750 lift was not completed before starting the 9,850 lift. While inspecting the area of the slope failure, the Division observed materials within the placed ore much larger than the normal crushed ore (**Photo 4**). The normal crushed ore is sized to a nominal 3/4 – 7/8 inch. After the inspection, on March 1, 2018, Mr. Bills informed the Division that CC&V is approved to use run-of-mine material in SGVLF. However, the Permit states that ore loading in the SGVLF is approved for crushed ore and agglomerated HGM tailings. The Permit does not authorize ore loading with run-of-mine material at the SGVLF. The Division also observed the slopes of the 9,850 lift in the area of the slope failure to be near the angle of repose, approximately 1.4H:1V. The Permit requires 2.5H:1V operational ore side slopes against down-sloping ground. The Division observed material dumped away from the side of the SGVLF and onto a downhill grade of DCF built at 2H:1V. The Permit requires the Operator to dump this ore in the SGVLF at a gentler slope (2.5H:1V, *not* 1.4H:1V). The Division believes the height of the ore lift, the inconsistent and variable size of the material being dumped, and the steep operational side slope of the dump being placed on a down slope, were all factors which led to the slope failure. Observations made during the inspection and recorded in this report indicate the Operator has failed to follow the approved plan for SGVLF required by the Permit. The above-mentioned issues are cited as Possible Violation 1, additional details are provided on page two of this report.

**Photo 3.** Area of slope failure outlined in dash-dot-dot red, top of 9,850 lift outlined in dotted blue, top of 9,750 lift outlined in dashed yellow; looking southeast.

**CORRECTIVE ACTIONS 1.2:** Within 14 days of the signature date of this report, due March 29, 2018, the Operator shall file a Technical Revision (TR) with the Office addressing the process whereby the liner for the Squaw Gulch Valley Leach Facility is recertified as an Environmental Protection Facility. The TR shall address the applicable requirements of the Act and Rules for such facilities, including the applicable requirements of Rules 7.3 and 7.4.

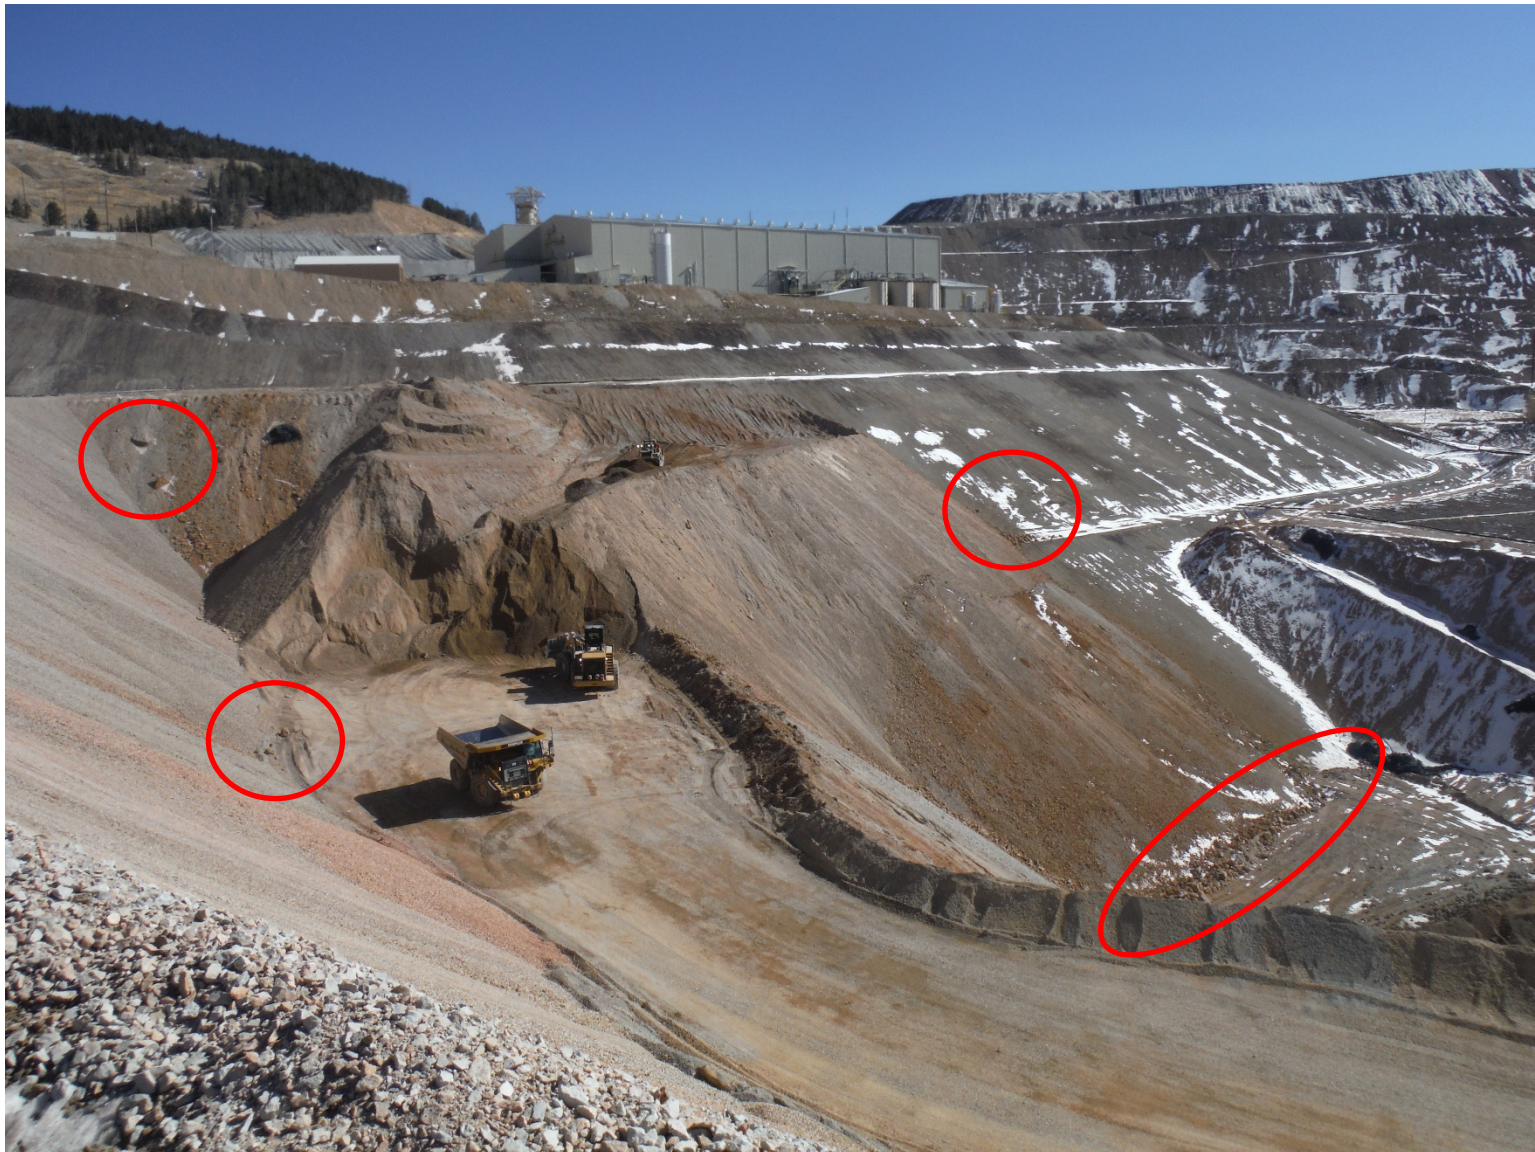
**Photos 4.** Area of slope failure, non-crushed ore (run-of-mine material) circled in red; looking south.

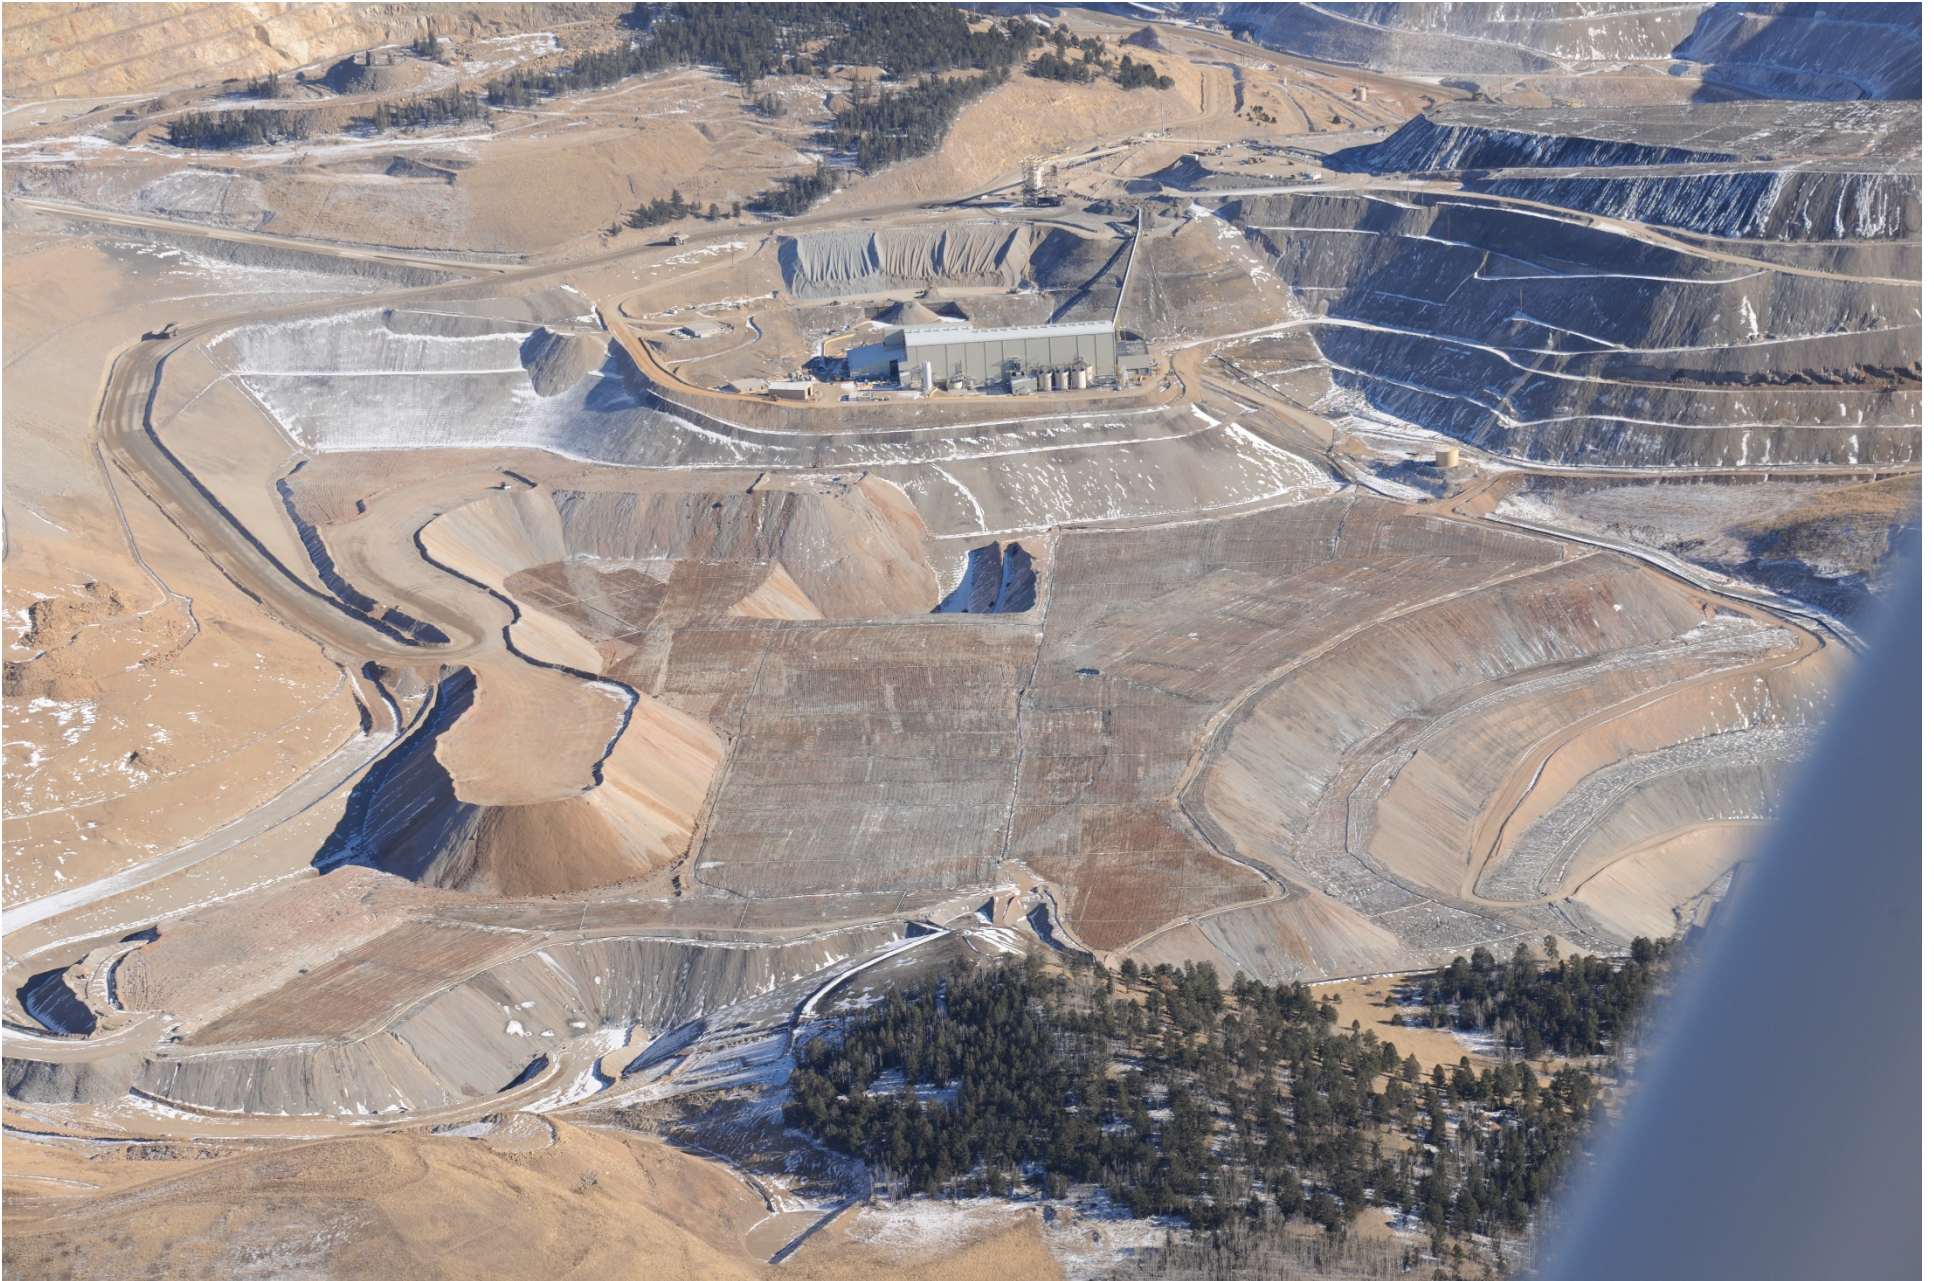
A photograph taken during the Division's January 16, 2018 aerial inspection shows the SGVLF slope failure prior to the observations made during the February 27, 2018 inspection (**Photo 5 and 6**). Additionally, as shown in Photos 5 and 6, crushed ore has also been end dumped onto the DCF from the approximate 10,050 lift. This new approximate 10,050 lift is in conflict with the standard ore loading sequence and operational ore side slopes against down-sloping ground as authorized by the permit. These issues are also cited as Possible Violation 1,

**Photo 5.** Aerial photo taken January 16, 2018; looking southeast.

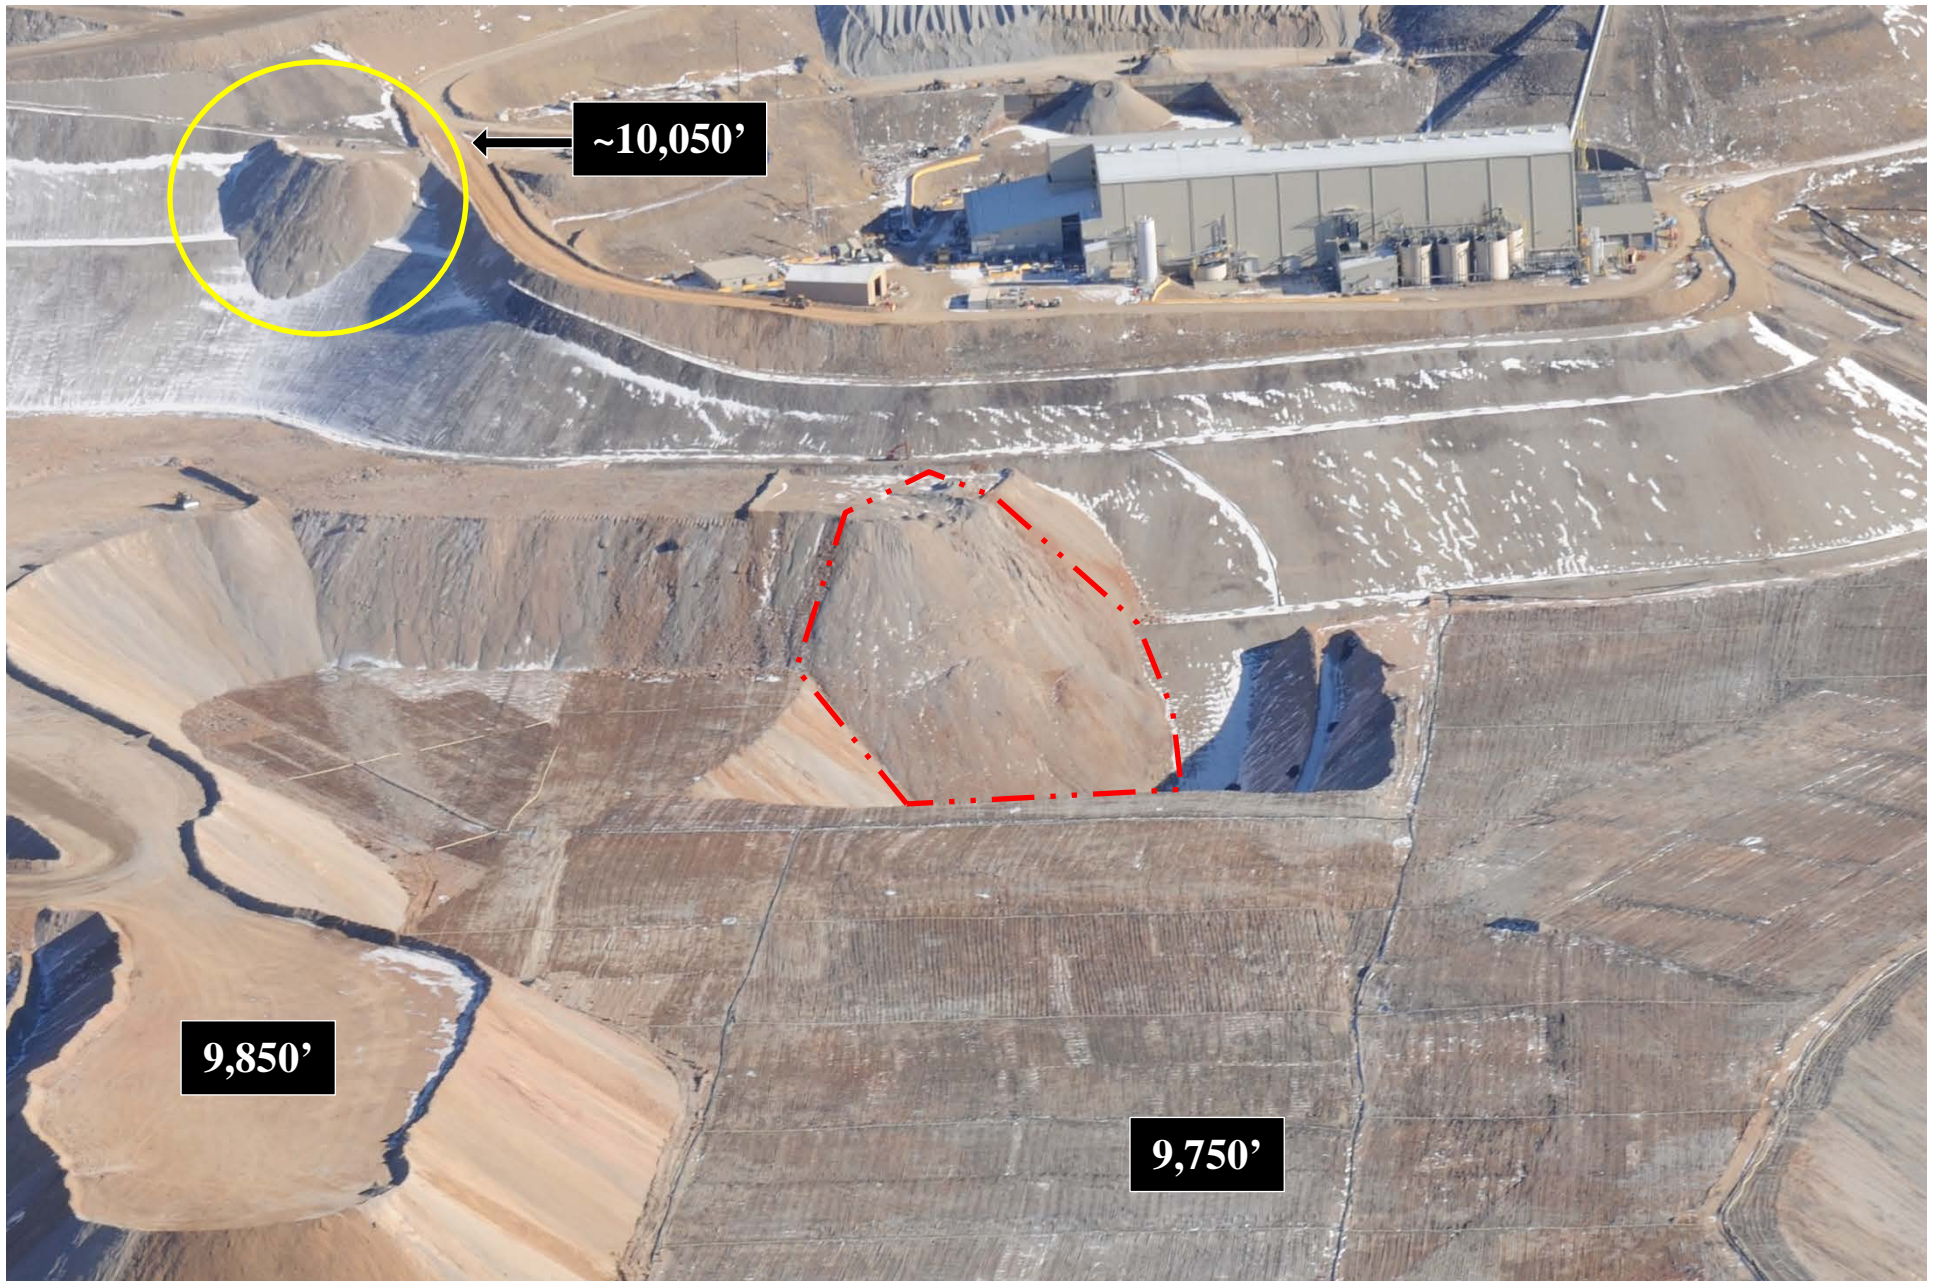
**Photo 6.** Zoomed in portion of Photo 5, area of slope failure outlined in dash-dot-dot red, approximate 10,050 lift circled in yellow; looking southeast.
