**PERMIT INFORMATION**

<b>Permit Number:</b> C-1981-035 <b>Mine Name:</b> King Coal Mine <b>Operator:</b> GCC Energy, LLC <b>Operator Address:</b> Mr. Tom Bird 6473 County Road 120 Hesperus, CO 81326	<b>County:</b> La Plata <b>Operation Type:</b> Underground <b>Permit Status:</b> Active <b>Ownership:</b> Federal
	<b>Operator Representative Present:</b>  Tom Bird
<b>Operator Representative Signature: (Field Issuance Only)</b>

<b>Inspection Start Date:</b> March 12, 2018 <b>Inspection Start Time:</b> 13:15 <b>Inspection End Date:</b> March 13, 2018 <b>Inspection End Time:</b> 16:00	<b>Inspection Type:</b> Coal Complete Inspection <b>Inspection Reason:</b> Normal I&E Program <b>Weather:</b> Cloudy
<b>Joint Inspection Agency:</b>  None	<b>Joint Inspection Contacts:</b>
<b>Post Inspection Agency:</b>  None	<b>Post Inspection Contacts:</b>
<b>Inspector(s):</b>  Robert D. Zuber, P.E.  Jason D. Musick	<b>Inspector's Signature:</b>  <i>Robert D. Zuber</i>  <b>Signature Date:</b>  3/19/2018

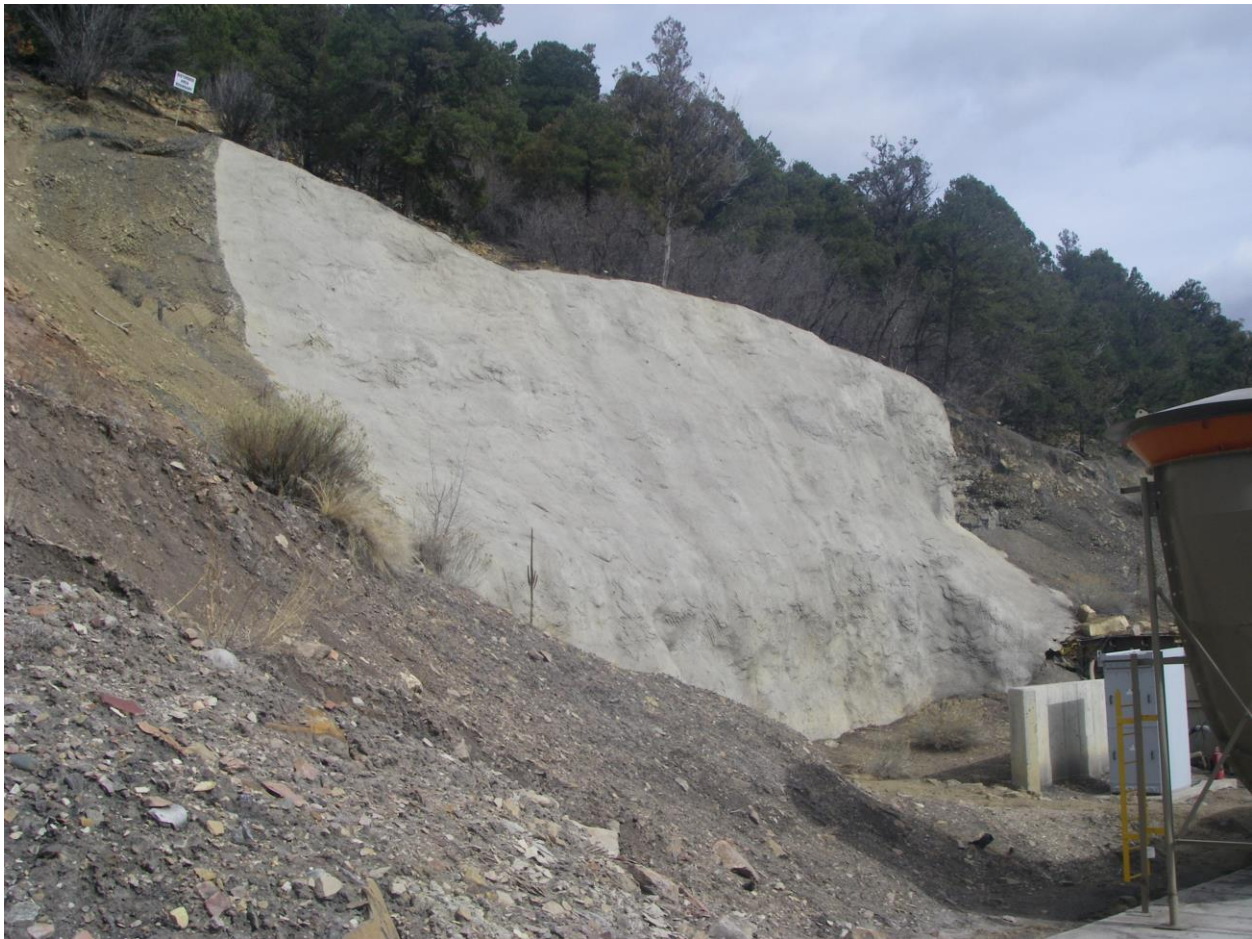
**Retaining wall at old fan site**

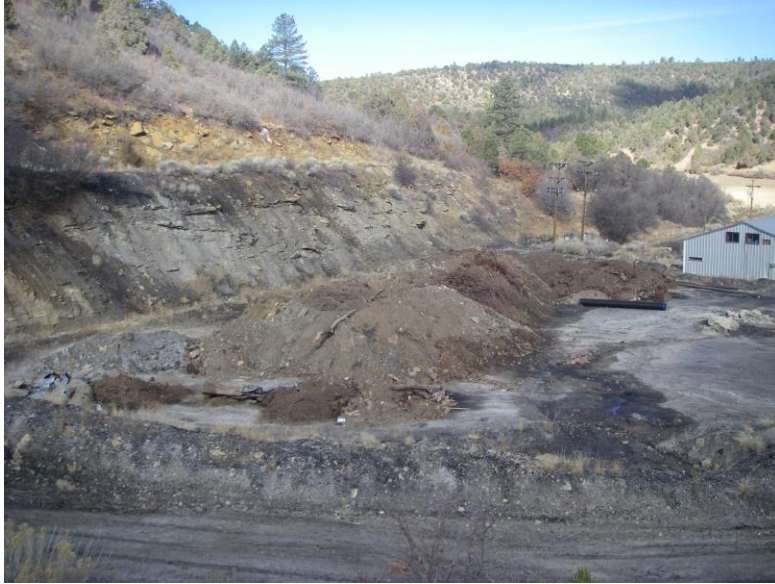
**Material from road construction placed on King I facility area**

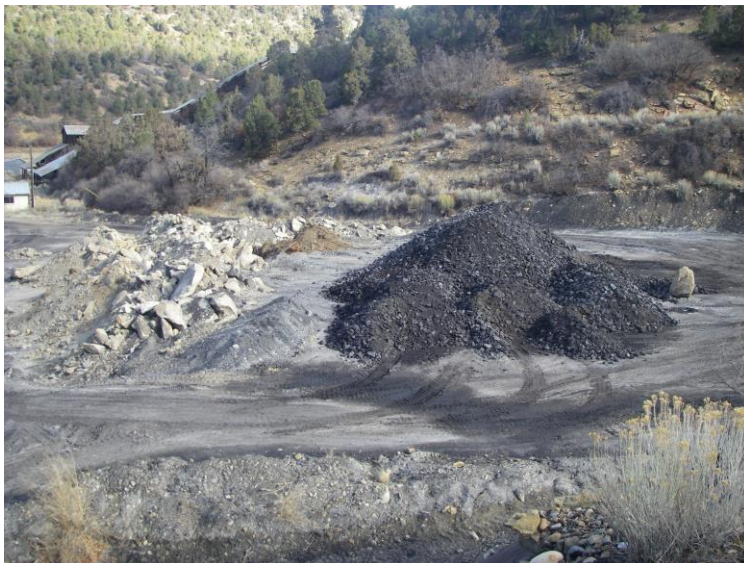
The material on the lower portion of the Refuse Pile appears to be well compacted. It appears to be waste from King II and not roadway material.

**Rock from road construction (on left) and King II mine waste (on right) placed on King I facility area**

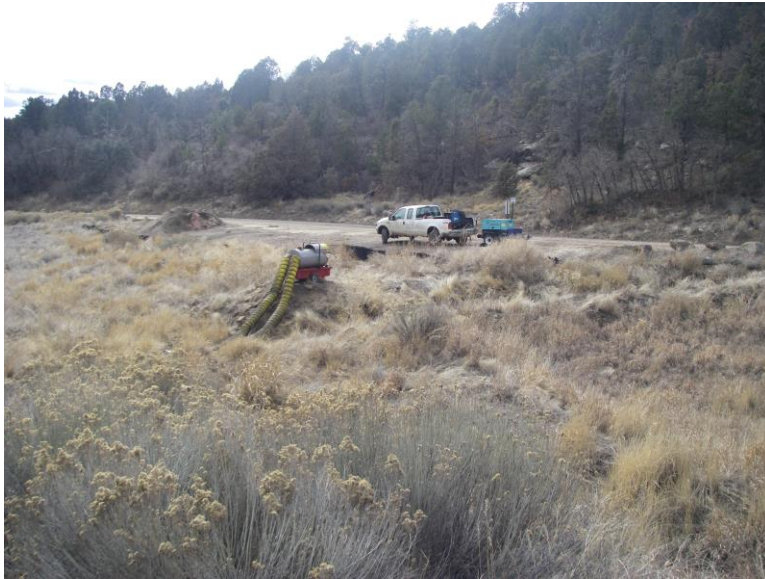
The King II pond was mostly dry and not discharging. GCC staff had placed equipment on site to dry out ice in the lower portion of the primary spillway, with the intent of locating a possible leak in the spillway. This structure should continually be monitored to determine if a leak exists, and if it is a problem. One theory expressed by Wade Wymore is that there is a leak within the pipe (perhaps at a seam) very close to the lower end, and water is entering the seam after infiltrating through a few inches of soil (the cover over the pipe is very small at the lower end). No problems were seen with the embankment of the King II pond.

**Heating equipment at King II Pond**

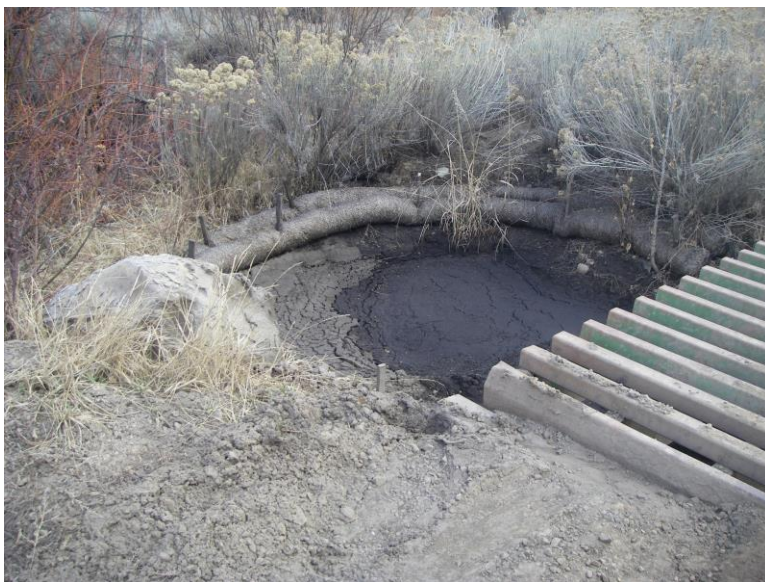
The BMPs at the King II entrance appear to be functioning well. No problems were seen in the clear water ditches at King II. Culvert C18 was inspected and no problems were seen.

**Sump at King II entrance**

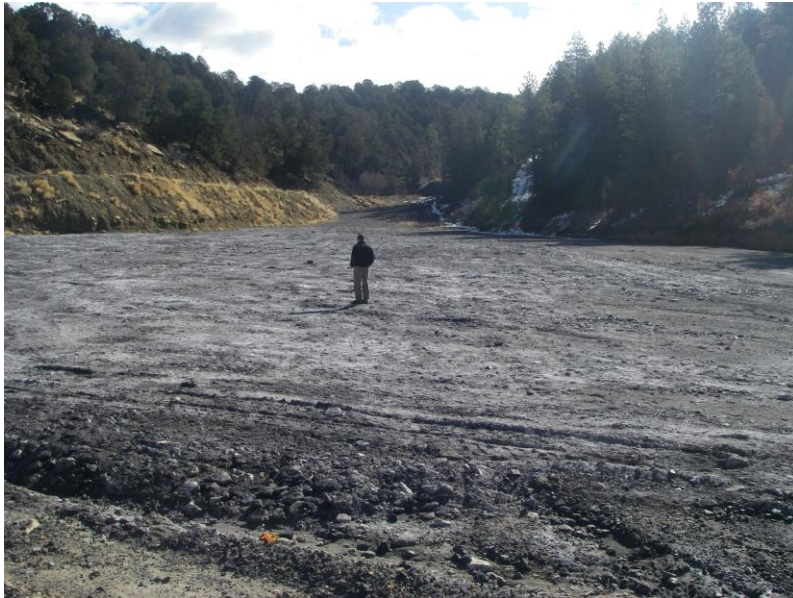
The un-reclaimed portion of the Refuse Pile (upper portion) had no piles of waste rock, and was in good condition except for minor rills. No puddles were seen on the surface of the Refuse Pile.

**Upper portion of King I Refuse Pile**

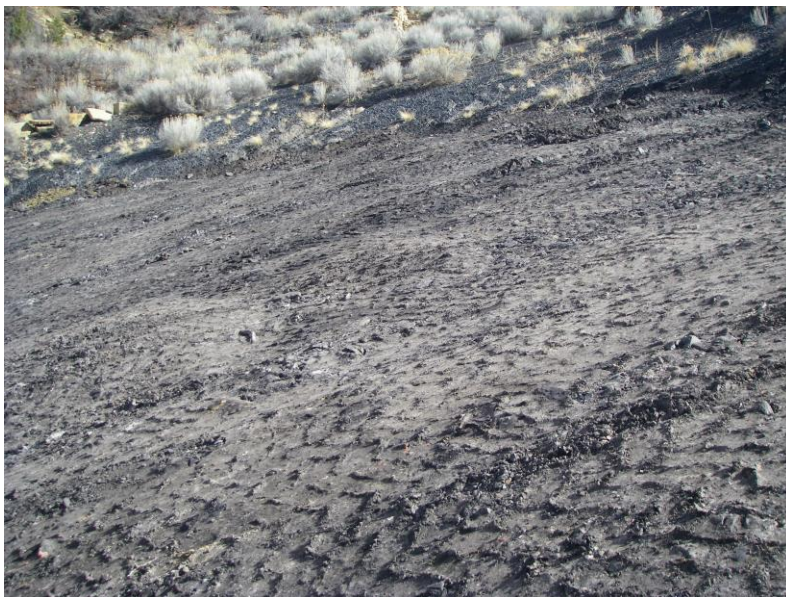
**Lower portion of King I Refuse Pile where material has been recently added**
