MINERALS PROGRAM INSPECTION REPORT

MINE NAME: Gloria Z Mine	MINE/PROSPECTING ID#: M-1984-094	MINERAL: Sand and gravel and	COUNTY: Park
INSPECTION TYPE: Surety-Related Inspection	INSPECTOR(S): Michael A. Cunningham	INSP. DATE: December 8, 2017	INSP. TIME: 11:30
OPERATOR: Playfair Land Company LLC	OPERATOR REPRESENTATIVE: Mike Pfister	TYPE OF OPERATION: 112c - Construction Regular Operation	
REASON FOR INSPECTION: Normal I&E Program	BOND CALCULATION TYPE: Complete Bond	BOND AMOUNT: \$161,417.00	
DATE OF COMPLAINT: NA	POST INSP. CONTACTS: None	JOINT INSP. AGENCY: None	
WEATHER: Clear	INSPECTOR'S SIGNATURE:

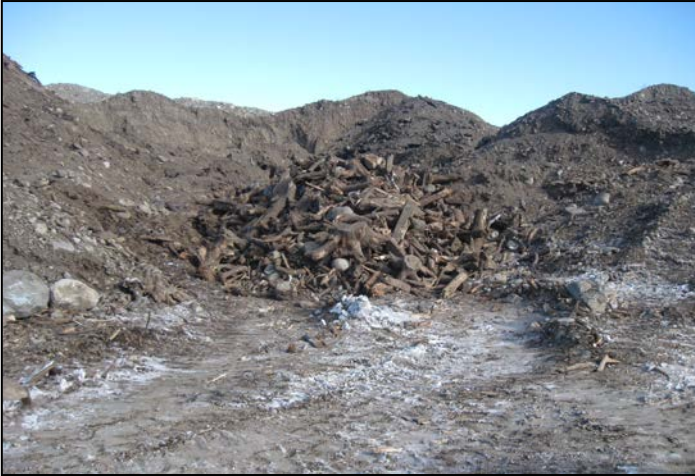
As noted in previous inspection reports, the Operator had imported tree stumps and slash (vegetation) into the site. The vegetation stockpiles covered an area of 1.28 acres and the stockpiles were between 6' to 8' in height. The current financial warranty includes \$2,000 to mulch the materials. Following the last inspection, the Operator obtained a permit from the Air Pollution Control Division which allowed the vegetation to be burned onsite. The Division inspected all of the areas where tree stumps had been stockpiled and found that the vegetation which previously occupied 1.28 acres of the mine site had been reduced to a total volume of approximately 10 cubic yards. The Operator informed the Division the remainder of the vegetation would be burned when weather conditions were favorable. The financial warranty will be adjusted to account for the removal of the vegetation.

1. Remainder of tree stumps.

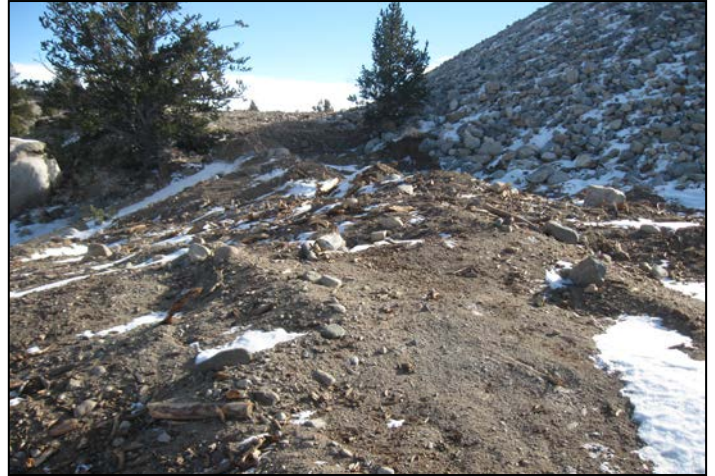
2. Area cleared of tree stumps and slash.

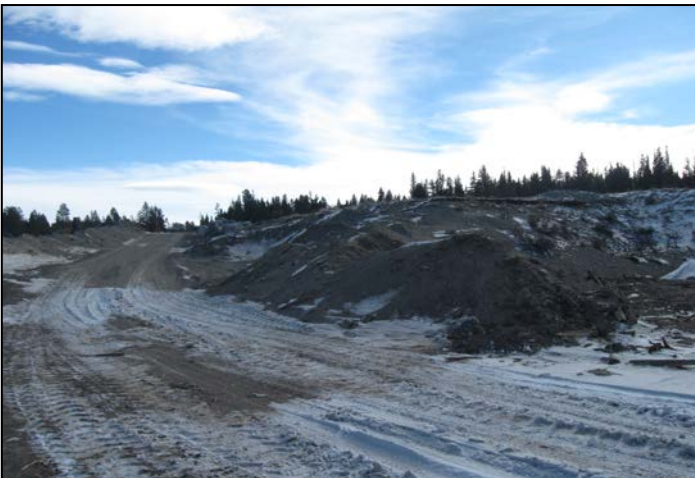
3. Area cleared of tree stumps and slash.
