COLORADO
Division of Reclamation,
Mining and Safety
Department of Natural Resources

Permit Number: C-1981-012 Mine Name: New Elk Mine Operator: New Elk Coal Company, LLC Operator Address: Mr. Louis Head 12250 Highway 12 Weston, CO 81091	County: Las Animas Operation Type: Underground Permit Status: Active Ownership: Private
	Operator Representative Present: Nick Mason
Operator Representative Signature: (Field Issuance Only)

Inspection Start Date: March 14, 2018 Inspection Start Time: 13:00 Inspection End Date: March 15, 2018 Inspection End Time: 16:00		Inspection Type: Coal Complete Inspection Inspection Reason: Normal I&E Program Weather: Clear	
Joint Inspection Agency: None		Joint Inspection Contacts: 	
Post Inspection Agency: None		Post Inspection Contacts: 	
Inspector(s): Robert D. Zuber, P.E. Jason D. Musick	Inspector's Signature:

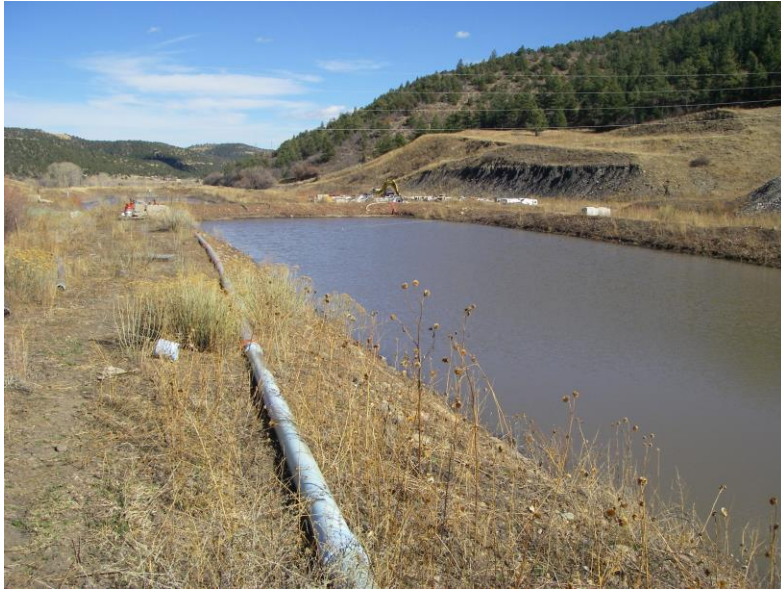
Ponds 001A, 004A, 006A, 007A, and 08 were inspected. None of them were discharging, but all but Pond 004A held water. A large amount of water was in Pond 006A, as NECC staff have pumped water into this pond from Pond 008A, which is relatively low. Use of a laser Range Finder indicated that the water level is approximately 13.5 feet below the invert of the emergency spillway. No flow into Pond 006A was seen. The impounded water in Pond 007A was below six rows of holes in the primary spillway. No significant issues were seen with the embankments of any ponds.

Pond 006A, holding considerable water

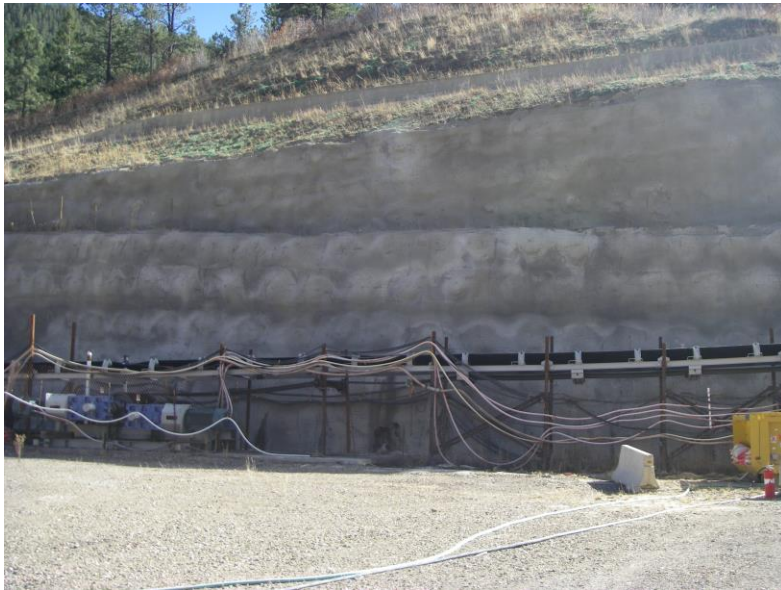
The water tank pad and the hill below the water tanks was observed, and no erosion or other problems were seen. The retaining wall by the Bates Portals appears stable. No problems were seen at the coal storage areas.

Retaining wall at Bates portal

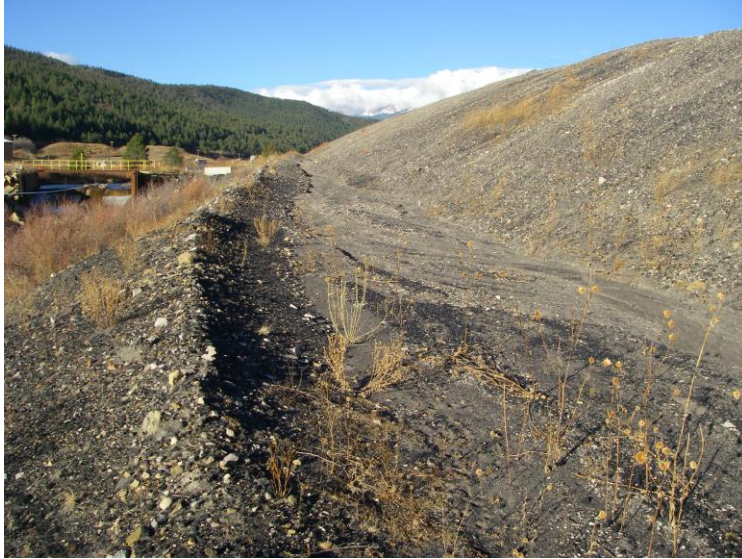
Erosion on DWDA#2 persists. The sump below DWDA#2 did not appear to need immediate maintenance.

DWDA #2 and Ditch D14

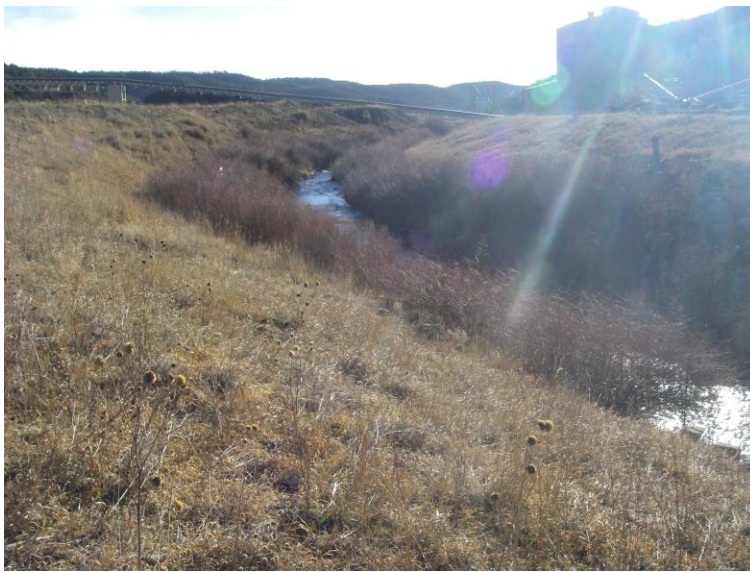
The Middle Fork of the Purgatoire River was inspected, and no eroding banks or signs of pollutant loading from the New Elk Mine were seen. Particular areas that were inspected include:

Middle Fork of the Purgatoire River near DWDA #2

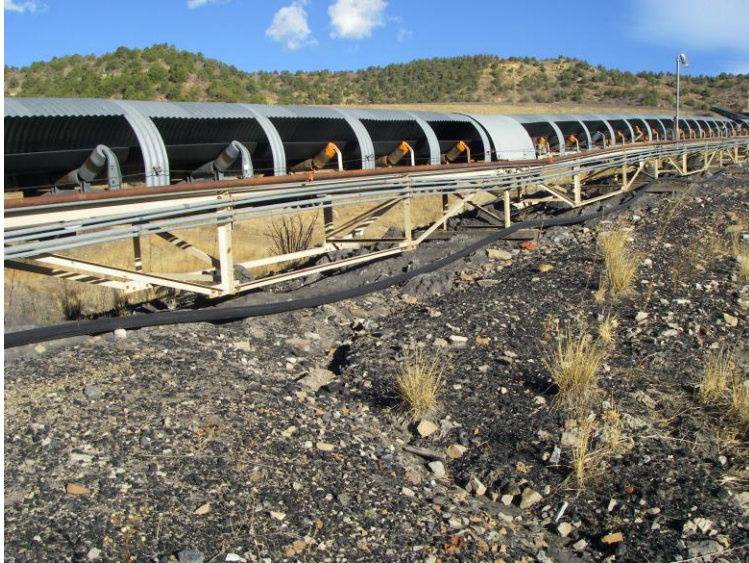
Containment Areas 1, 2, 3, and 4 were dry. Containment Area 5 was holding water that was several feet below the top of the structure. There was no sign of problems with these structures. However, the area by the conveyor that is in between Containment Areas 3 and 4 needs to be addressed. The refuse material under the conveyor needs to be removed, and the berm by the conveyor needs to be maintained to direct runoff to the containment areas. Any portions of the conveyor that do not drain to containment areas need to have a catch pan installed.

Waste under conveyor

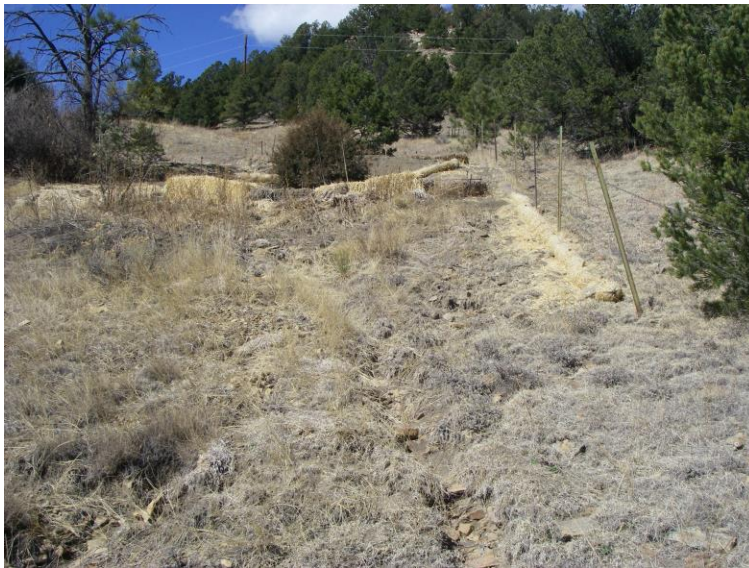
The sediment and erosion BMPs at the former Golden Eagle shaft appeared to be functioning well.

BMPs at former Golden Eagle shaft site

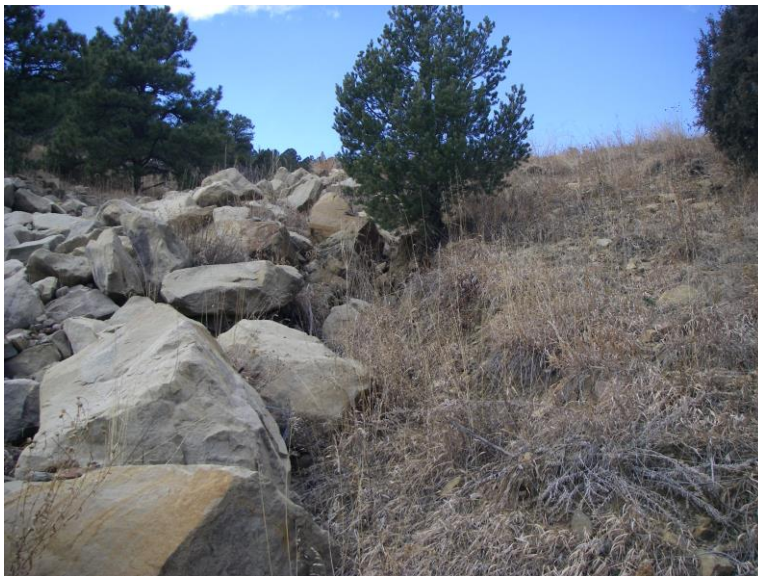
Erosion (beside tree) near toe of Refuse Pile

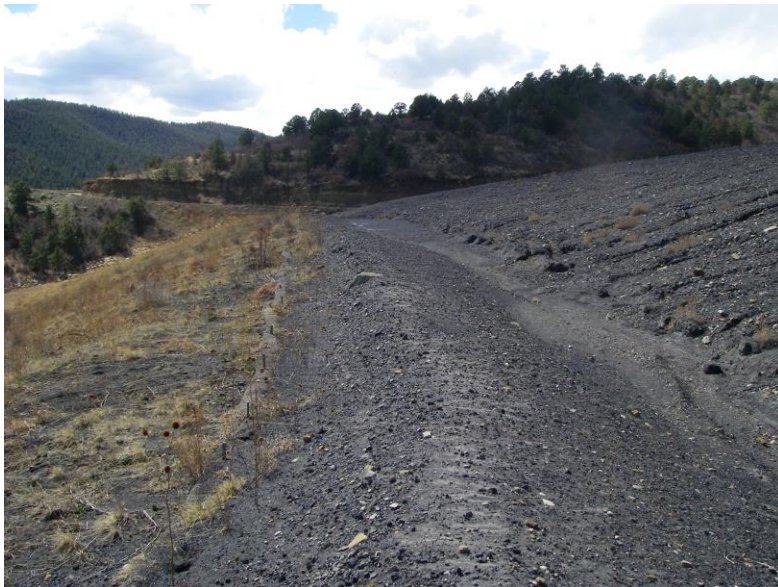
No problems were seen with the upper portion of the RDA, including the ditch and sumps between the un-reclaimed (upper) and reclaimed (lower) portions, but recently placed piles should be spread in the near future. NECC staff were cleaning ditches during the inspection. The east clear water ditch (D55) was walked and no issues were seen.

RDA – interface between upper and lower portions

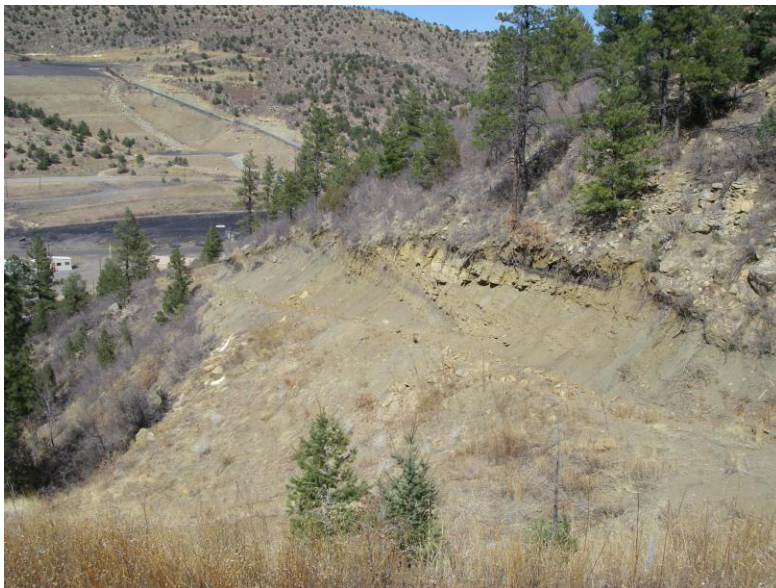
Ditch D26, below water tanks
