MINERALS PROGRAM INSPECTION REPORT PHONE: (303) 866-3567

MINE NAME:		MINE/PROSPECTING ID#:	MINERAL:	COUNTY:	
Martin Mesa Drilling		P-2017-012	Uranium	Montrose	
INSPECTION TYPE:		INSPECTOR(S):	INSP. DATE:	INSP. TIME:	
Surety Release Inspection		Dustin M. Czapla	March 7, 2018	11:00	
OPERATOR:		OPERATOR REPRESENTATIVE:	TYPE OF OPERATION:		
Andrews Mining LLC		Not Present	MP - Mineral Prospecting		
REASON FOR INSPECTION:		BOND CALCULATION TYPE:	BOND AMOUNT:		
Surety Release Requested		None	\$3,500.00		
DATE OF COMPLAINT:		POST INSP. CONTACTS:	JOINT INSP. AGENCY:		
NA		None	None		
WEATHER:	INSPECTOR'S SIGNATURE:		SIGNATURE DATE:		
Clear	De		March 8, 2018

PERMIT #: P-2017-012 INSPECTOR'S INITIALS: DMC INSPECTION DATE: March 7, 2018

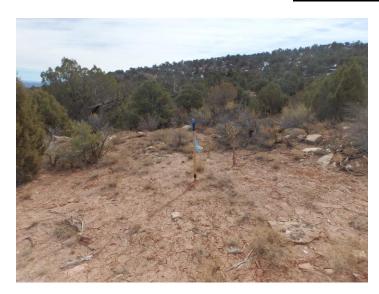
DH-1 DH-2

The operation included three boreholes drilled on Martin Mesa, approximately nineteen miles northwest of Nucla and accessed from T-12 Road. The boreholes were drilled on lands managed by BLM. The three dry holes were backfilled with cuttings and plugged with concrete. Fines were spread over the boreholes in order to blend the reclamation with the surrounding area. This inspection confirmed that reclamation was complete and adequate.
