## MINERALS PROGRAM INSPECTION REPORT

<b>MINE NAME:</b> Snyder Quarry	<b>MINE/PROSPECTING ID#:</b> M-1977-210	<b>MINERAL:</b> Limestone (general)	<b>COUNTY:</b> El Paso
<b>INSPECTION TYPE:</b> Monitoring	<b>INSPECTOR(S):</b> Timothy A. Cazier	<b>INSP. DATE:</b> January 30, 2018	<b>INSP. TIME:</b> 10:20
<b>OPERATOR:</b> Continental Materials Corporation	<b>OPERATOR REPRESENTATIVE:</b> Brandon Heser, Andre Laroche	<b>TYPE OF OPERATION:</b> 110c - Construction Limited Impact	
<b>REASON FOR INSPECTION:</b> Priority	<b>BOND CALCULATION TYPE:</b> Partial Bond	<b>BOND AMOUNT:</b> \$340,000.00	
<b>DATE OF COMPLAINT:</b> NA	<b>POST INSP. CONTACTS:</b> None	<b>JOINT INSP. AGENCY:</b> None	
<b>WEATHER:</b> Cloudy	<b>INSPECTOR'S SIGNATURE:</b>

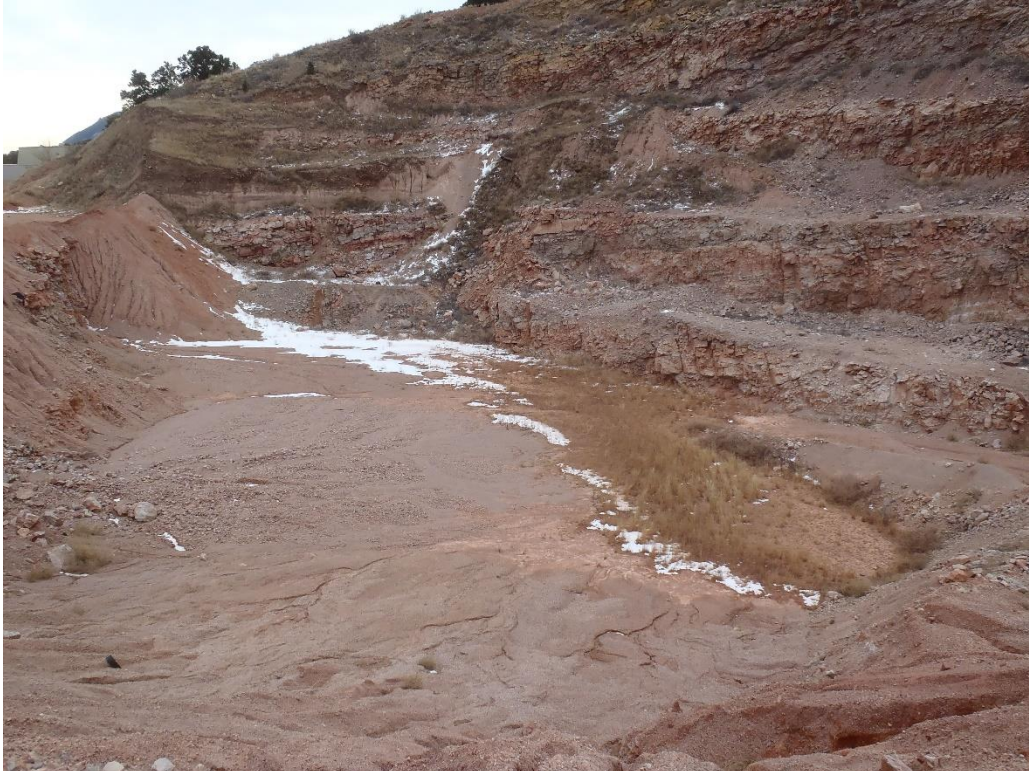
Hydrologic Balance: No standing water was observed in the pit (see **Photos 1, 2 and 3**) and no exposed groundwater was observed.

Sediment Control: The haul road between the lower and upper pits shows signs of severe erosion. However, any eroded sediment is captured in the large sediment pond near the lower pit (see **Photo 1**), so this is not cited as a problem at this time. Final reclamation will need to address these erosion gullies. No erosion best management practices (BMPs) were needed at the time of the inspection.

Photo 1. Sediment pond in south end of Phase WP Pit (looking south).

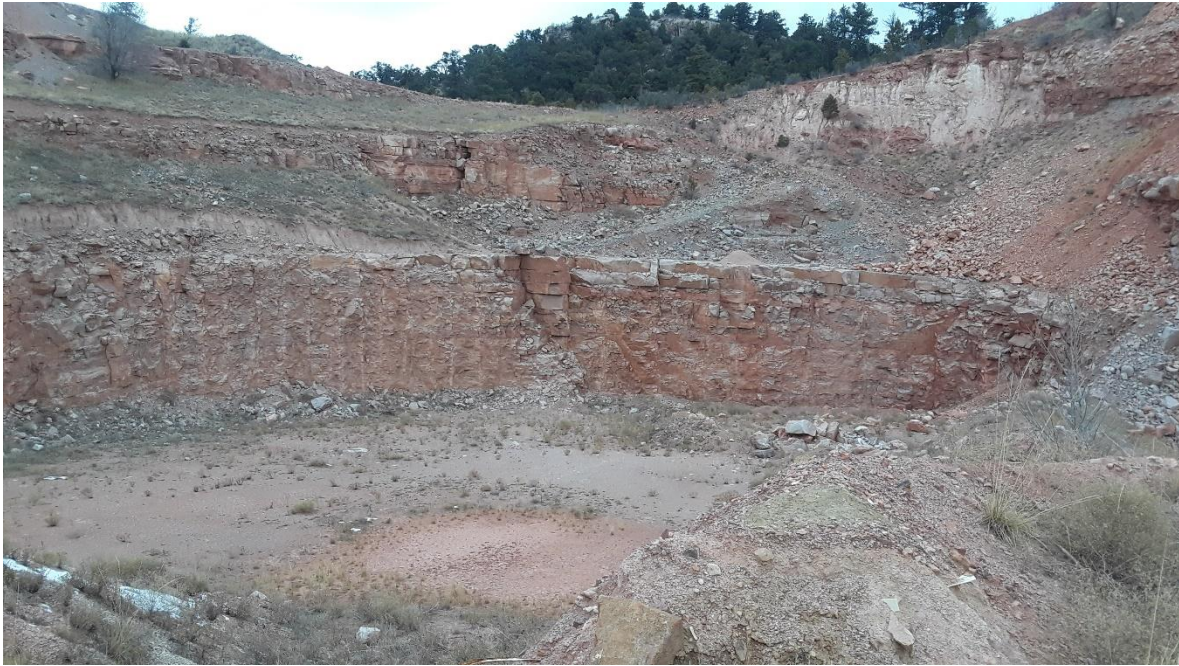
Photo 2. Pit floor in north end of Phase WP Pit (looking NW).

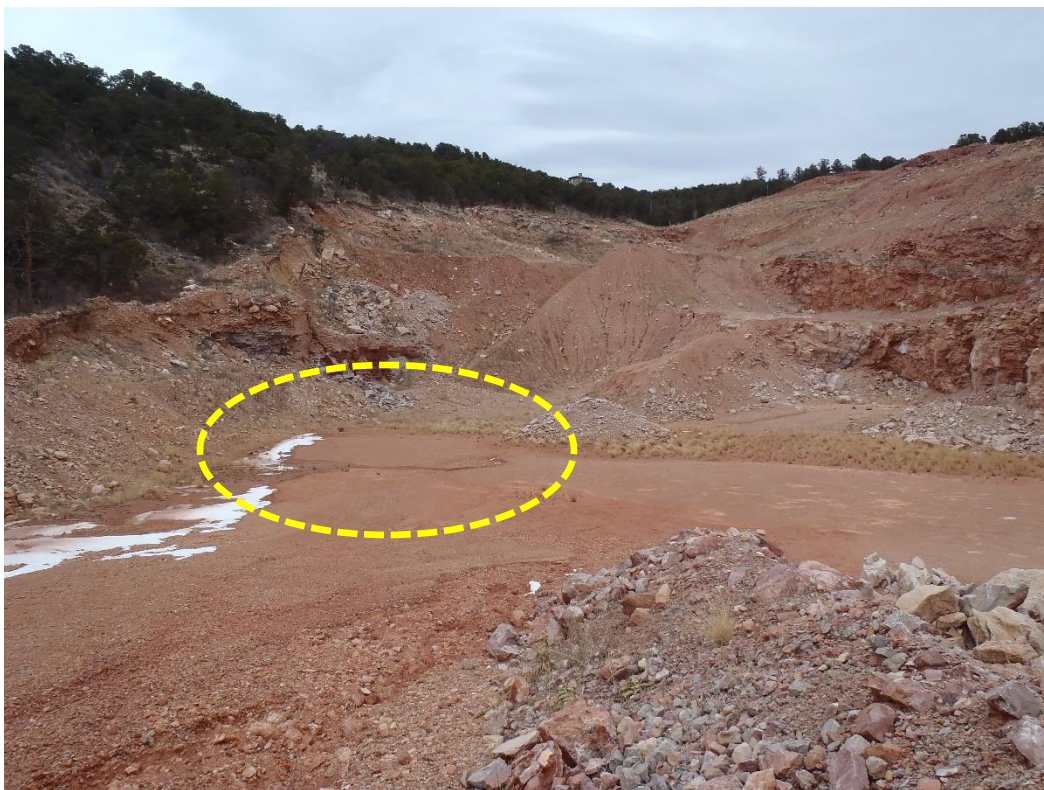
Photo 3. Shallow sediment pond on the west side of Phase AP Pit (looking north).

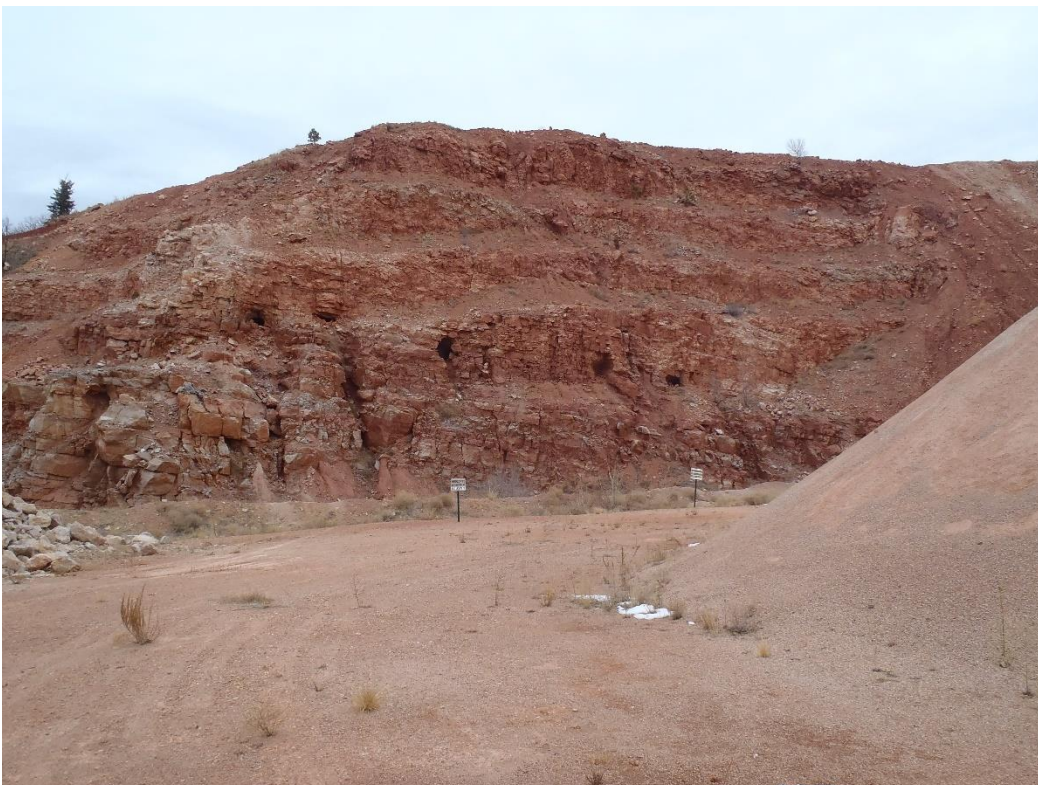
Reclamation Success: Reclamation has been initiated and appears complete on some portions of the Phase WP pit area. However, the water storage pond added for the rock wash plant as part of amendment 2 (AM-02) is in poor condition due to lack of maintenance, with the liner torn and ineffective. A review of permit documents by the Division revealed the water storage pond was to be reclaimed after mining. The Division acknowledges mining activity as defined by Rule 1.1(27) is still occurring, but the mining activity requiring the storage pond has apparently ceased. As such, the Division's position is the storage pond should be reclaimed as it is no longer used or needed as part of the current mining operation. **The poor and unreclaimed condition of the water storage pond is cited as Problem No. 2 on page 1 of this report.** It also appears based on review of permit documents additional blasting and benching may be needed to reduce the slope in areas of the West Ridge (see

**Photo 4)** and northeast portions of the WP pit (see **Photo 5**).

Photo 5. Northeast portion of the WP pit needing benching for final reclamation (looking NE).

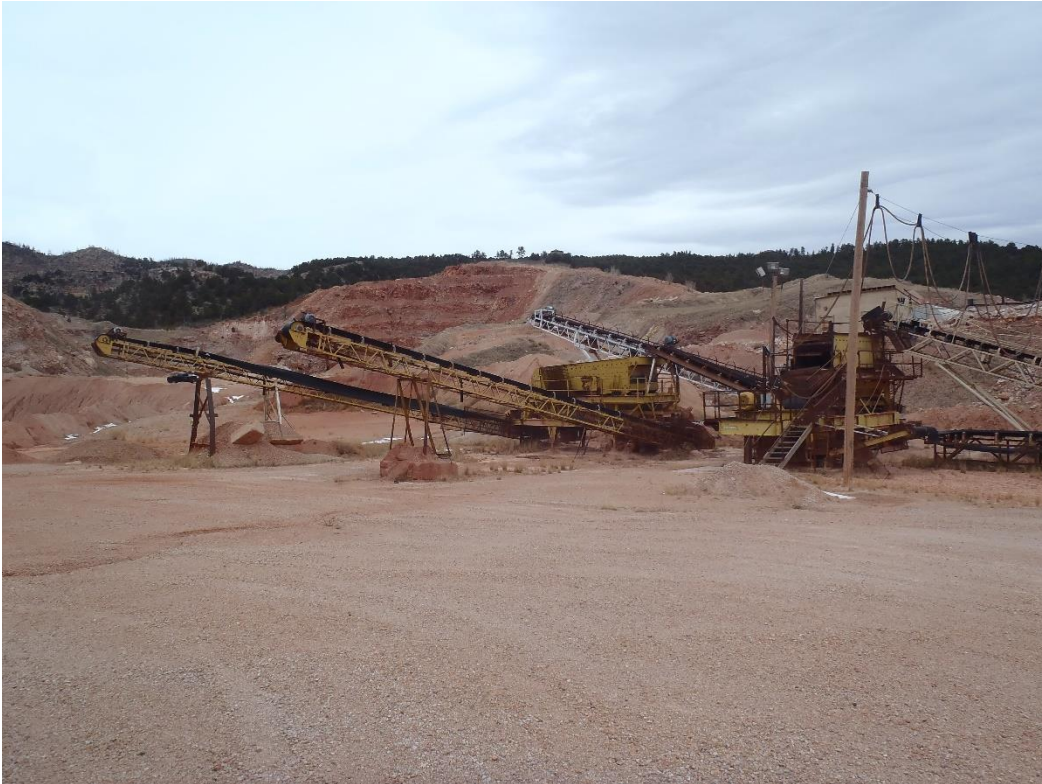
Support Facilities On-site: A screen plant was observed on site (see **Photo 6**).

Photo 6. Screen plant (south end of site).

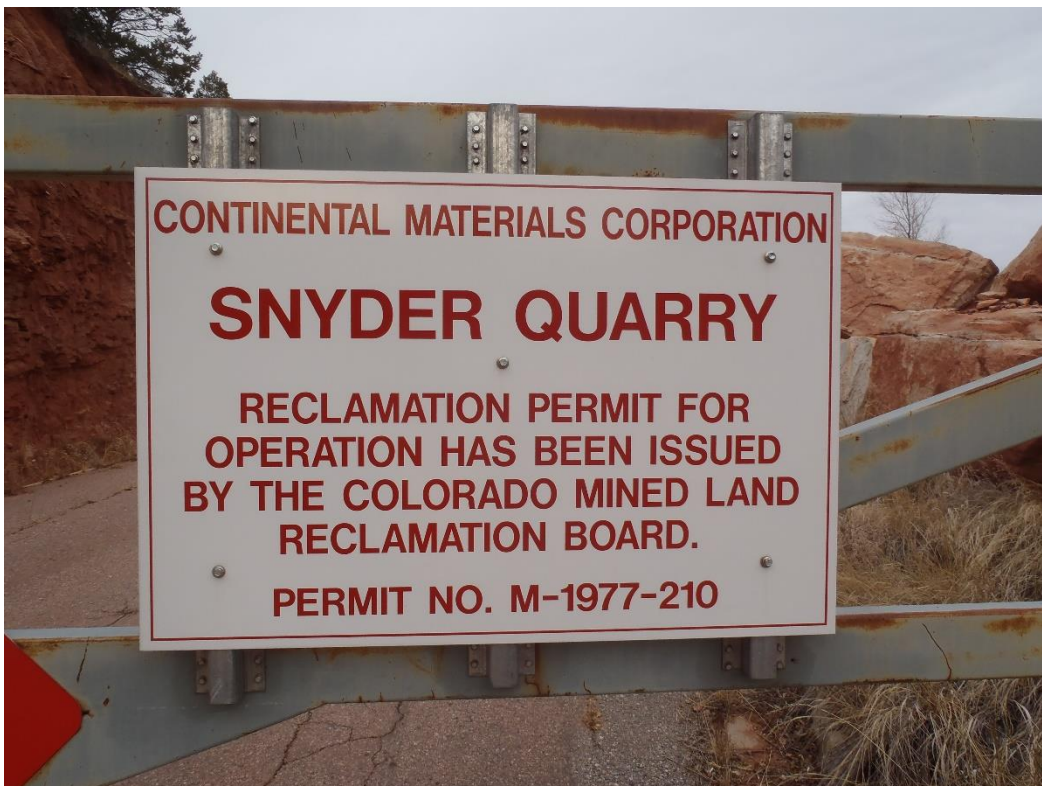
Signs and Markers: The permit sign was properly posted (see **Photo 7**) and boundary markers were observed to delineate the permit boundary (see **Photo 8**).

Photo 7. Permit sign at entrance.

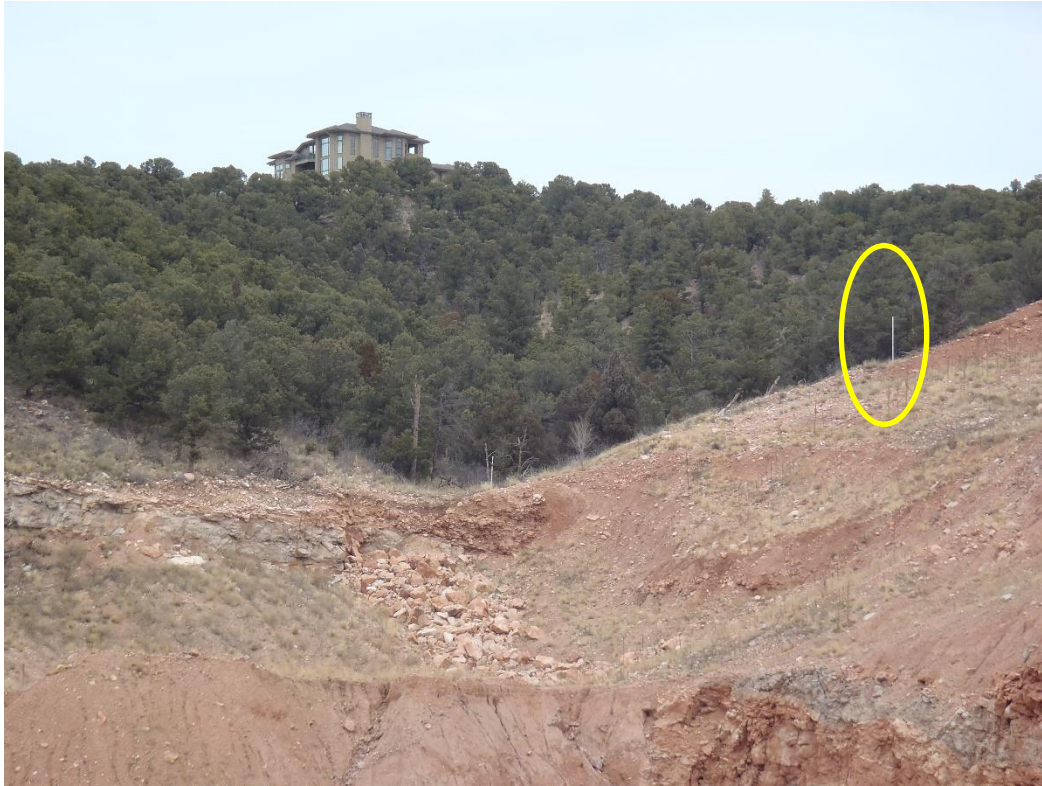
Photo 8. Typical permit boundary marker (north side of AP pit).
