COLORADO DIVISION OF RECLAMATION, MINING AND SAFETY
MINERALS PROGRAM INSPECTION REPORT
PHONE: (303) 866-3567

MINE NAME: Pikeview Quarry	MINE/PROSPECTING ID#: M-1977-211	MINERAL: Limestone (general), granite, and dolomite	COUNTY: El Paso
INSPECTION TYPE: Monitoring	INSPECTOR(S): Timothy A. Cazier, Amy Eschberger	INSP. DATE: January 30, 2018	INSP. TIME: 08:00
OPERATOR: Continental Materials Corporation	OPERATOR REPRESENTATIVE: Brandon Hesper & Andre Laroche	TYPE OF OPERATION: 112c - Construction Regular Operation

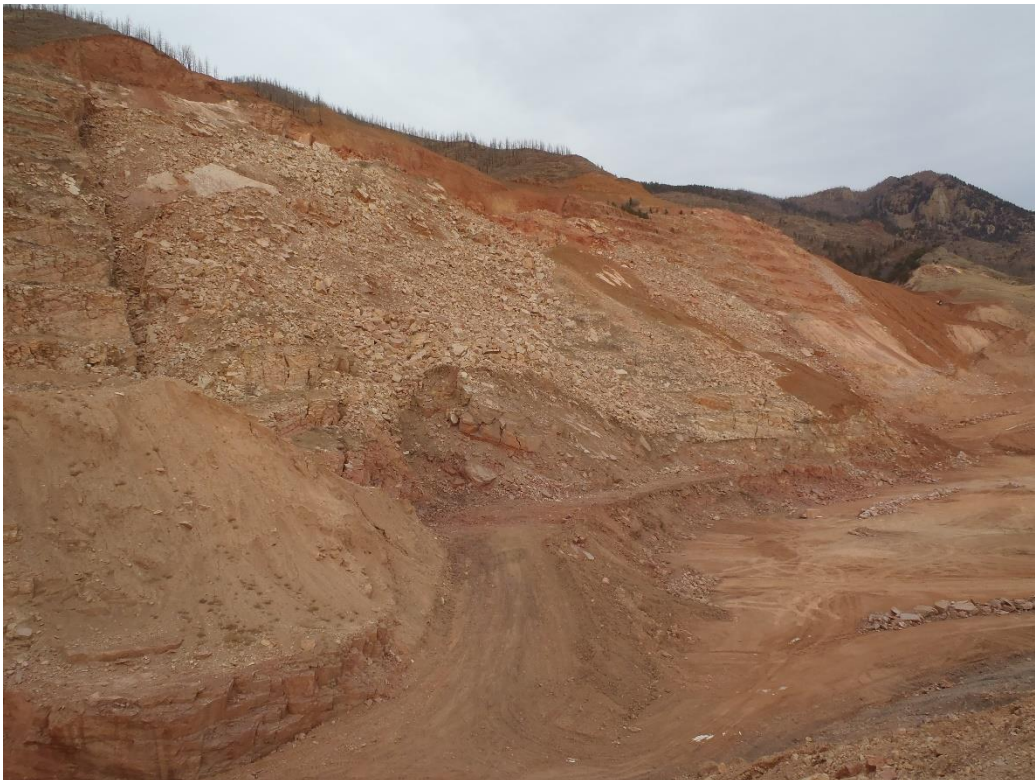
Backfilling and Grading: Sufficient backfill material appeared to be available as the mine plans to push overburden down from the top (see **Photo 1**) as part of the effort to stabilize and reclaim the pit.

Photo 1. Area to be reclaimed by pushing material down from the top (looking NNW).

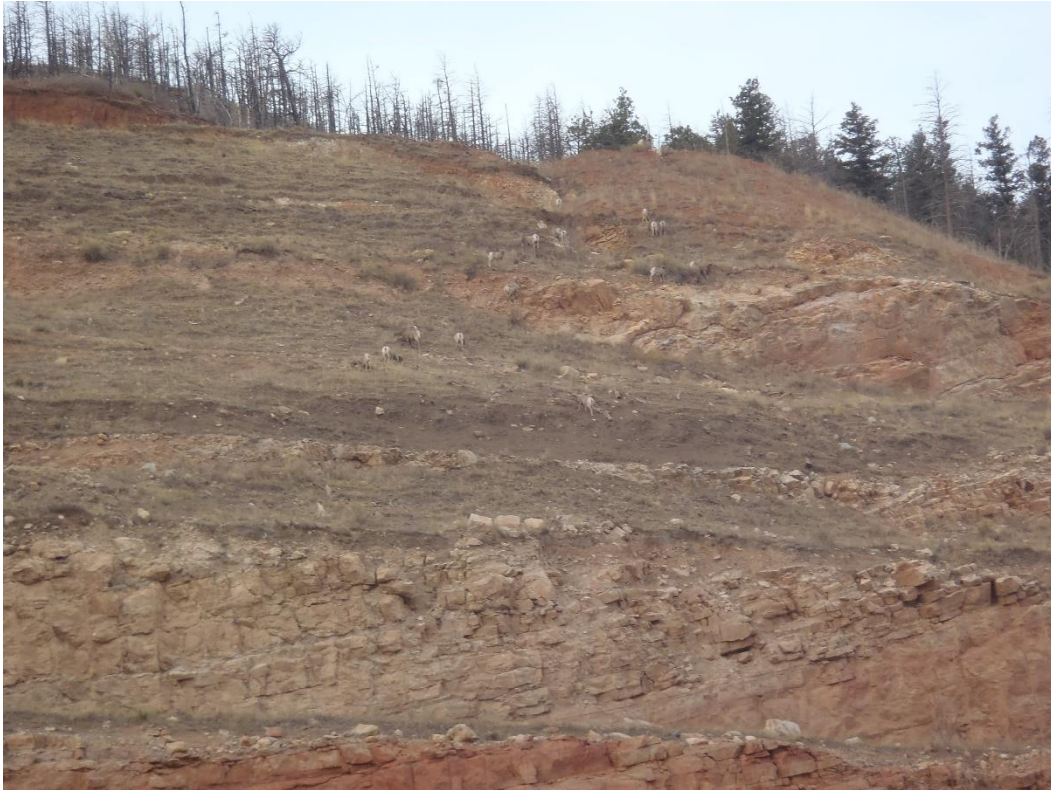
Fish and Wildlife: No impact to fish or wildlife was observed. Bighorn sheep were observed on the reclaimed benches on the south end of the pit (see **Photo 2**).

Revegetation: Some revegetation has occurred on the far north end of the pit (see **Photo 4**) and the south end (see **Photo 2**). No noxious weeds were observed.

Photo 2. Bighorn sheep on south end reclaimed slopes.

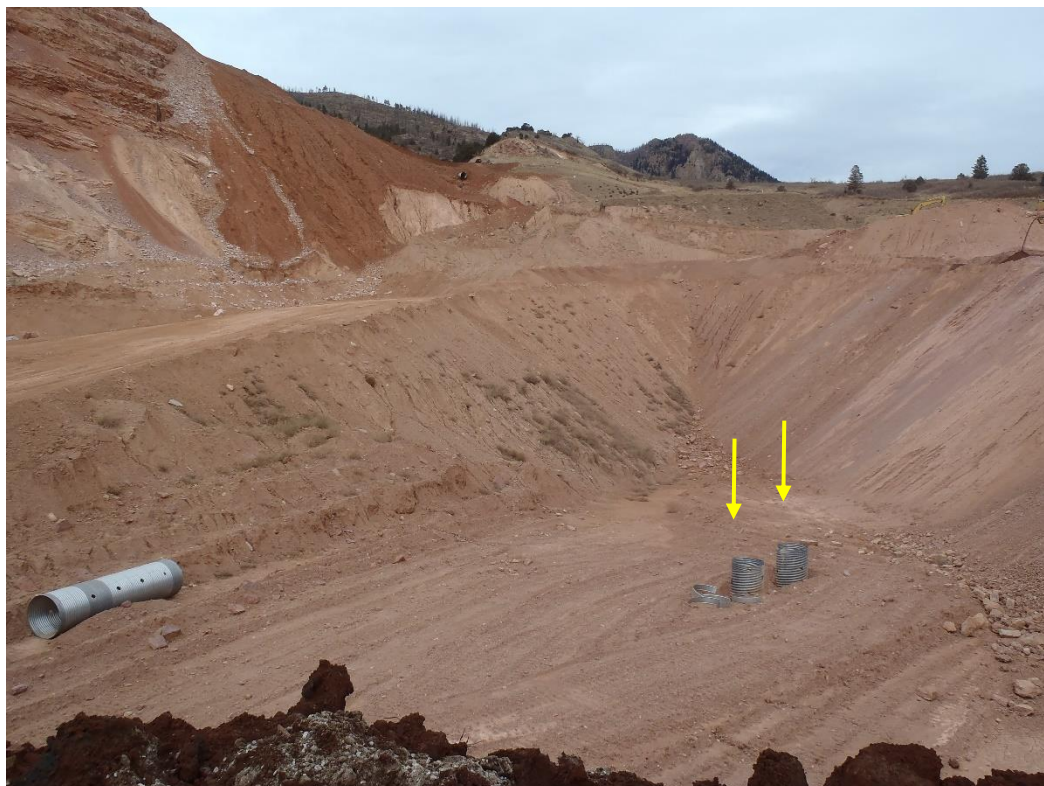
Hydrologic Balance: No standing water was observed in the pit and no exposed groundwater was observed (see **Photo 3**).

Photo 3. Riser pipes in stormwater detention pond (looking NNW).

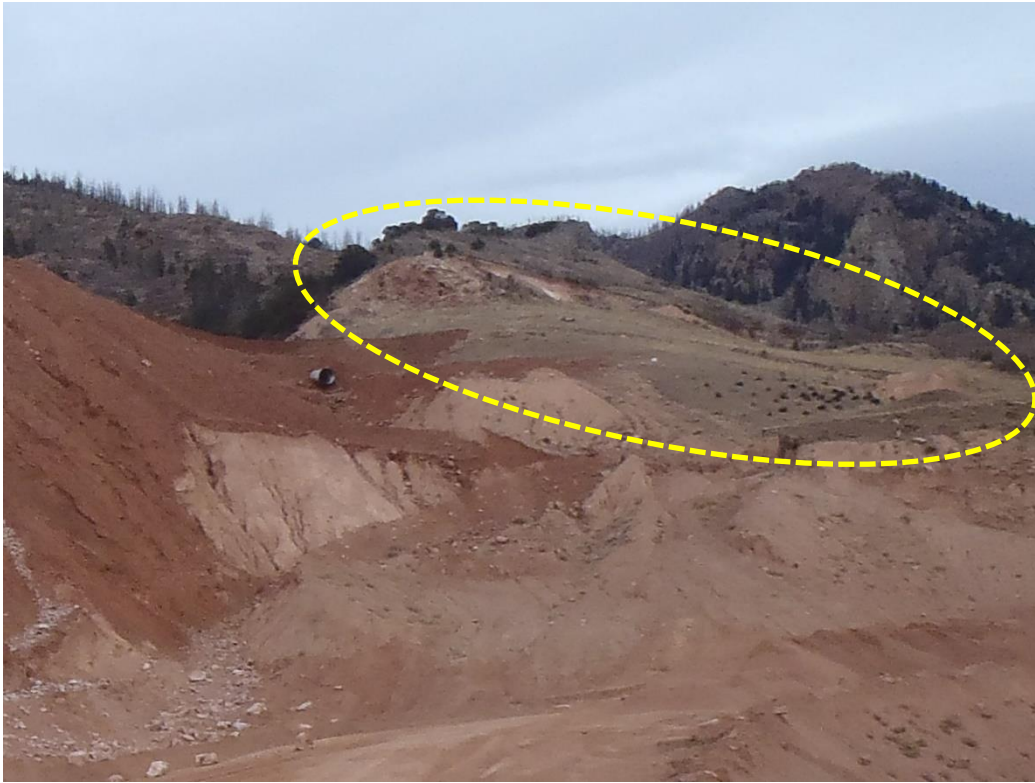
Photo 4. Reclaimed area on north end (looking NNW).

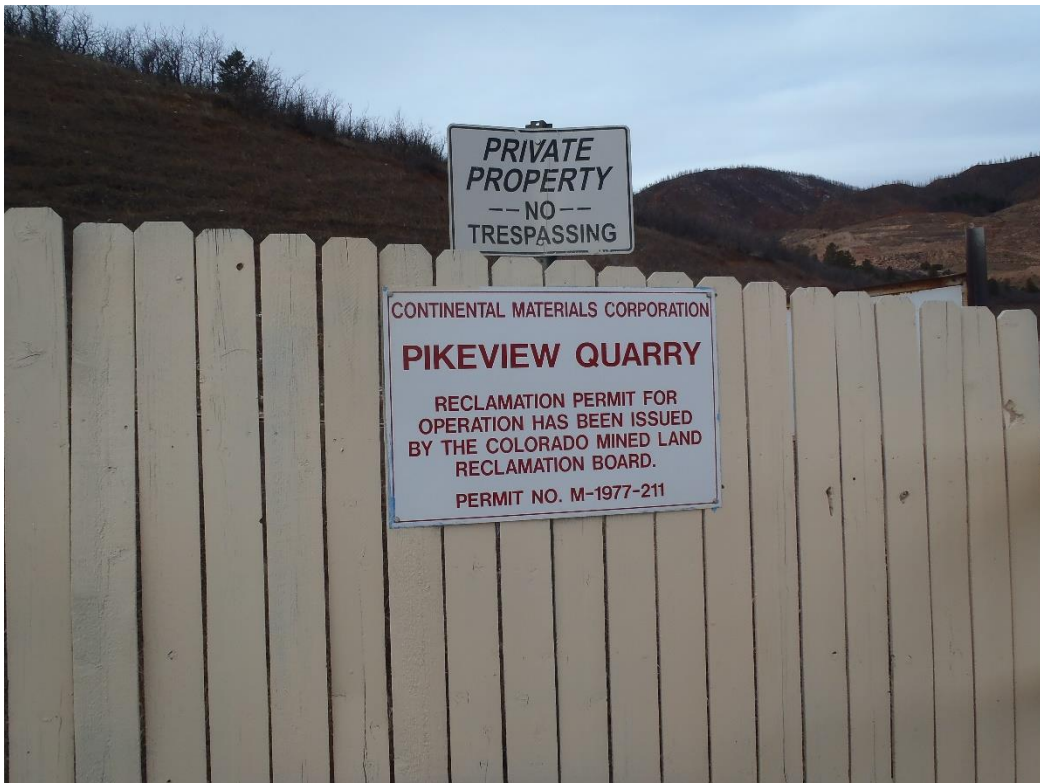
Signs and Markers: The permit sign was properly posted (see **Photo 5**).

Photo 5. Permit sign – at entrance.

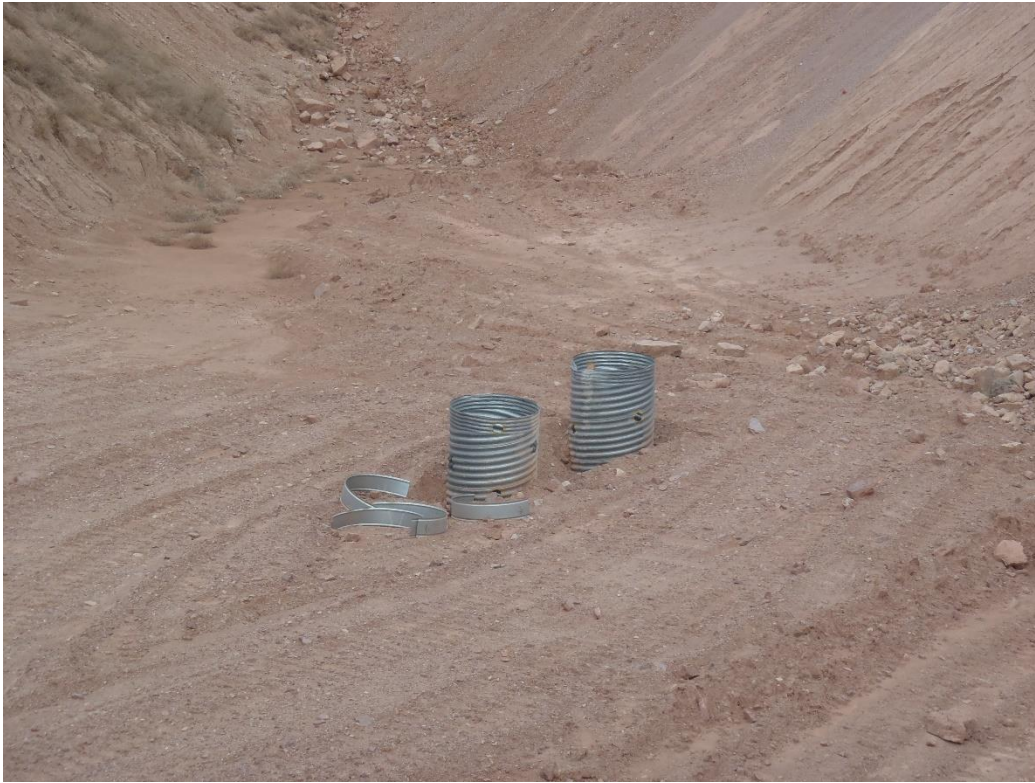
Storm Water MGT Plan: No oil or fuel spills observed. Stormwater drains to the pond in the pit and is decanted through the riser pipes (see **Photo 6**).

Photo 6. Stormwater pond risers.
