MINERALS PROGRAM INSPECTION REPORT
PHONE: (303) 866-3567

MINE NAME: Mesa DeMaya Pit	MINE/PROSPECTING ID#: M-2014-019	MINERAL: Sand and gravel	COUNTY: Las Animas
INSPECTION TYPE: Monitoring	INSPECTOR(S): Michael A. Cunningham	INSP. DATE: January 30, 2018	INSP. TIME: 13:00
OPERATOR: Las Animas County	OPERATOR REPRESENTATIVE: Clell Goode	TYPE OF OPERATION: 110c - Construction Limited Impact	
REASON FOR INSPECTION: Normal I&E Program	BOND CALCULATION TYPE: None	BOND AMOUNT: \$0.00	
DATE OF COMPLAINT: NA	POST INSP. CONTACTS: None	JOINT INSP. AGENCY: None	
WEATHER: Clear	INSPECTOR'S SIGNATURE:

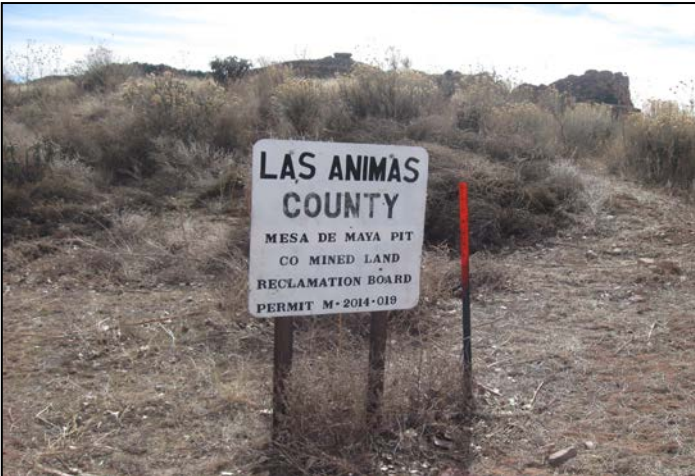
The permit sign was posted at the site entrance and the boundary of the affected area was clearly delineated as required by Rule 3.1.12.

1. Permit sign at site entrance.

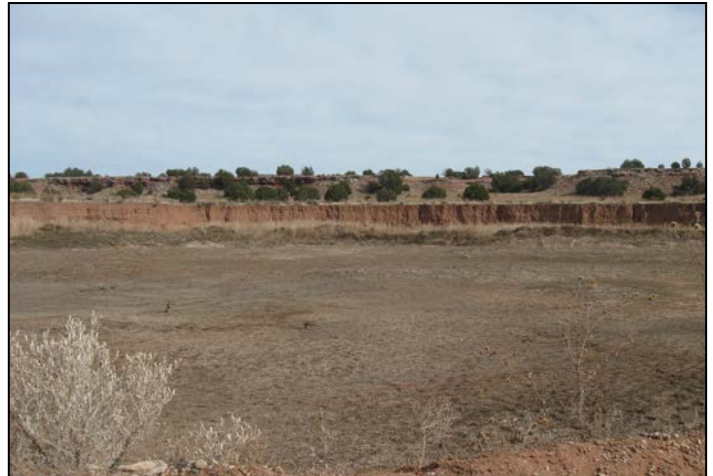
2. Overview of pit floor, photo taken facing east.

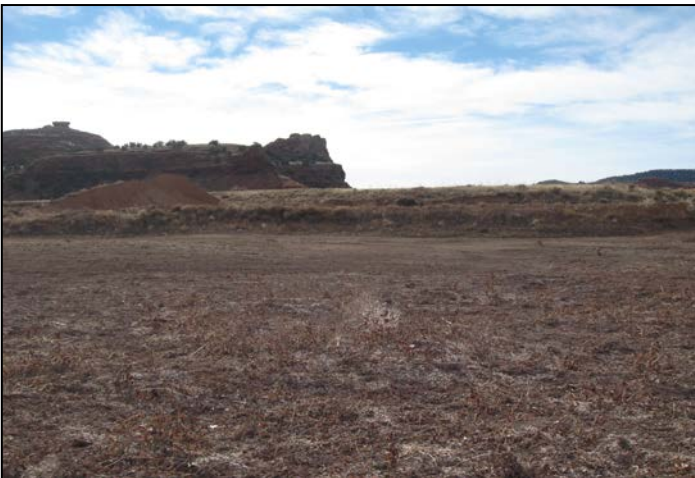
3. Overview of pit floor, photo taken facing west.

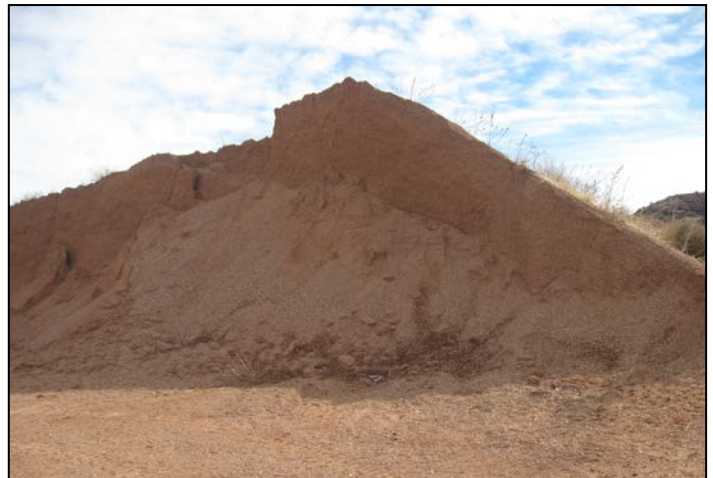
4. Product stockpile.

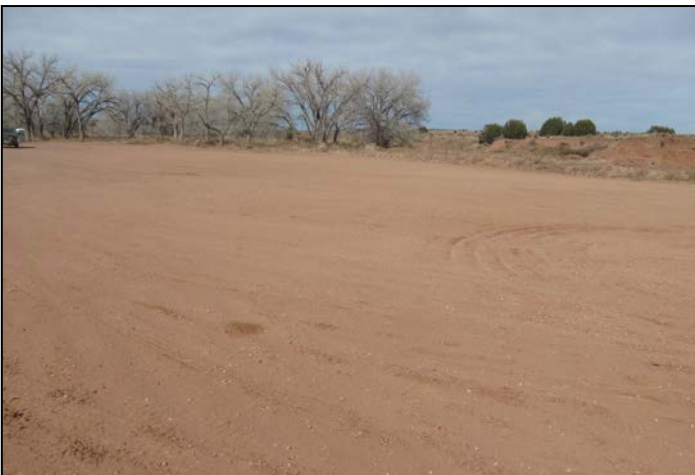
5. Load-out and stockpile area.
