**MINERALS PROGRAM INSPECTION REPORT**  
**PHONE: (303) 866-3567**

<b>MINE NAME:</b> Mitchell Pit	<b>MINE/PROSPECTING ID#:</b> M-1987-023	<b>MINERAL:</b> Sand and gravel	<b>COUNTY:</b> Adams
<b>INSPECTION TYPE:</b> Monitoring	<b>INSPECTOR(S):</b> Jared L. Ebert	<b>INSP. DATE:</b> February 15, 2018	<b>INSP. TIME:</b> 09:00
<b>OPERATOR:</b> Ricky W. Mitchell	<b>OPERATOR REPRESENTATIVE:</b> Rick Mitchell	<b>TYPE OF OPERATION:</b> 110c - Construction Limited Impact	
<b>REASON FOR INSPECTION:</b> Normal I&E Program	<b>BOND CALCULATION TYPE:</b> IT.Bondcalculationtype.CD.Desc	<b>BOND AMOUNT:</b> \$10,430.00	
<b>DATE OF COMPLAINT:</b> NA	<b>POST INSP. CONTACTS:</b> None	<b>JOINT INSP. AGENCY:</b> None	
<b>WEATHER:</b> Clear	<b>INSPECTOR'S SIGNATURE:</b>

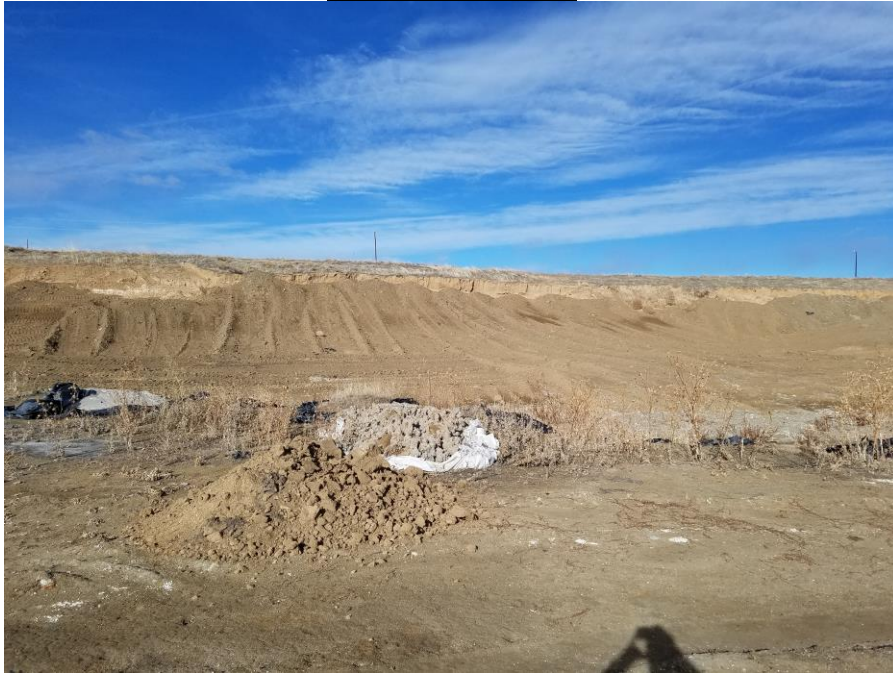
The site consists of an excavation that daylights to the east. The highwall created by the operation is currently being backfilled with fill material. The placement of the fill is nearing the top of the highwall. According to Mr. Mitchell, he intends to finish grading the highwall this summer.

**Figure 1. Near the south boundary looking northwest. Highwall backfill**

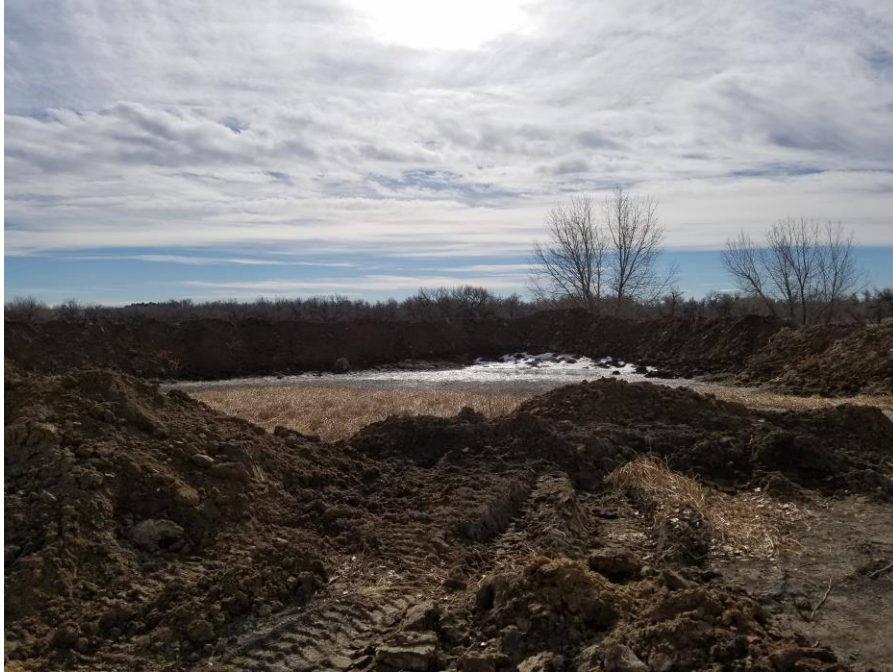
It does not appear the site is actively being mined. However, there are currently three bermed basins at the base of the pit where inert material is being placed.

**Figure 5. Inert fill basin**
