MINERALS PROGRAM INSPECTION REPORT**PHONE: (303) 866-3567**

| MINE NAME: Greeley 35th Ave Pit | MINE/PROSPECTING ID#: M-1977-036 | MINERAL: Sand and gravel | COUNTY: Weld |
| INSPECTION TYPE: Monitoring | INSPECTOR(S): Peter S. Hays | INSP. DATE: March 8, 2018 | INSP. TIME: 12:00 |
| OPERATOR: Martin Marietta Materials, Inc. | OPERATOR REPRESENTATIVE: Julie Mikulas | TYPE OF OPERATION: 112c - Construction Regular Operation | |

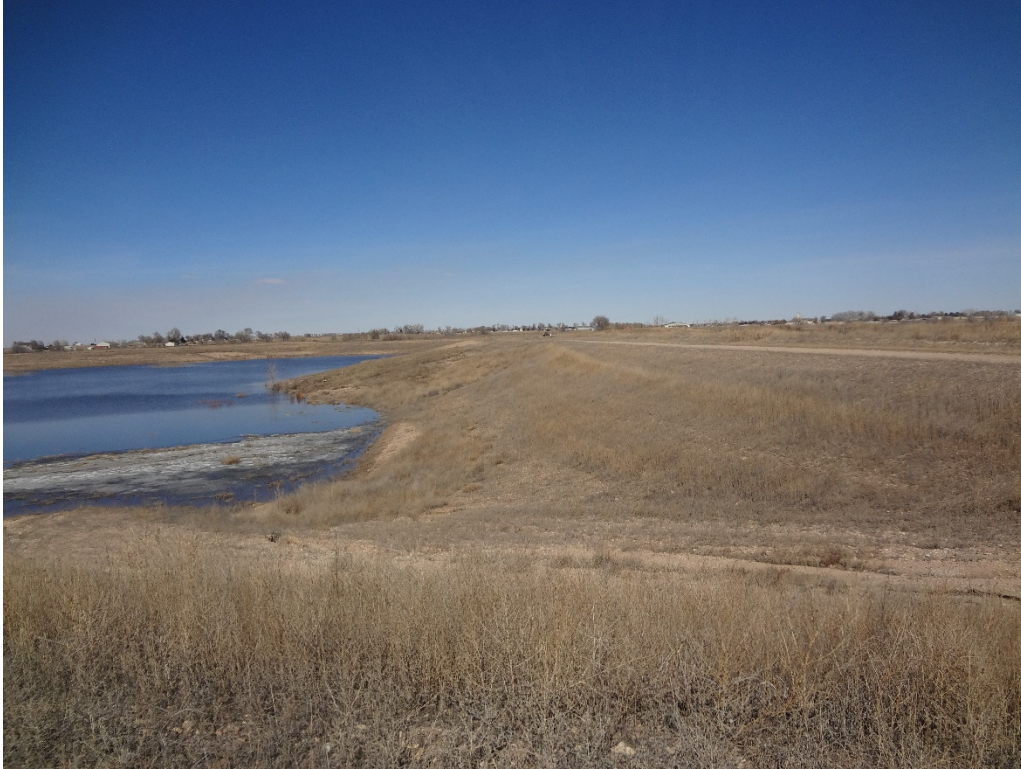
View of the West Pit from the southeast corner looking north

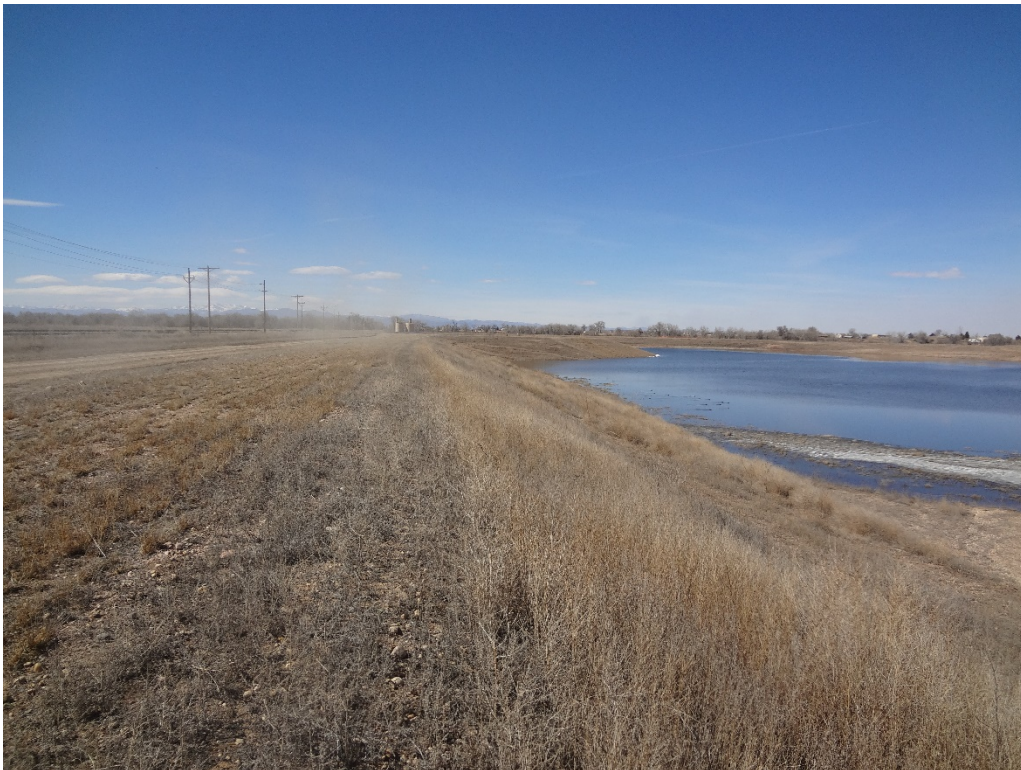
View of the West Pit from the southeast corner looking west

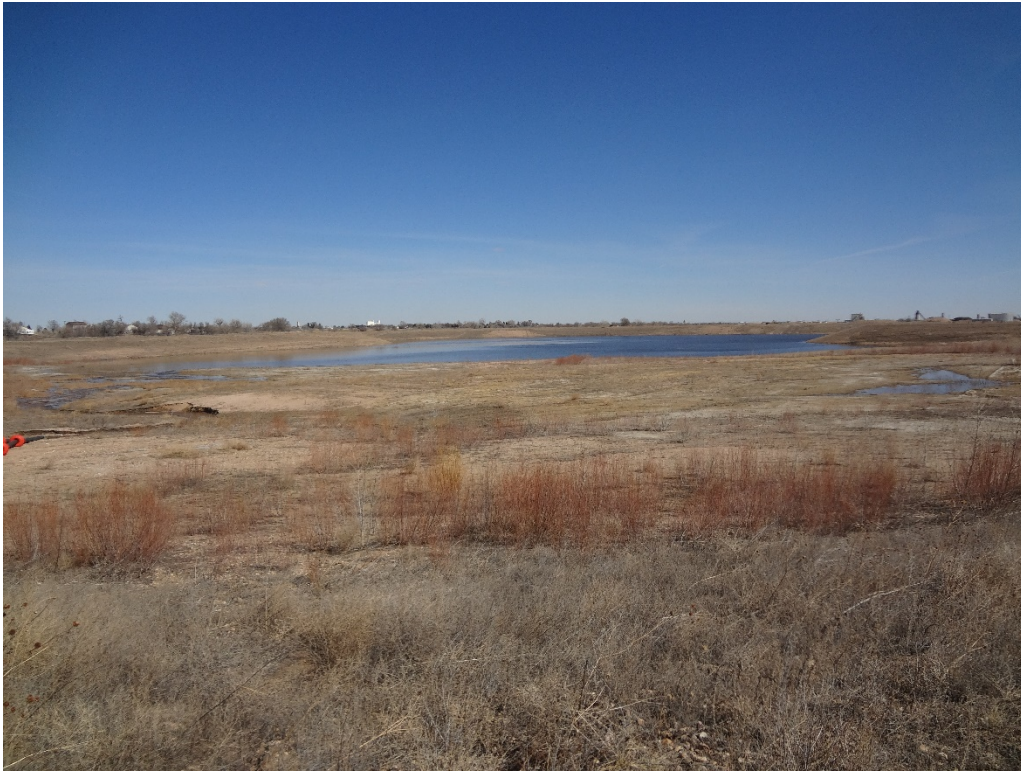
View of the West Pit from the southwest corner looking northeast (pipes from Poudre River in left side of photo)

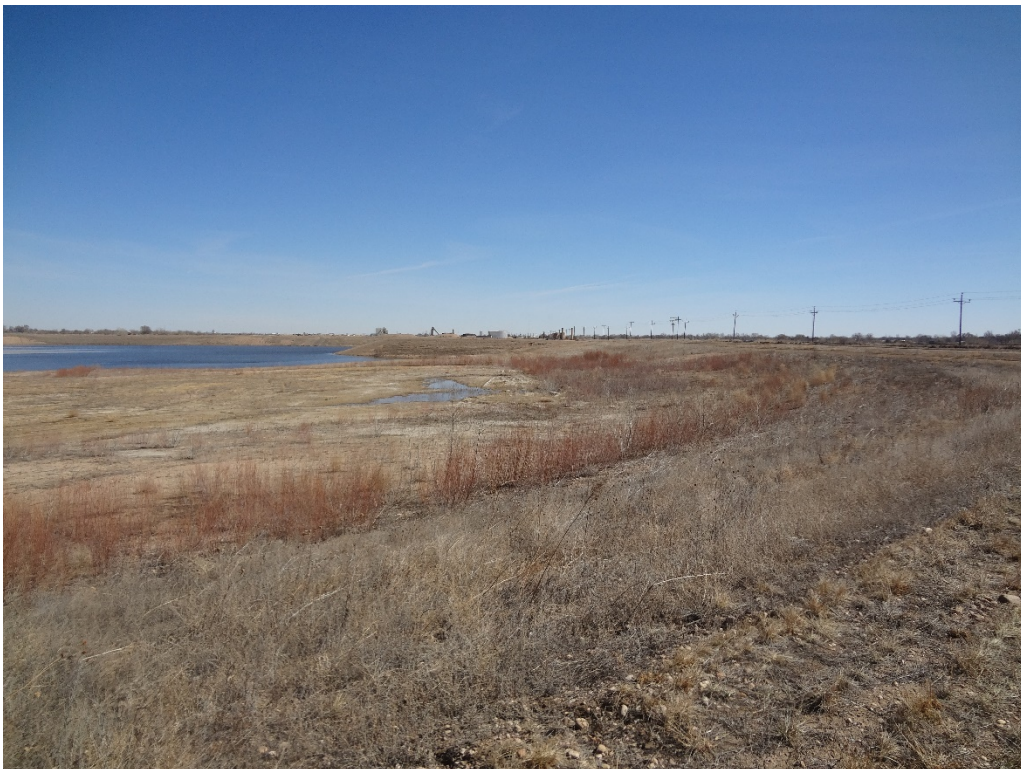
View of the West Pit from the southwest corner looking east

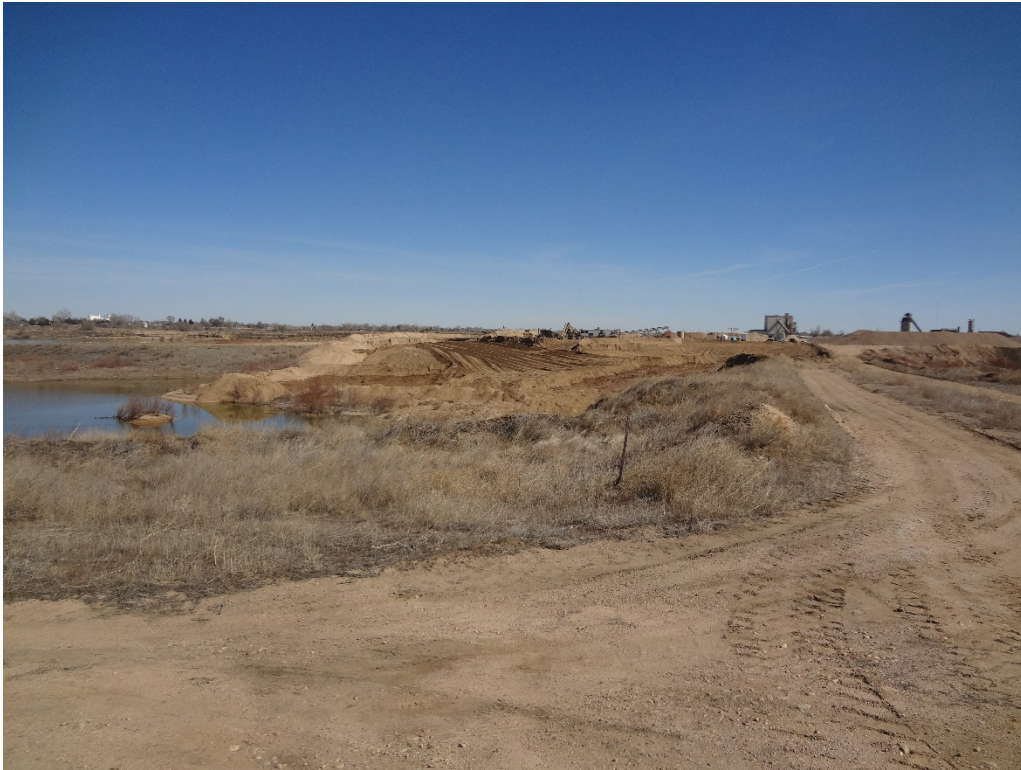
View of the active mining activity during the inspection looking northeast

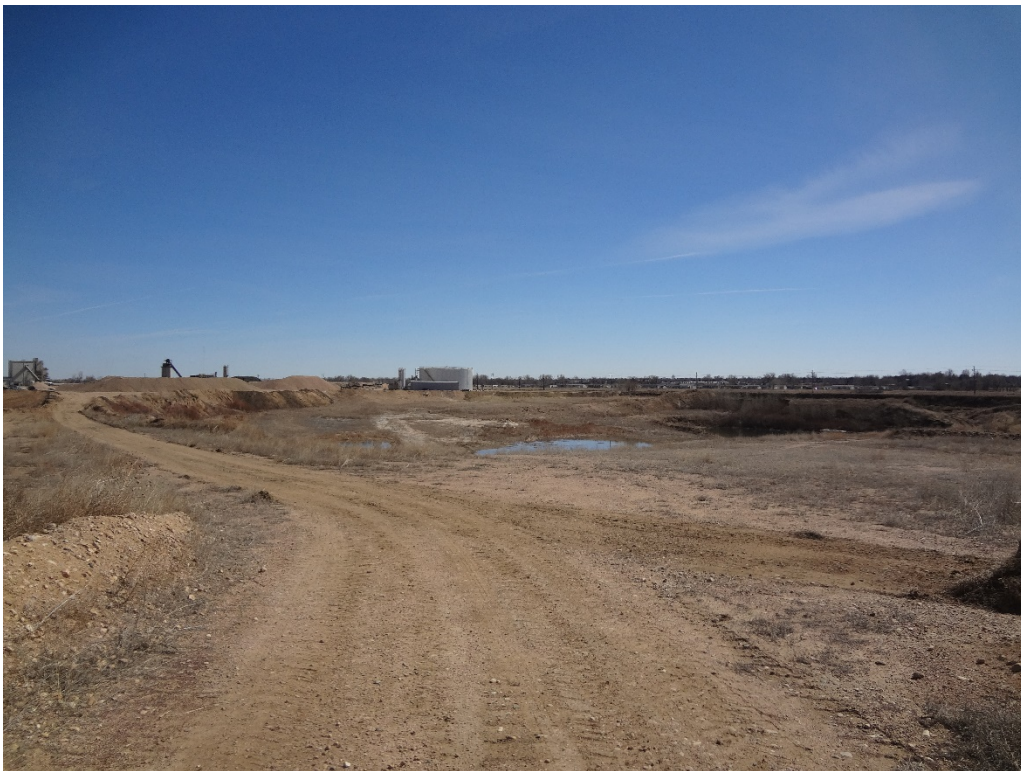
View of the sedimentation pond from the northwest corner of the pond looking southeast

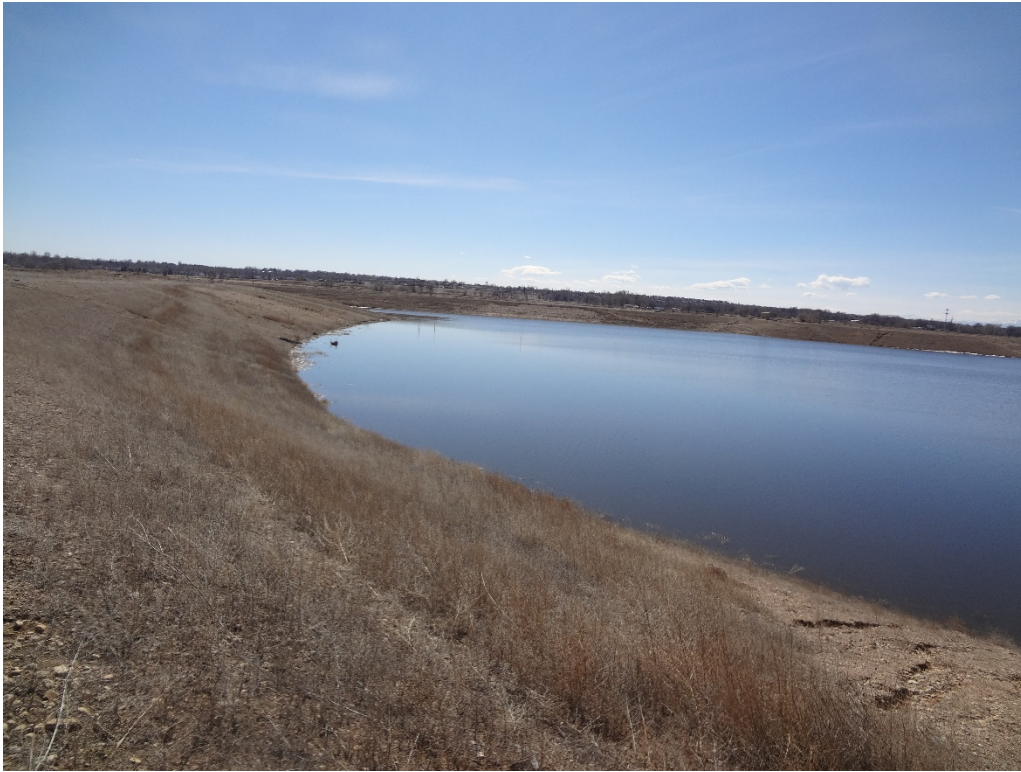
View of the West Pit from the east shoreline looking south

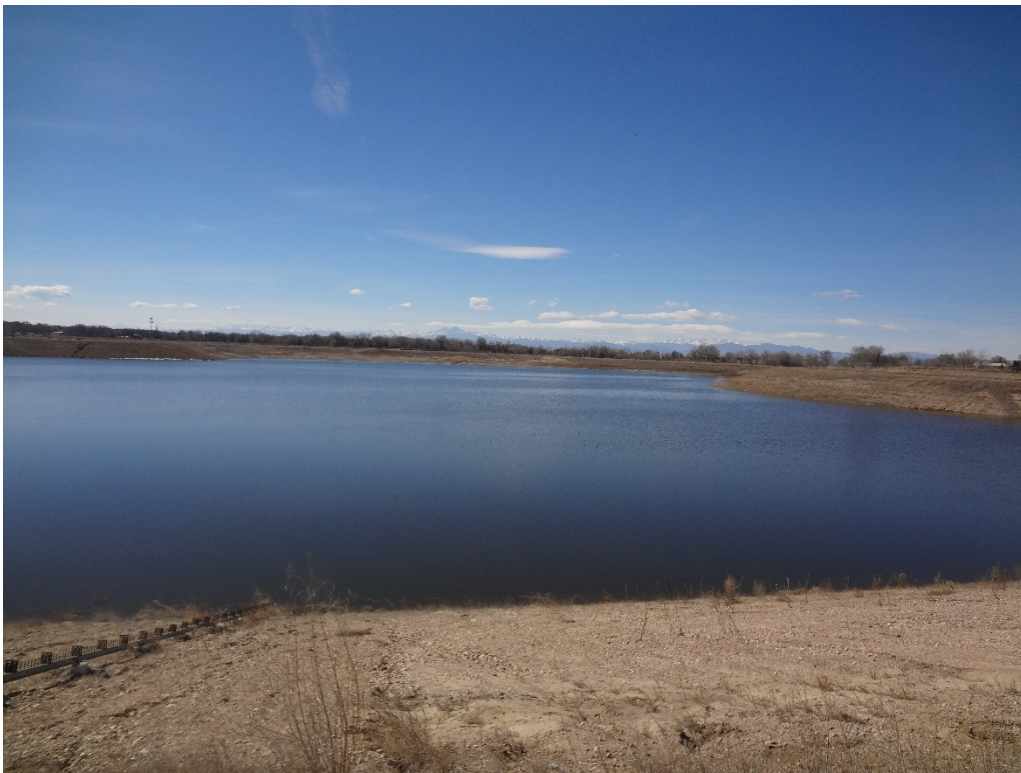
View of the West Pit from the east shoreline looking west

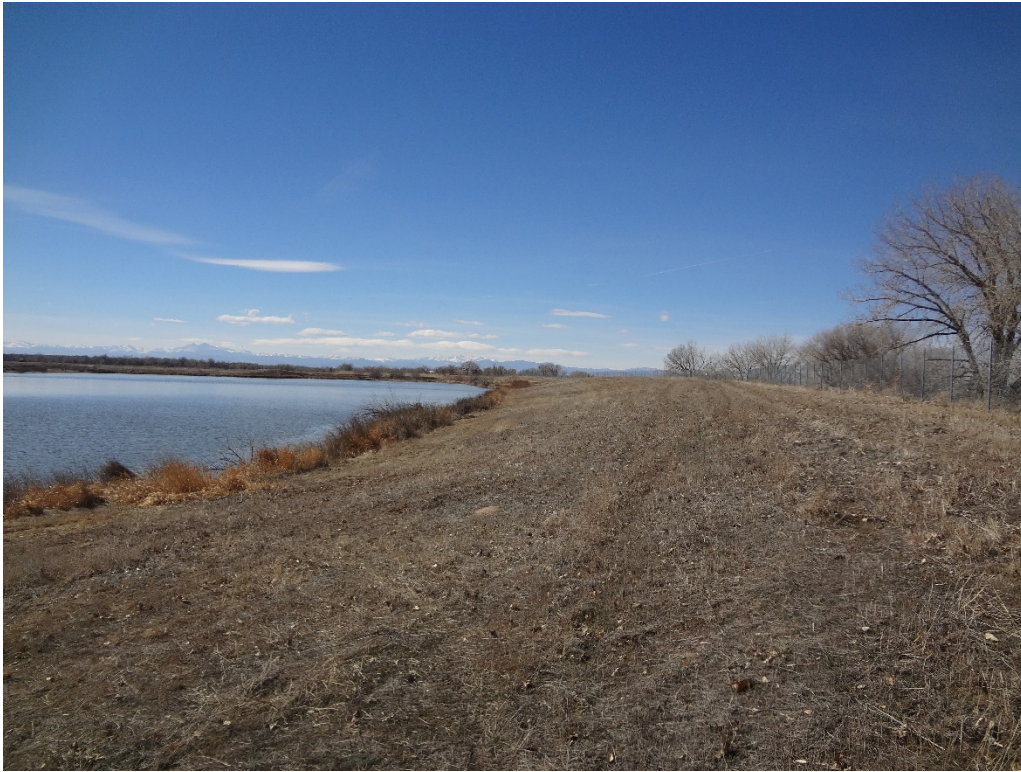
View of the north lake from the northeast corner looking west

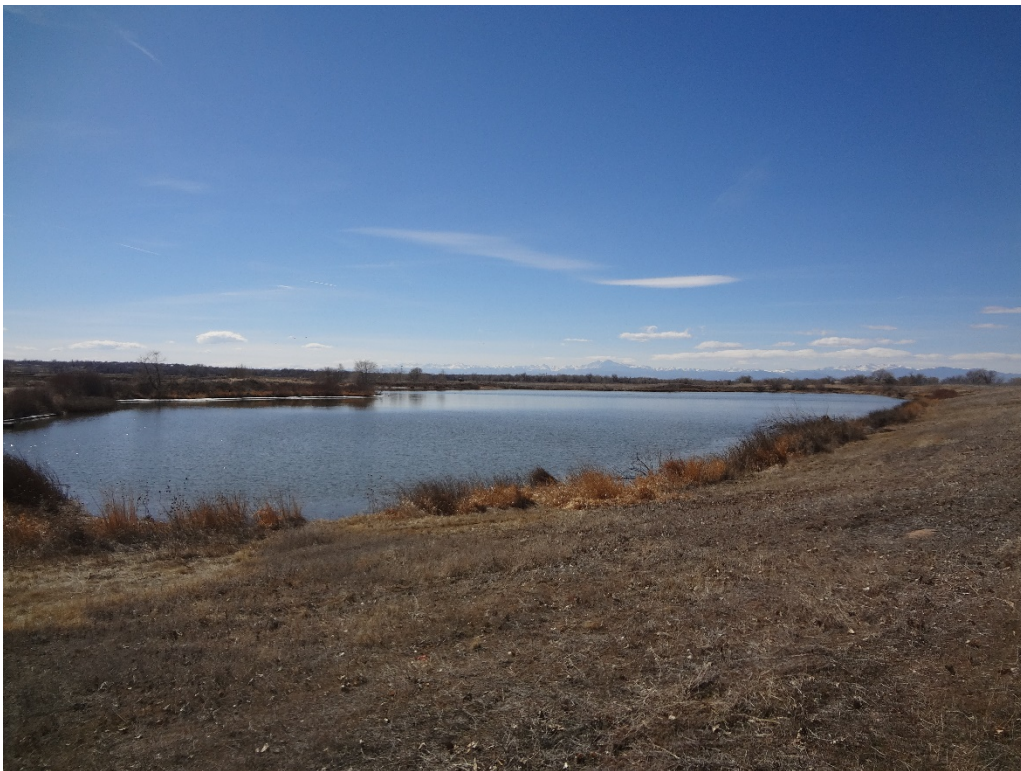
View of the north lake from the northeast corner looking southwest

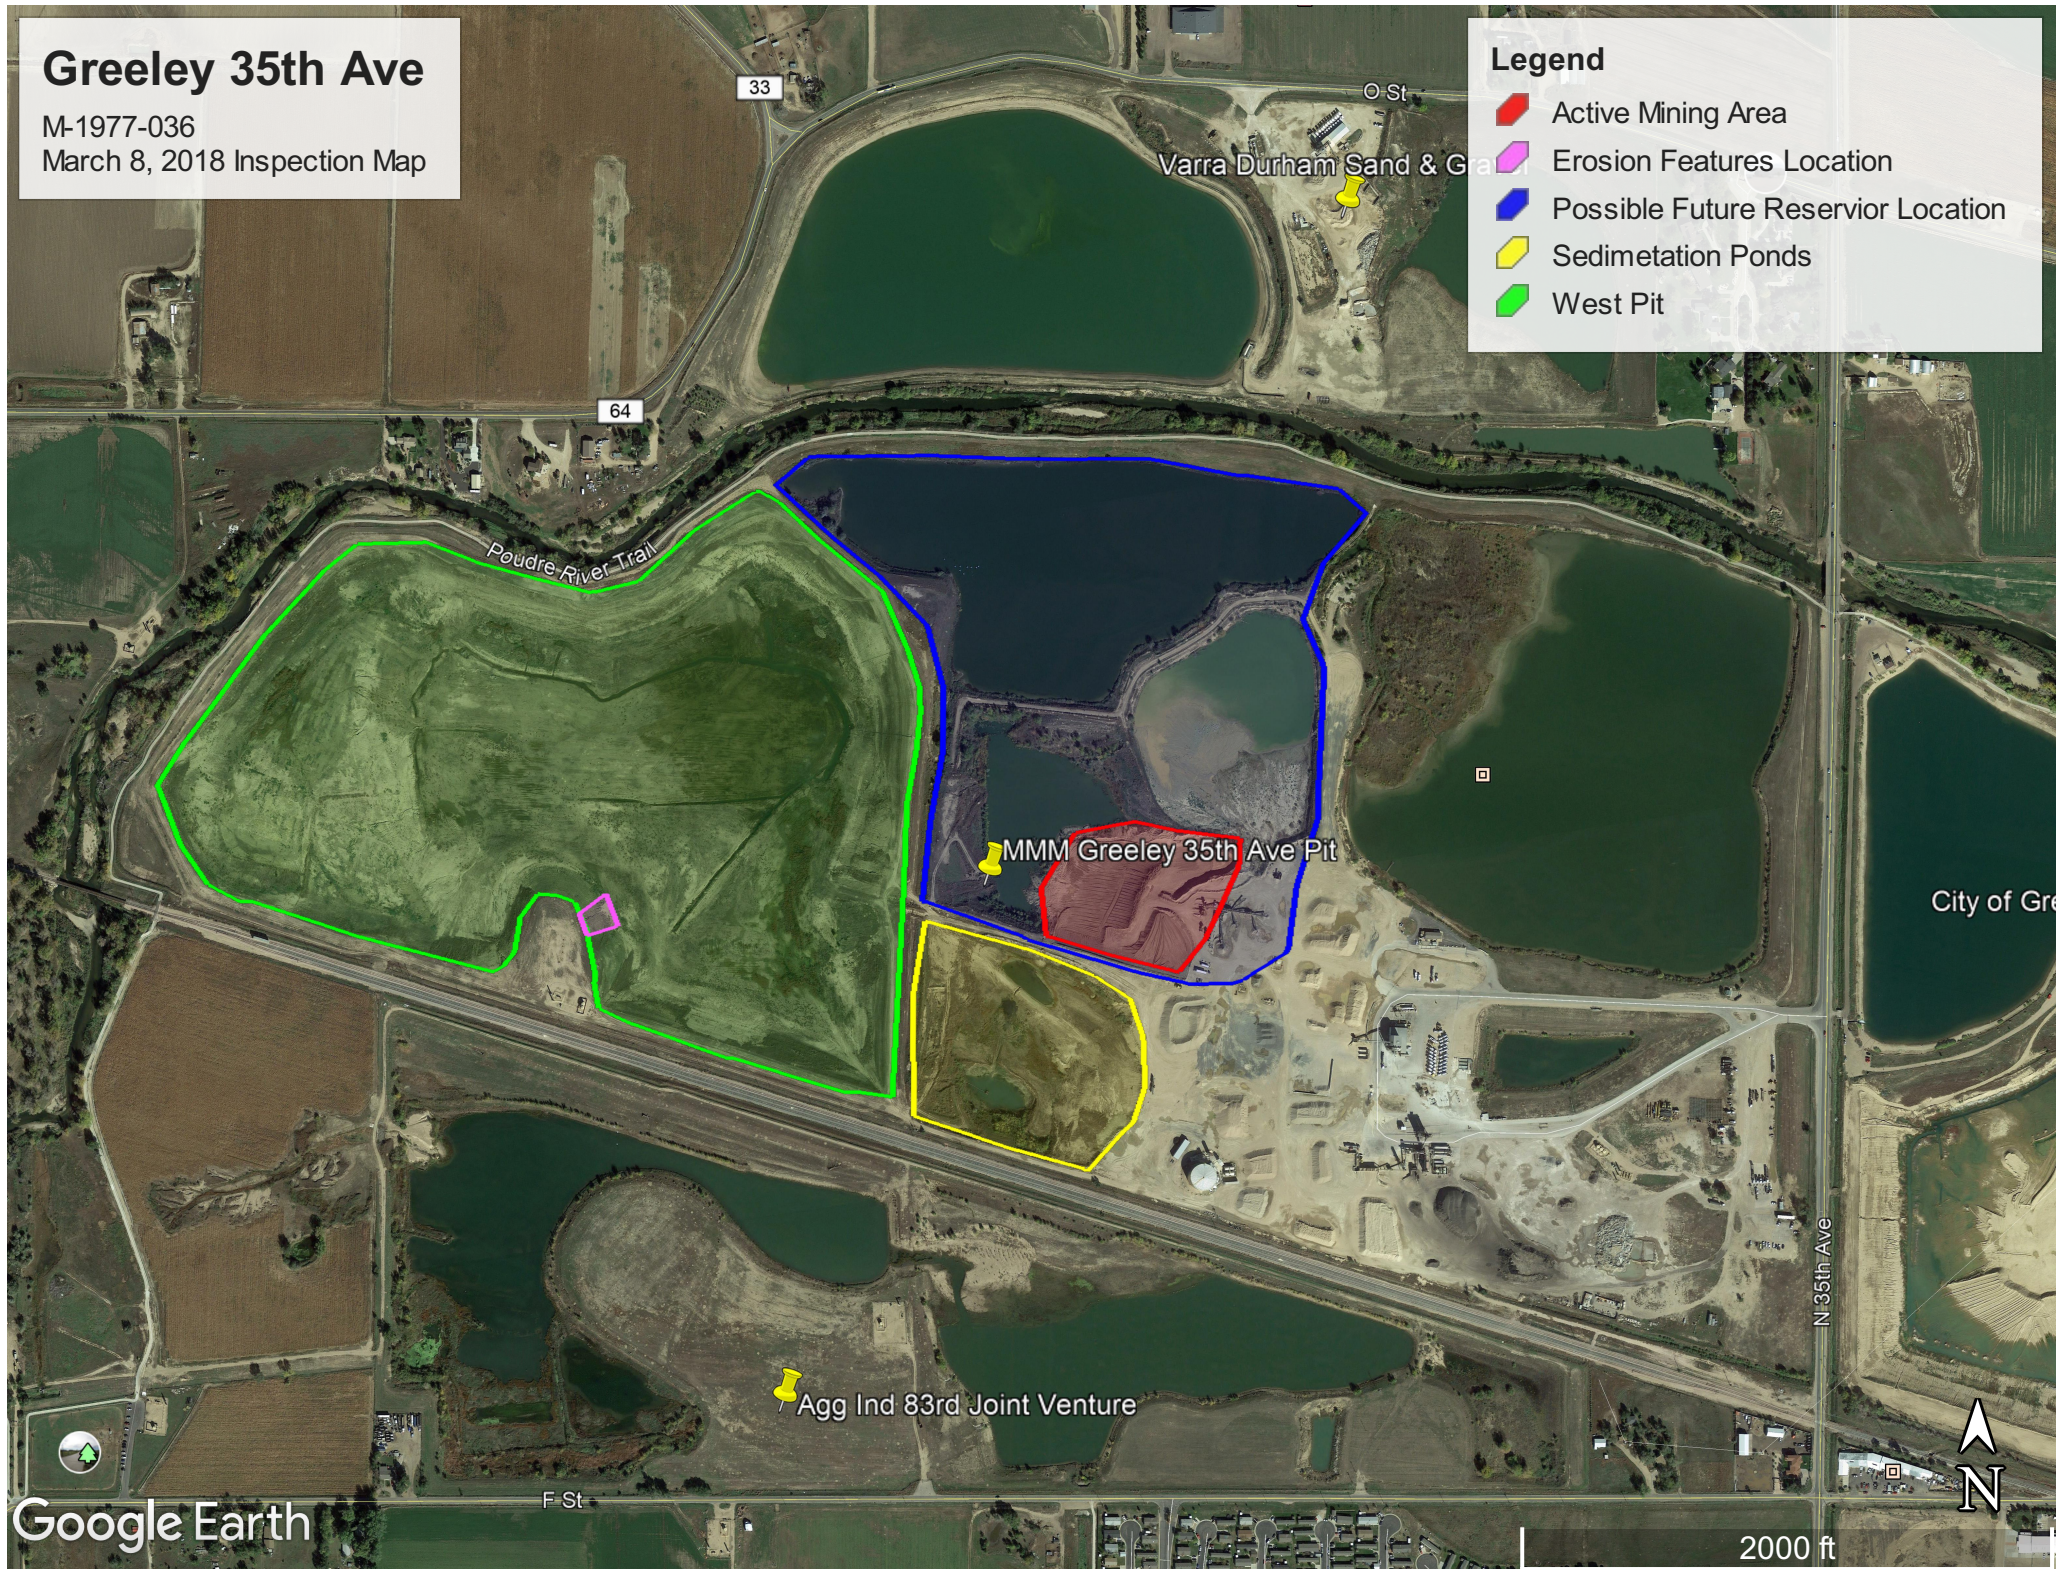
March 8, 2018 Inspection Map

The West Pit is in final reclamation. The slurry wall around the West Pit was certified by the Division of Water Resources on December 1, 2015 according to the 2017-2018 Substitute Water Supply Plan. The pit slopes were graded to the approved 3H:1V slopes and the areas above the anticipated high water level were seeded. The pit vegetation consisted predominately of annual weeds. The reservoir was being filled with free water from the Cache La Poudre River during the inspection. Two erosion features were observed on the southeast slope of the oil and gas well pad along the south side of the pit.
