MINERALS PROGRAM INSPECTION REPORT
PHONE: (303) 866-3567

MINE NAME: Mitchell Pit #2	MINE/PROSPECTING ID#: M-1990-131	MINERAL: Gravel	COUNTY: Adams
INSPECTION TYPE: Monitoring	INSPECTOR(S): Jared L. Ebert	INSP. DATE: February 15, 2018	INSP. TIME: 10:00
OPERATOR: Ricky W. Mitchell	OPERATOR REPRESENTATIVE: Rick Mitchell	TYPE OF OPERATION: 110c - Construction Limited Impact	
REASON FOR INSPECTION: Normal I&E Program	BOND CALCULATION TYPE: Partial Bond	BOND AMOUNT: \$5,000.00	
DATE OF COMPLAINT: NA	POST INSP. CONTACTS: None	JOINT INSP. AGENCY: None	
WEATHER: Cloudy	INSPECTOR'S SIGNATURE:

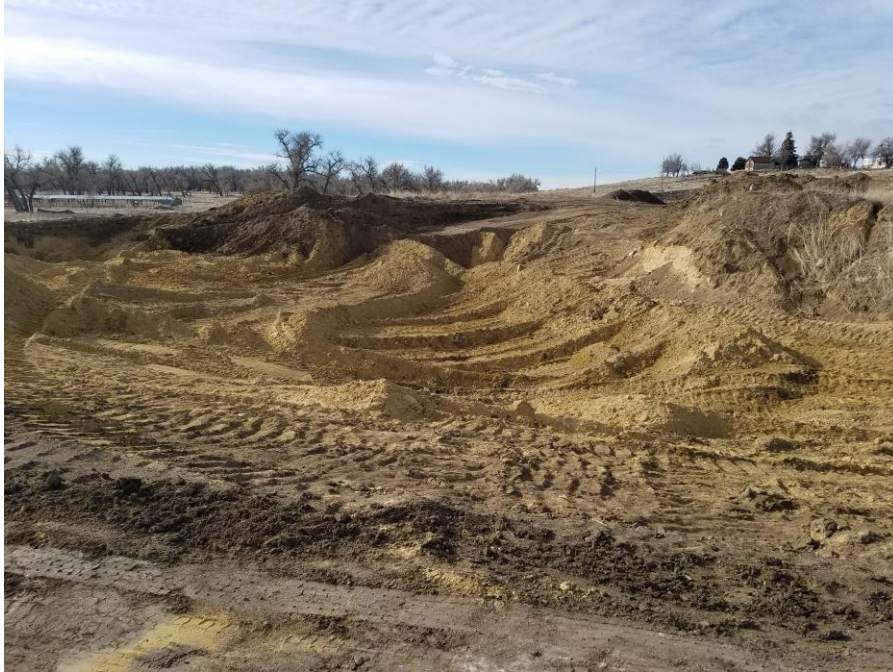
A shallow excavation exists in the eastern side of the site near the eastern boundary. Topsoil material is stockpiled adjacent to the excavation.

Figure 1. Shallow excavation on the east side of the site.

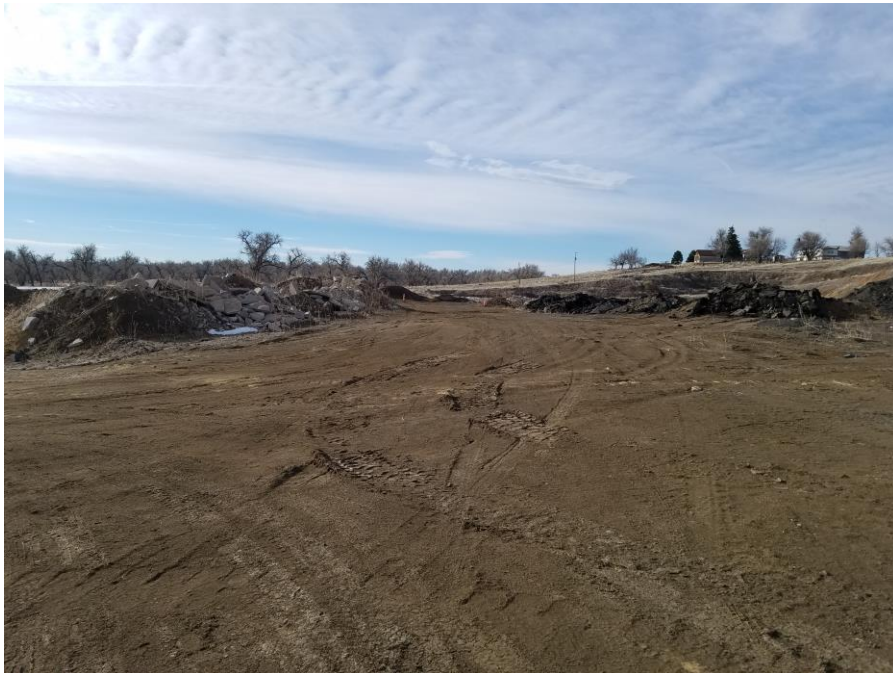
Mr. Mitchell also has various piles of inert material such as soil and concrete piles located throughout the site that he recycles for his landscaping materials business.

Figure 2. Stockpiles of inert material placed in the base of the pit.

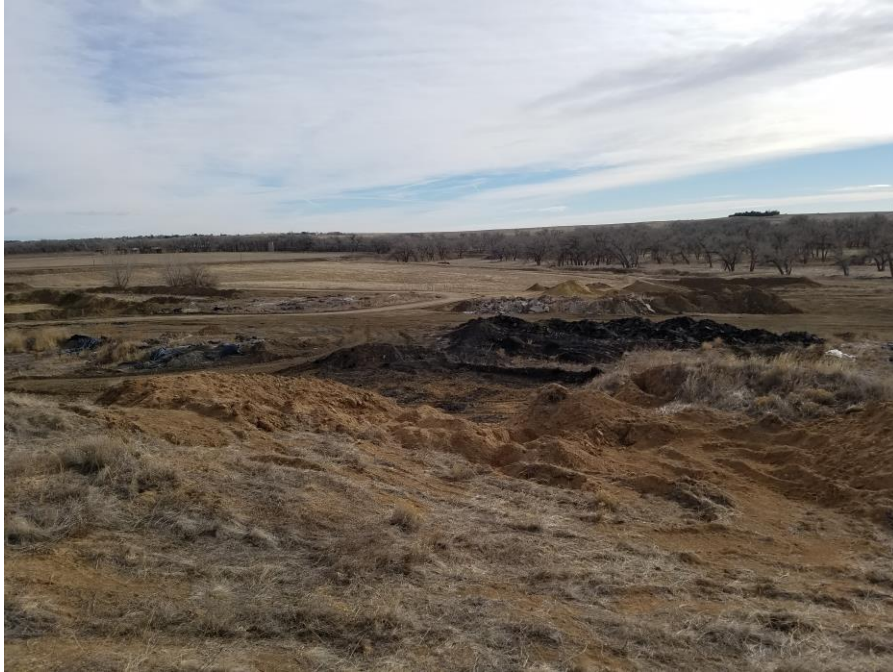
Figure 3. From the west side of the site looking east.

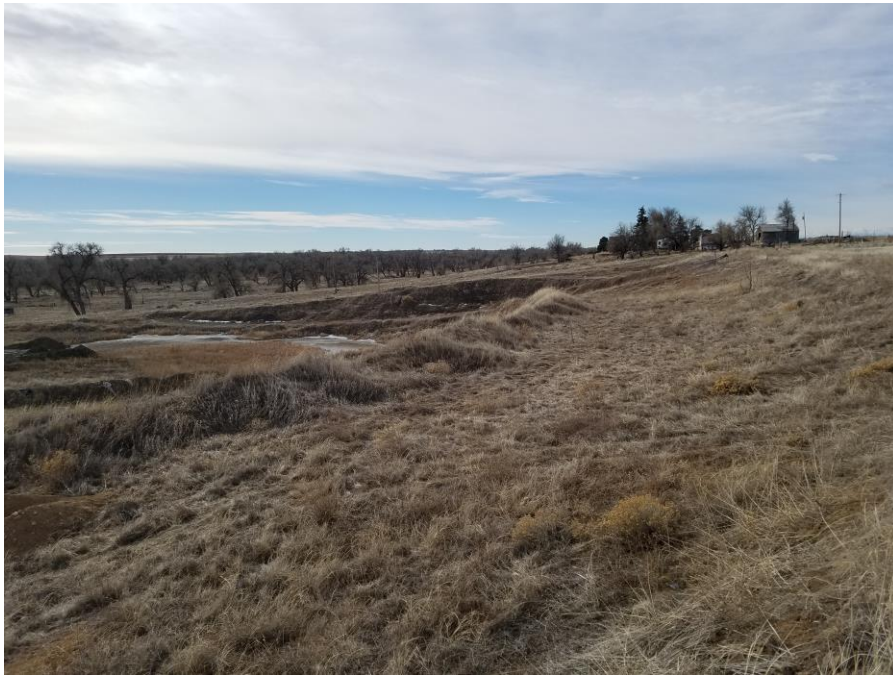
The site consists of a pit excavation that daylights to the east. The western mine face is set at a 2H:1V angle or less in some areas and is partially vegetated. The site is adjacent to another 110c mining operation operated by Mr. Mitchell (M-1987-023). Mr. Mitchell is backfilling the western highwall in the adjacent pit with fill material. Mr. Mitchell indicated he would be backfilling the rest of the highwall this summer. However, Mr. Mitchell has indicated that CDOT may bring a road through the property or a housing development may wish to bring a stormwater drain through the property. He is waiting to see what plans develop which may impact the future reclamation of the site.

Figure 4. From the north side of the west excavation slope looking south.
