MINERALS PROGRAM INSPECTION REPORT
PHONE: (303) 866-3567

MINE NAME: Thornburg Pit	MINE/PROSPECTING ID#: M-1983-060	MINERAL: Sand and gravel	COUNTY: Adams
INSPECTION TYPE: Monitoring	INSPECTOR(S): Jared L. Ebert	INSP. DATE: February 15, 2018	INSP. TIME: 10:45
OPERATOR: Thornburg Family Limited Partnership	OPERATOR REPRESENTATIVE: Stanley Thornburg	TYPE OF OPERATION: 112c - Construction Regular Operation	
REASON FOR INSPECTION: Normal I&E Program	BOND CALCULATION TYPE: Complete Bond	BOND AMOUNT: \$14,500.00	
DATE OF COMPLAINT: NA	POST INSP. CONTACTS: None	JOINT INSP. AGENCY: None	
WEATHER: Clear	INSPECTOR'S SIGNATURE:

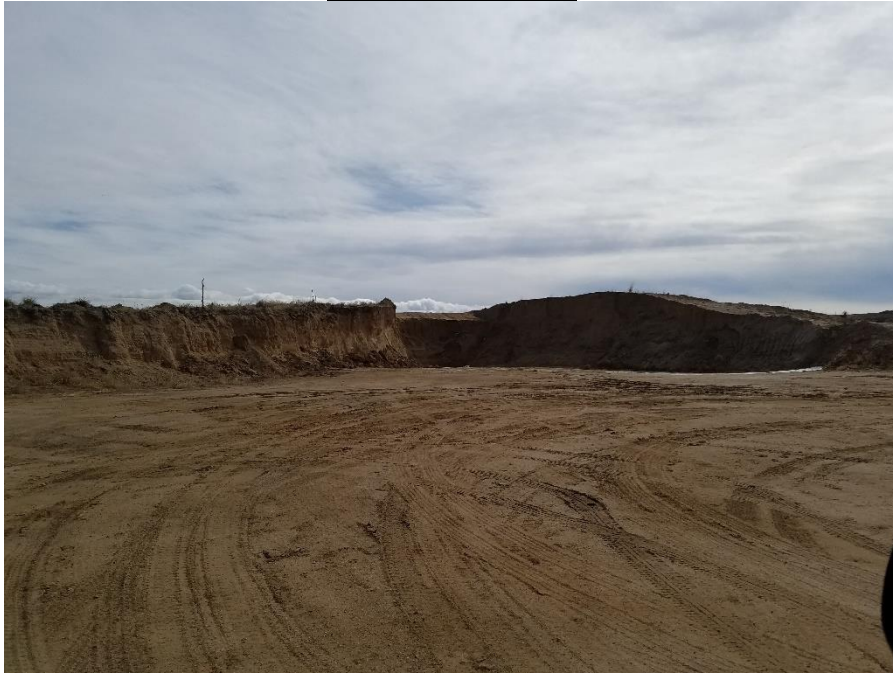
The affected area of the mine is estimated to be about six acres in size. Mining appears to have been conducted in the M1, M2 and M3 phased areas and the operator appears to be conducting concurrent reclamation. Two un-reclaimed excavated areas exist at the site. The first area is a small excavation that daylights to the northwest in the M2/M3 phased area. This is a small pit with 1.5 to 2 horizontal (H) to 1 vertical (V) slopes that are about 18 feet in height. The highwall was measured to be about 307 feet in length. The second area is located in the M1/M2 phased area. The highwall was vertical and about 22 feet in height and about 343 feet in length. The previously mined areas have gentle slopes that are at a 3H:1V angle or less.

Figure 1. Excavation in the M1/M2 area.

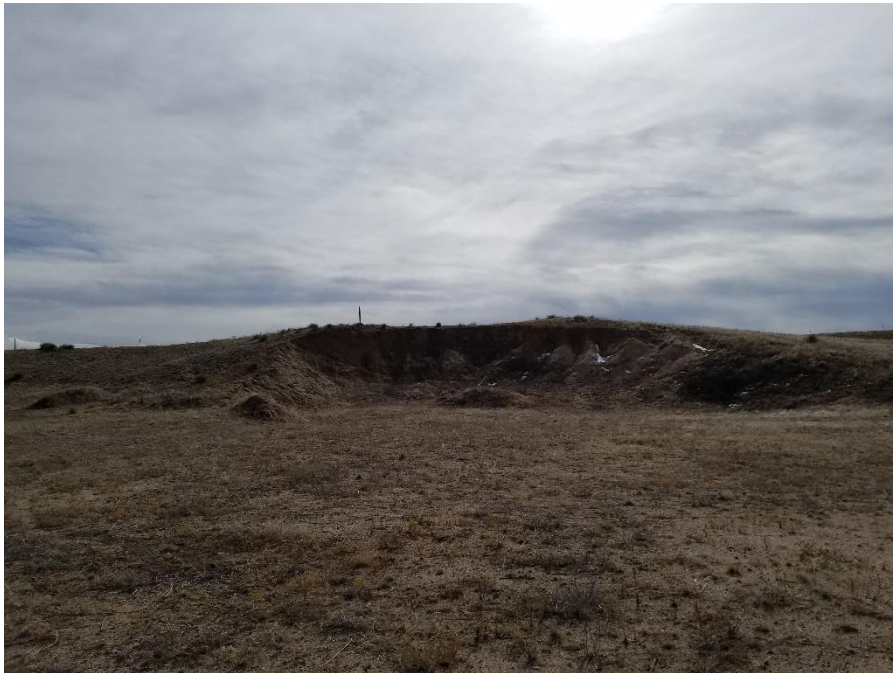
Figure 2. Excavation in the M2/M3 area.

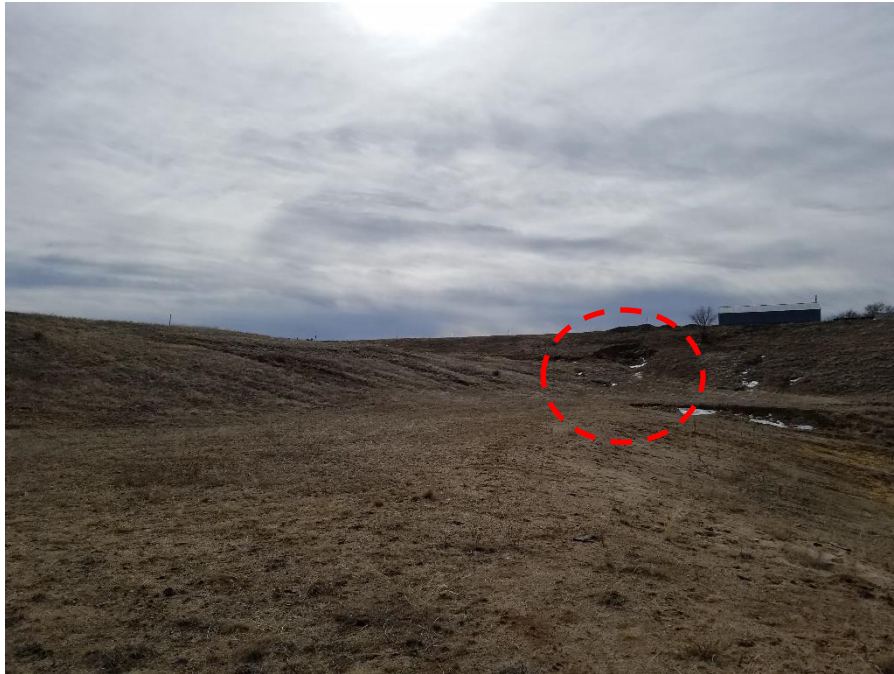
A small gully was observed on the east side of the M2 mine phase. This gully appears to be within a previously mined and reclaimed area. Mr. Thornburg indicated they intend to repair the gully.

Figure 3. East of the M2/M3 area, gully observed.

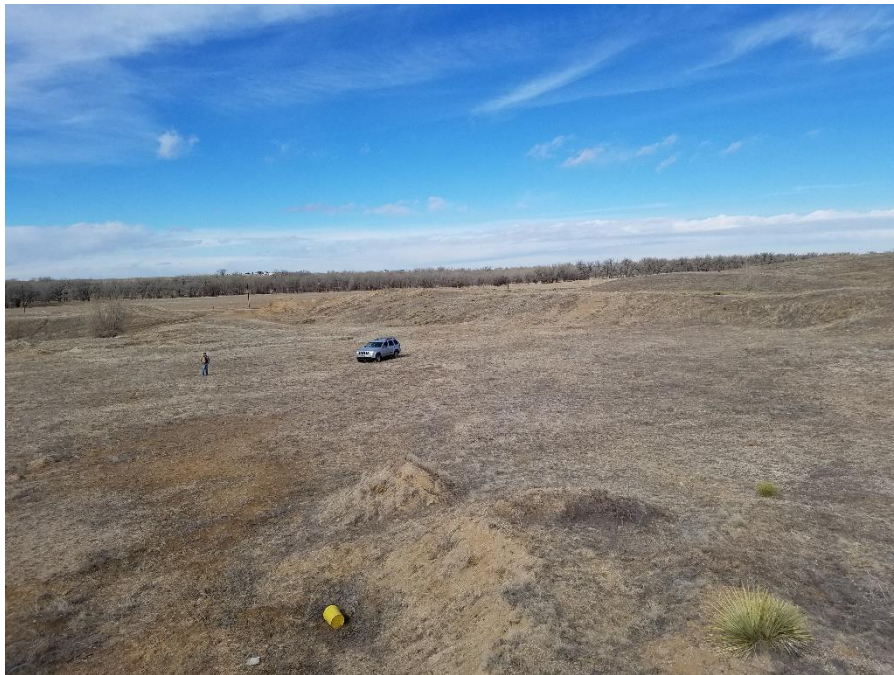
Figure 4. M1, 2 and 3 Pit Floor.
