**MINERALS PROGRAM INSPECTION REPORT**  
**PHONE: (303) 866-3567**

| <b>MINE NAME:</b><br>Bradbury Pit | <b>MINE/PROSPECTING ID#:</b><br>M-1978-357 | <b>MINERAL:</b><br>Sand and gravel | <b>COUNTY:</b><br>Mesa |
| <b>INSPECTION TYPE:</b><br>Monitoring | <b>INSPECTOR(S):</b><br>Amy C. Yeldell | <b>INSP. DATE:</b><br>March 20, 2018 | <b>INSP. TIME:</b><br>08:30 |

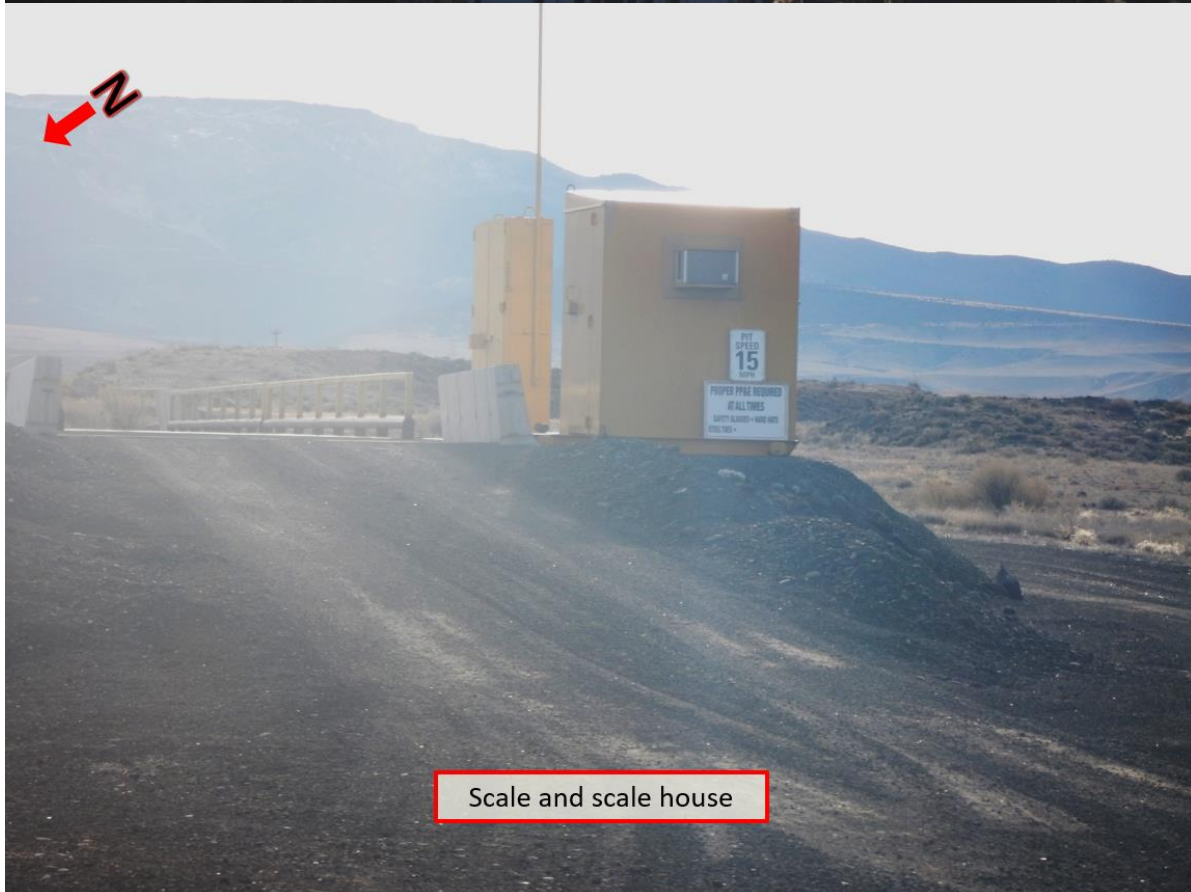
Scale and scale house
