MINERALS PROGRAM INSPECTION REPORT
PHONE: (303) 866-3567

MINE NAME: Gunnison River Gravel Pits	MINE/PROSPECTING ID#: M-2009-048	MINERAL: Sand and gravel	COUNTY: Mesa
INSPECTION TYPE: Monitoring	INSPECTOR(S): Amy C. Yeldell	INSP. DATE: March 20, 2018	INSP. TIME: 11:00
OPERATOR: Grand Junction Concrete Pipe Co.	OPERATOR REPRESENTATIVE: Jon Muller	TYPE OF OPERATION: 112c - Construction Regular Operation	
REASON FOR INSPECTION: Normal I&E Program	BOND CALCULATION TYPE: Complete Bond	BOND AMOUNT: \$88,767.00	
DATE OF COMPLAINT: NA	POST INSP. CONTACTS: None	JOINT INSP. AGENCY: None	
WEATHER: Clear	INSPECTOR'S SIGNATURE:

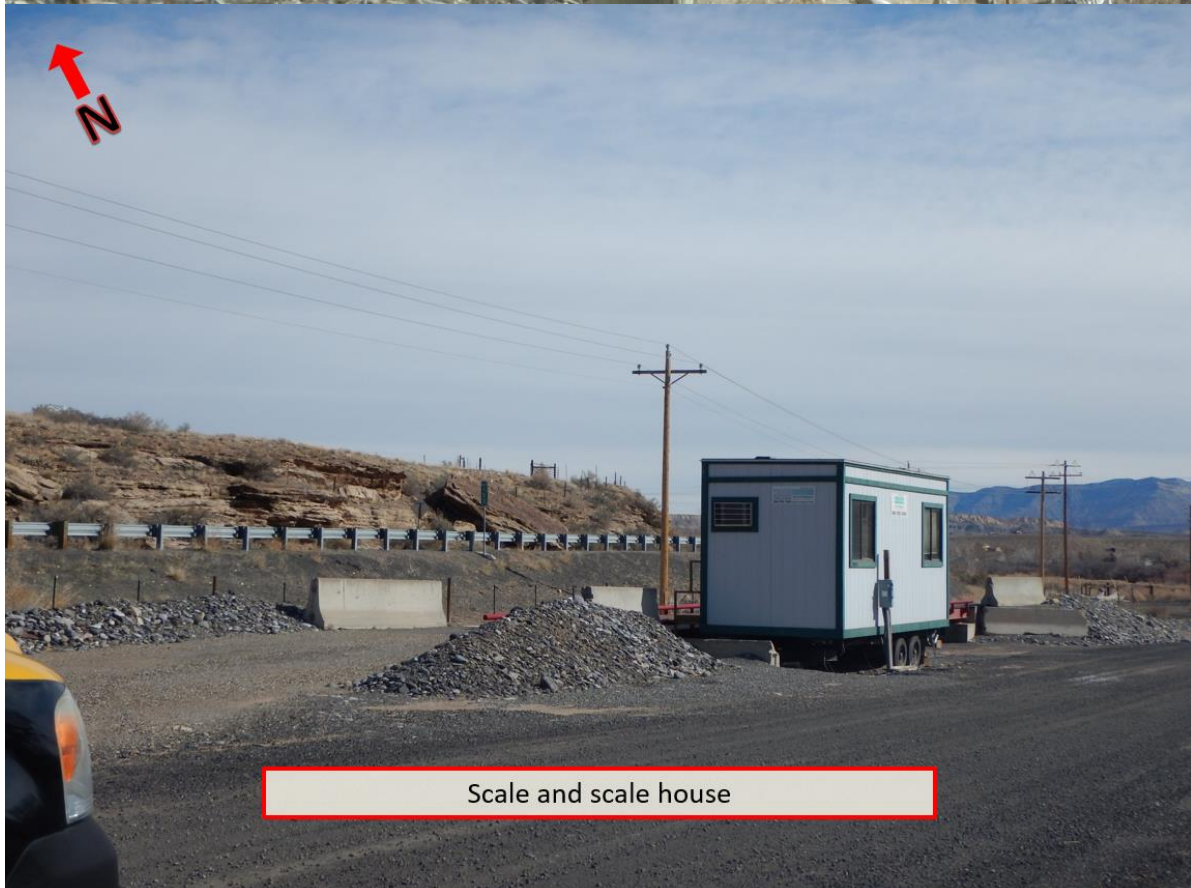
Scale and scale house
