MINERALS PROGRAM INSPECTION REPORT
PHONE: (303) 866-3567

| MINE NAME: Mule Farm Gravel Pit | MINE/PROSPECTING ID#: M-1991-079 | MINERAL: Sand and gravel | COUNTY: Mesa |
| INSPECTION TYPE: Monitoring | INSPECTOR(S): Amy C. Yeldell | INSP. DATE: March 20, 2018 | INSP. TIME: 11:30 |

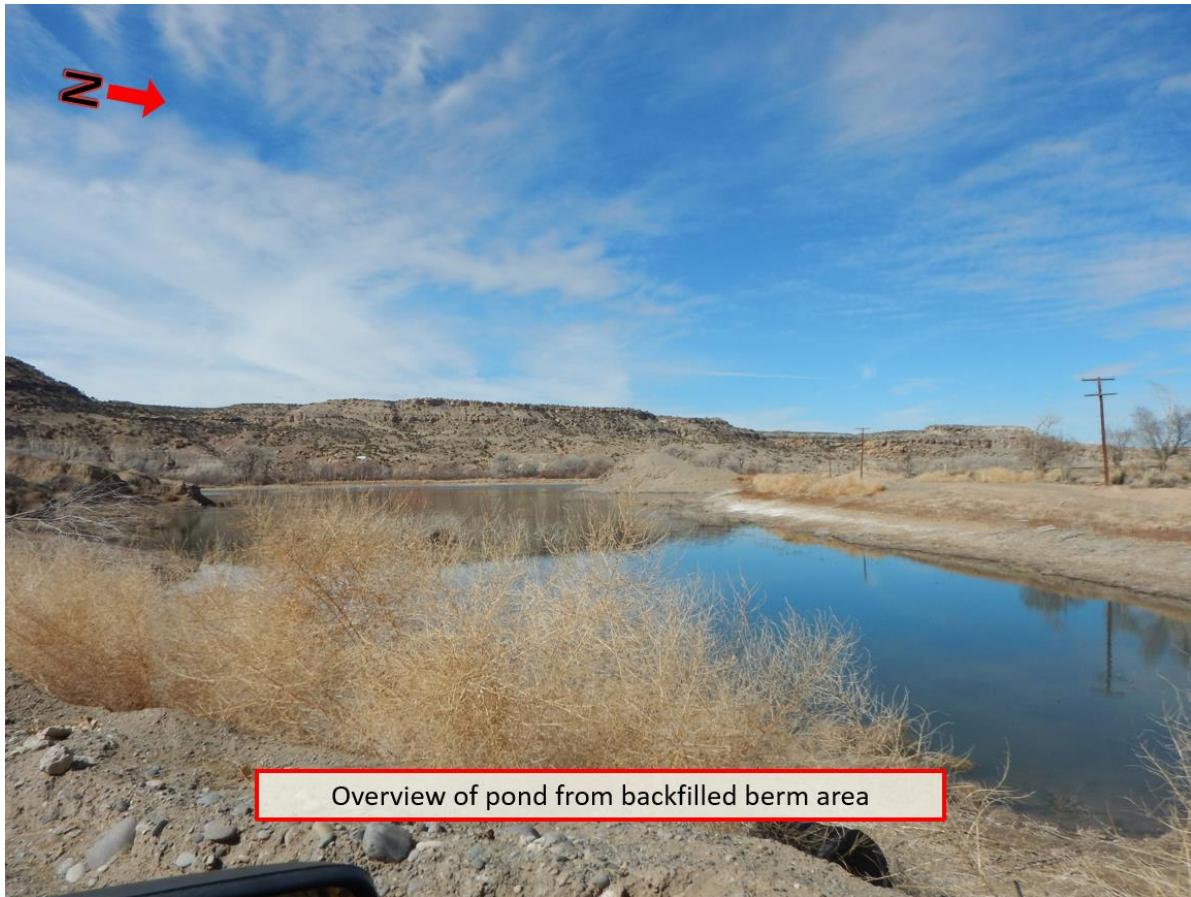
Overview of pond from backfilled berm area

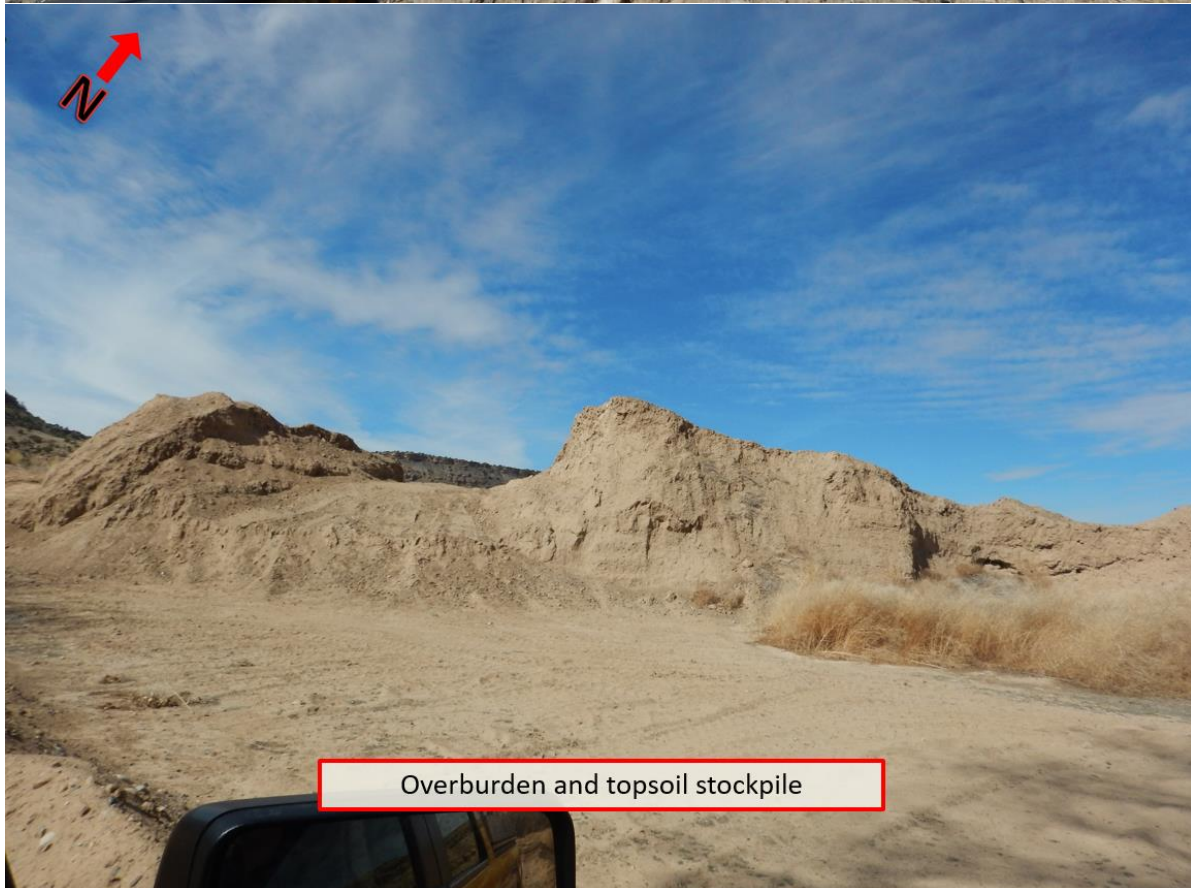
Approximately 1 acre is left to be mined. This area has been stripped and is above water. The rest of the pit is inundated and dewatering will be required for mining. Approximately 1200 linear feet of highwall 20 feet tall requires grading. This site has a maximum disturbance of 18 acres, approximately 38 acres is currently affected. However the majority of this area will be a pond so the actual reclamation liability is less than 18 acres. One main large stockpile of processed material remains on site. The topsoil and overburden pile is located on the southeast side of the pit adjacent to the river.

Overburden and topsoil stockpile
