MINERALS PROGRAM INSPECTION REPORT
PHONE: (303) 866-3567

MINE NAME: Soaring Eagle Gravel Pit	MINE/PROSPECTING ID#: M-1999-025	MINERAL: Sand and gravel	COUNTY: Mesa
INSPECTION TYPE: Monitoring	INSPECTOR(S): Amy C. Yeldell	INSP. DATE: March 20, 2018	INSP. TIME: 12:30
OPERATOR: Grand Junction Pipe & Supply Co.	OPERATOR REPRESENTATIVE: Jon Muller	TYPE OF OPERATION: 112c - Construction Regular Operation	
REASON FOR INSPECTION: Normal I&E Program	BOND CALCULATION TYPE: Complete Bond	BOND AMOUNT: \$242,488.00	
DATE OF COMPLAINT: NA	POST INSP. CONTACTS: None	JOINT INSP. AGENCY: None	
WEATHER: Clear	INSPECTOR'S SIGNATURE:

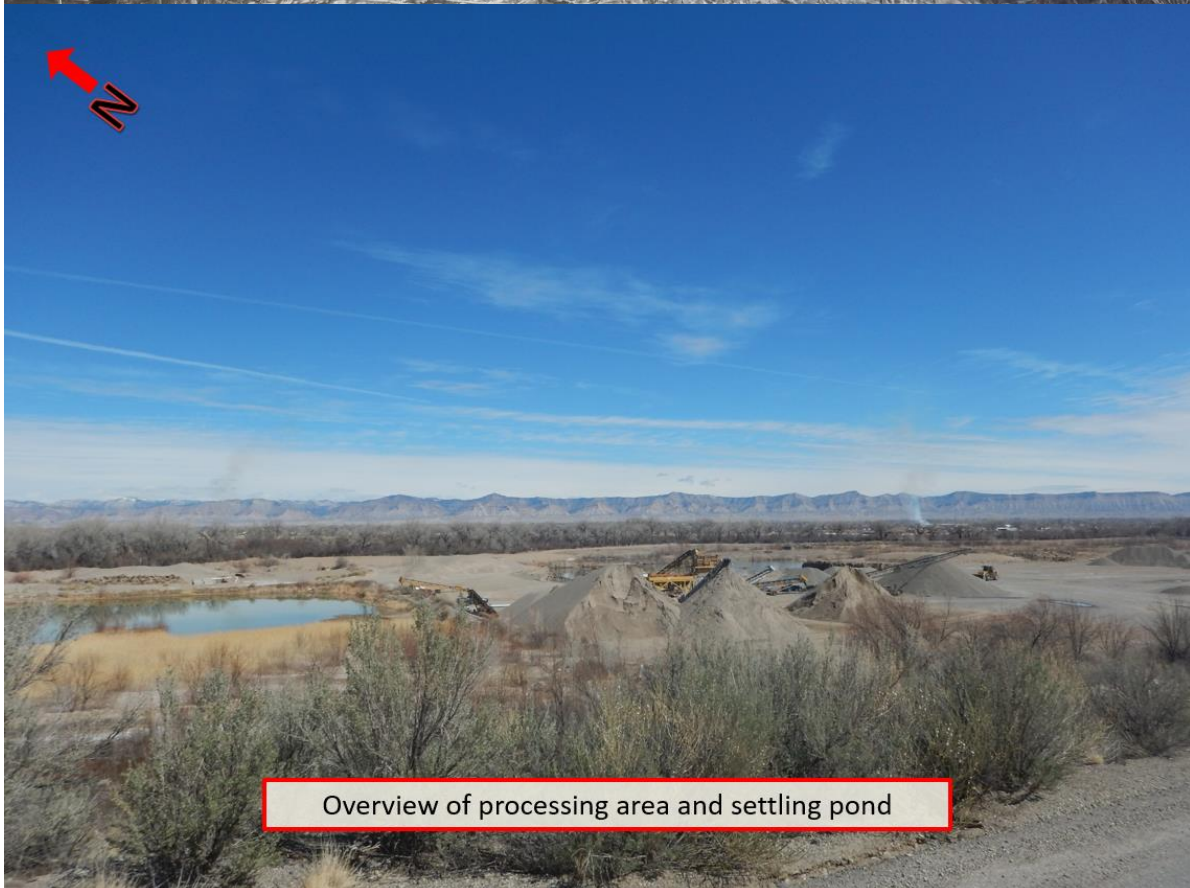
Most of the slopes where mining has concluded have been graded. The western half of graded slopes require seed. Several stockpiles are stored adjacent to the processing plant. Approximately 27 acres is being used for stockpiles and processing of material. This site has a maximum disturbance of 32 acres.

Overview of processing area and settling pond

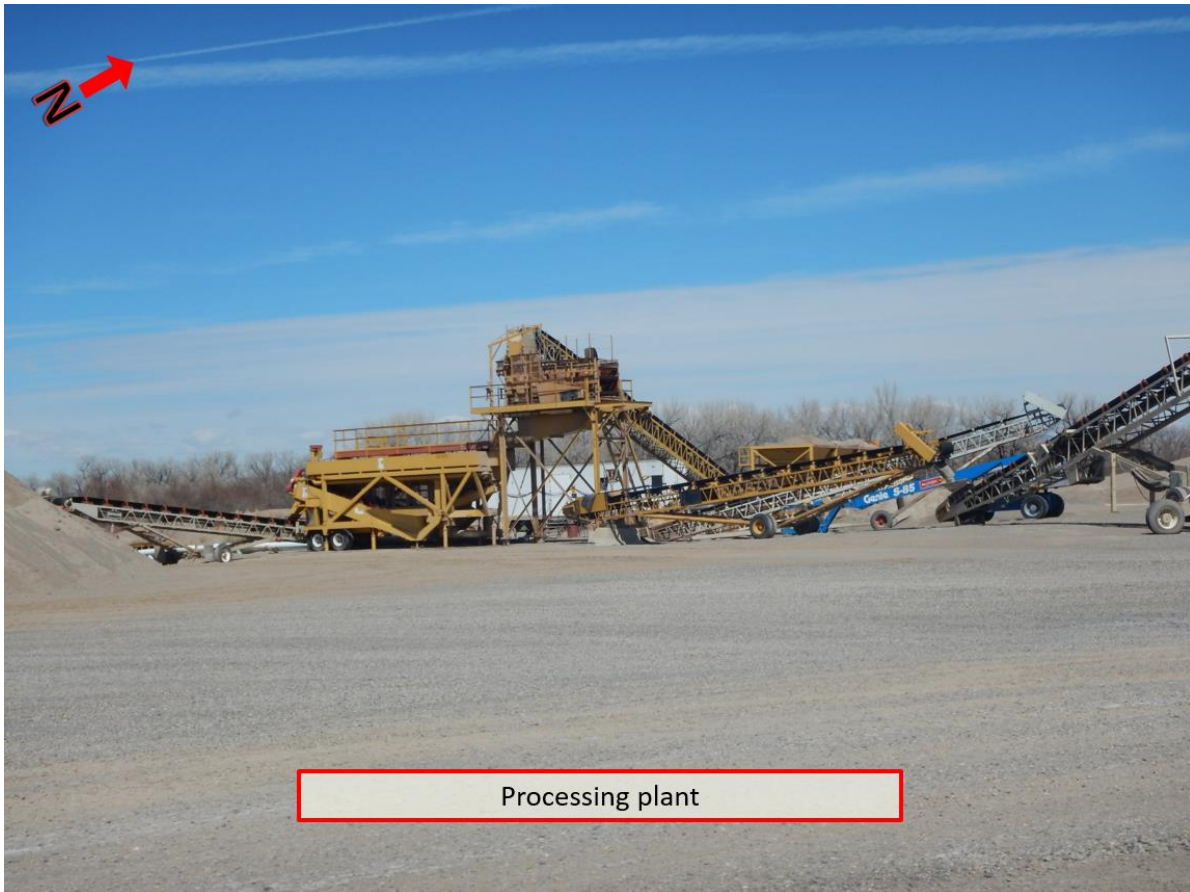
Processing plant

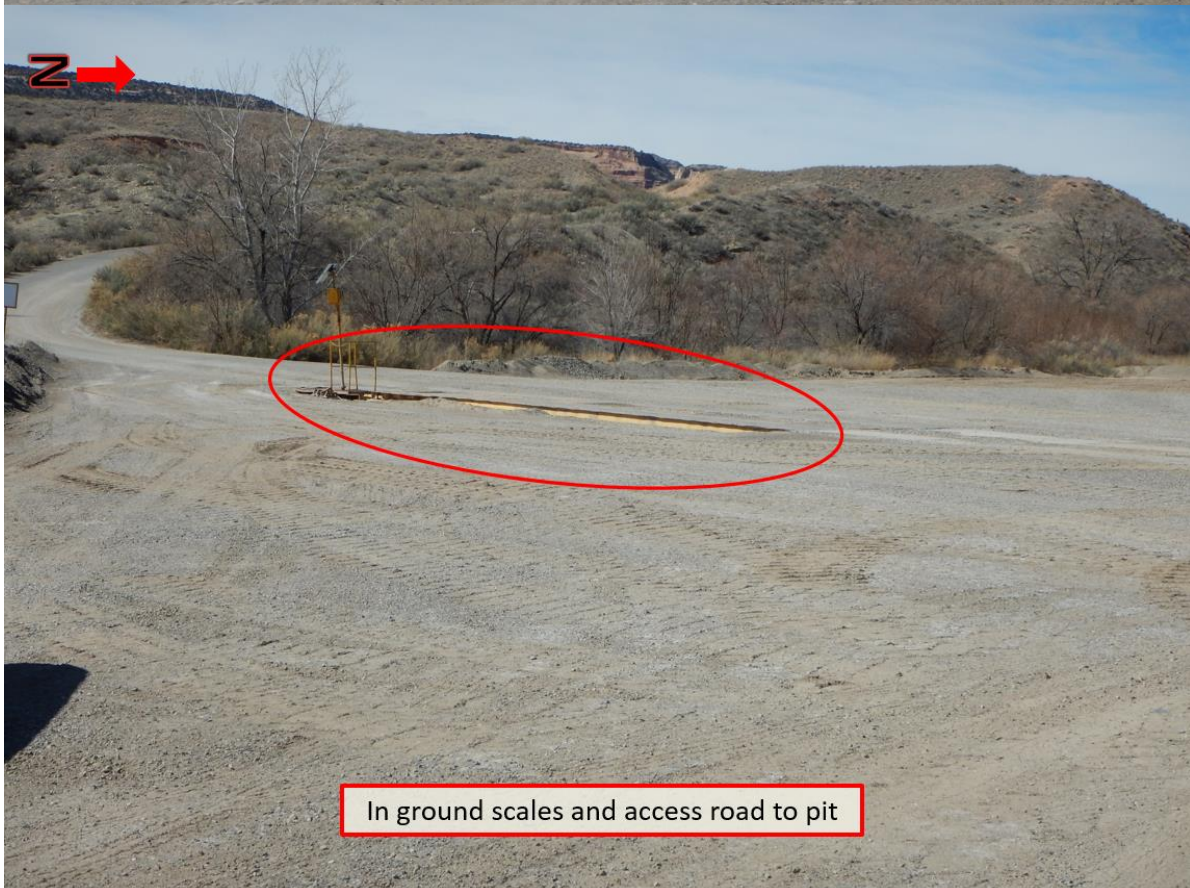
The mine identification sign and affected area boundary markers are in place and in compliance with Rule 3.1.12. A mine sign is posted at the permit boundary entrance. A locked gate is at entrance to the access road off of Broadway. The access road is paved the entire length into the pit. The permit boundary is delineated by fences. A scale is at the entrance of the pit with a solar panel scale readout, no scale house is present. Two fuel tanks were observed in proper secondary containment.

In ground scales and access road to pit

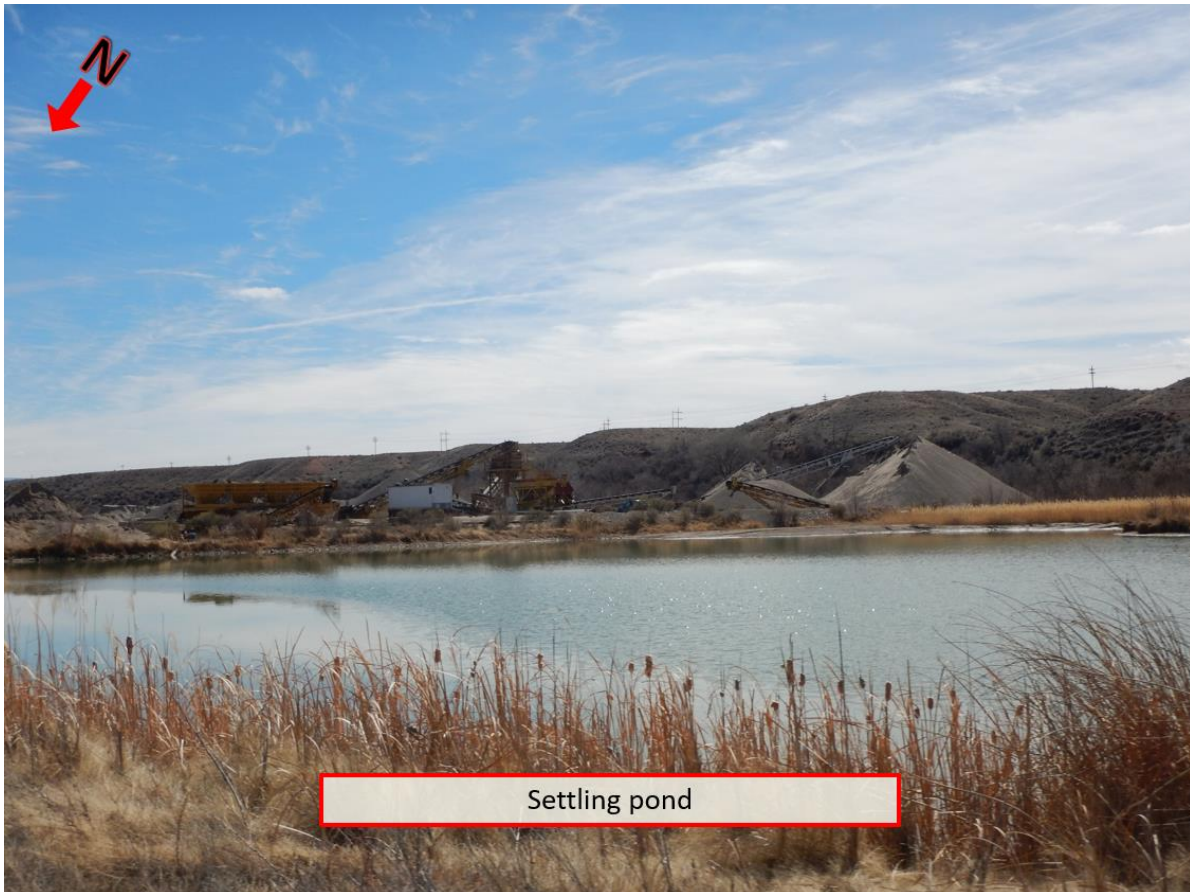
There is also a settling pond in the southwest corner of the permit. This pond is a thriving riparian area with dense vegetation and wildlife. The settling pond is approximately five and half acres with 3 acres of water currently exposed.

Settling pond

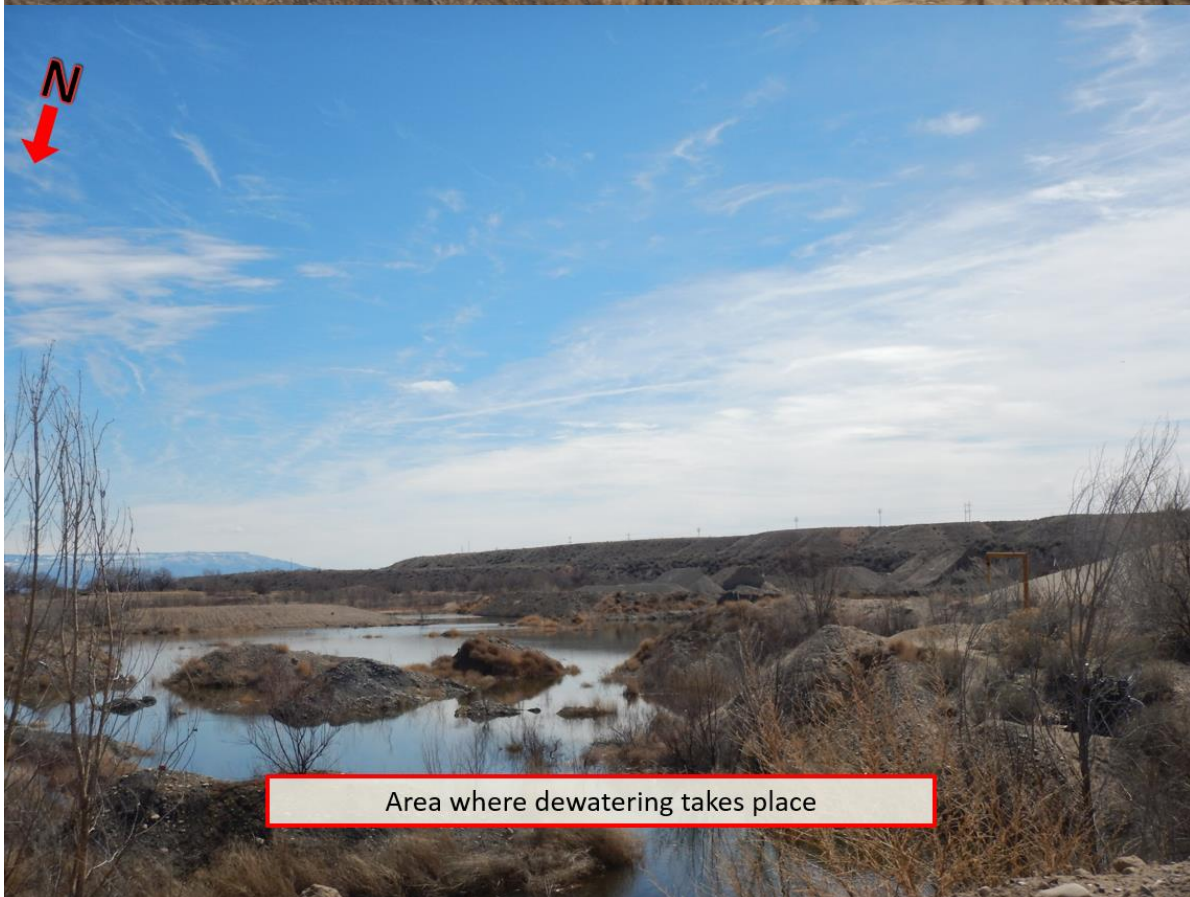
The pit was inundated. Mr. Muller indicated that due to water quality, dewatering was on hold until sediment drops out and pumping can resume. The pond is approximately 41 surface acres. Two islands are located within the pond. They appear to be well vegetated and stable.

Area where dewatering takes place

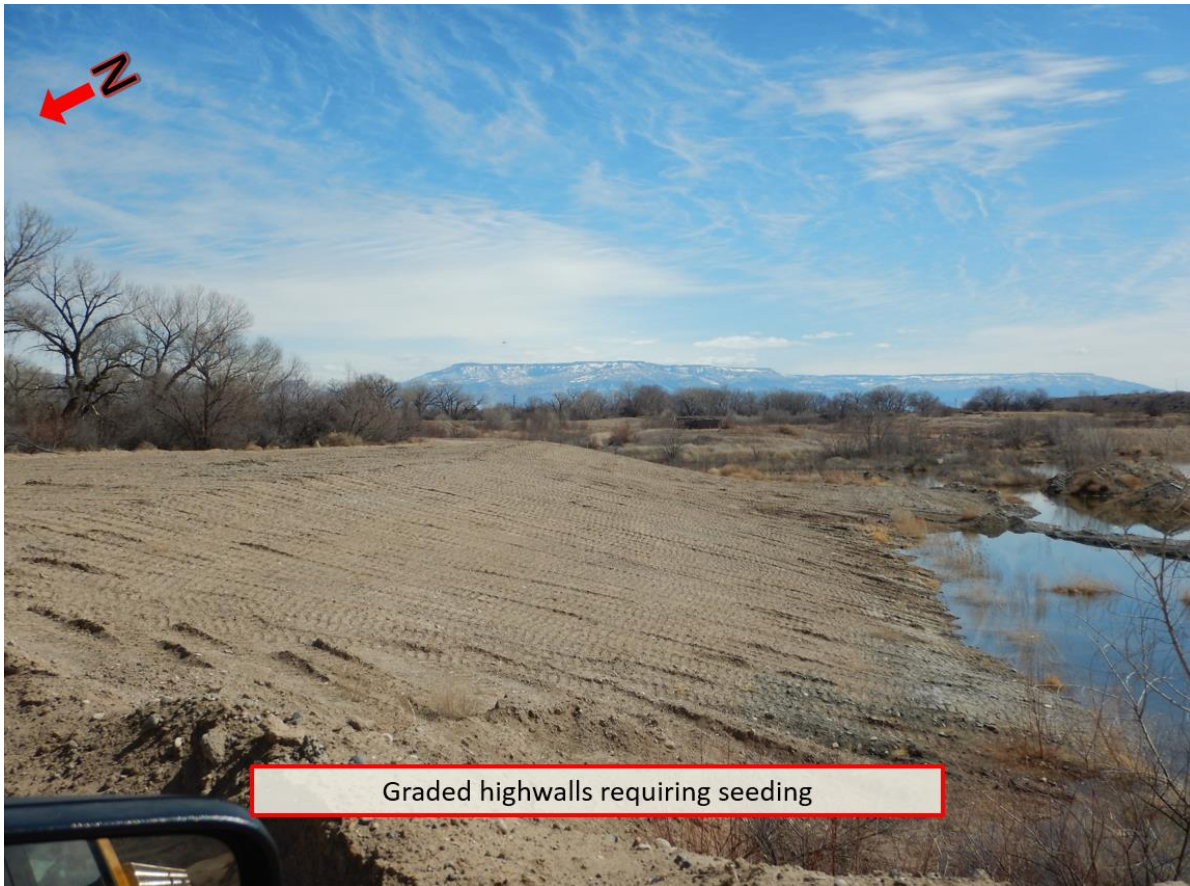
Graded highwalls requiring seeding

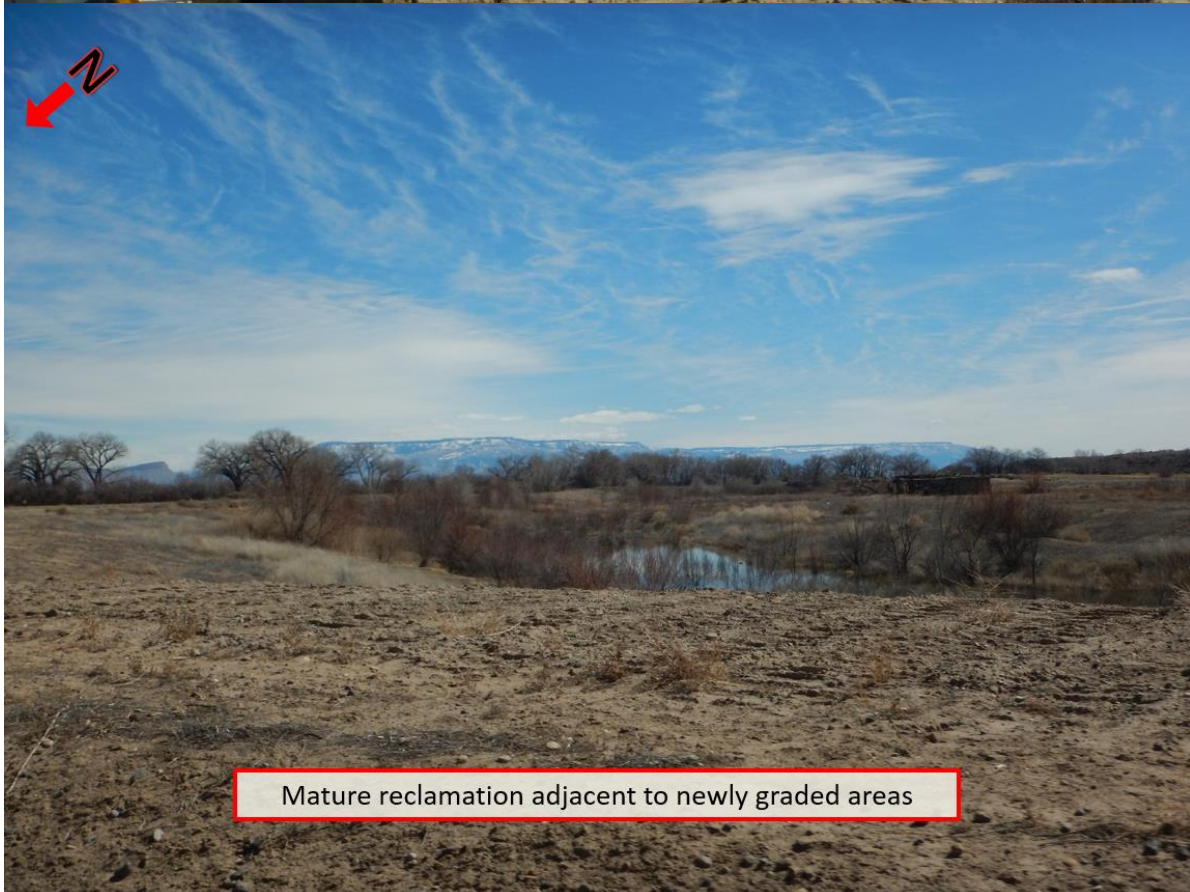
Mature reclamation adjacent to newly graded areas
