MINERALS PROGRAM INSPECTION REPORT
PHONE: (303) 866-3567

| MINE NAME: South Fruita Gravel Pit | MINE/PROSPECTING ID#: M-1981-243 | MINERAL: Sand and gravel | COUNTY: Mesa |
| INSPECTION TYPE: Monitoring | INSPECTOR(S): Amy C. Yeldell | INSP. DATE: March 20, 2018 | INSP. TIME: 13:30 |
| OPERATOR: Grand Junction Concrete Pipe Co. | OPERATOR REPRESENTATIVE: Jon Muller | TYPE OF OPERATION: 112c - Construction Regular Operation | |

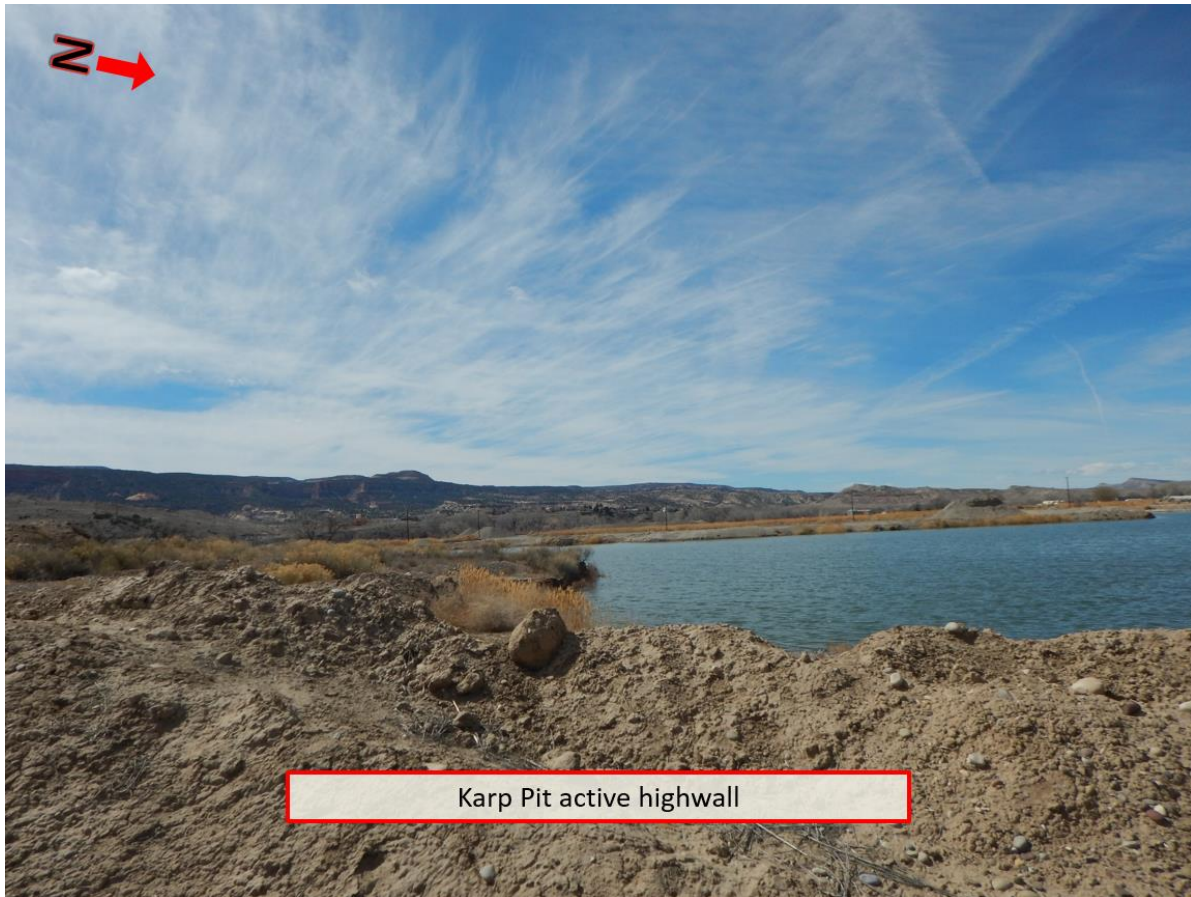
The northeast pit also known as the Karp Pit and was also inundated at the time of the inspection. The northeastern banks of the Karp Pit were graded and all other slopes remain near vertical. Staff estimates that approximately 2000 linear feet requires grading. Mining has the potential to move further north towards the permit boundary however at this time the landowner would like the land for pasture.

Karp Pit active highwall

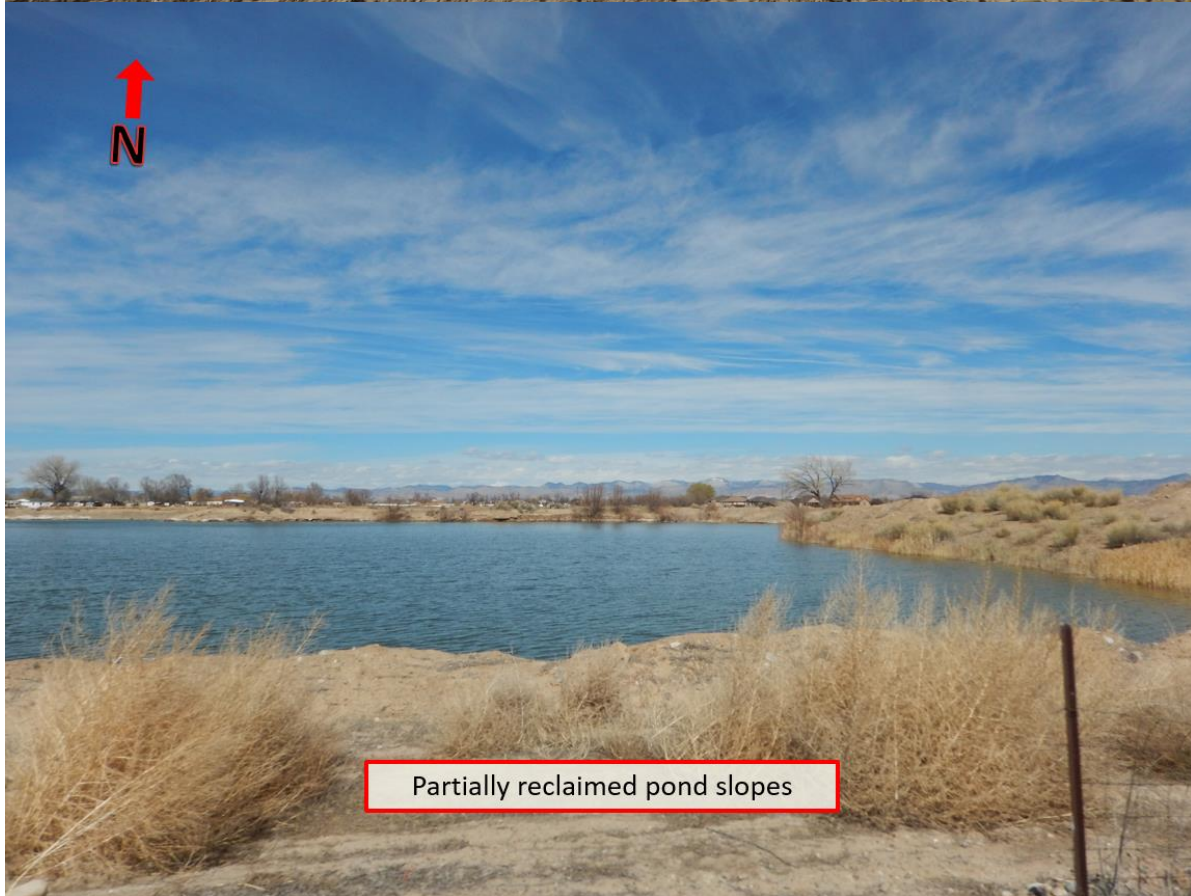
Partially reclaimed pond slopes
