**MINERALS PROGRAM INSPECTION REPORT****PHONE: (303) 866-3567**

<b>MINE NAME:</b> Deer Trail Pit	<b>MINE/PROSPECTING ID#:</b> M-1988-090	<b>MINERAL:</b> Sand and gravel	<b>COUNTY:</b> Arapahoe
<b>INSPECTION TYPE:</b> Monitoring	<b>INSPECTOR(S):</b> Jared L. Ebert	<b>INSP. DATE:</b> February 15, 2018	<b>INSP. TIME:</b> 11:45
<b>OPERATOR:</b> 5A Aggregate LLC	<b>OPERATOR REPRESENTATIVE:</b> None	<b>TYPE OF OPERATION:</b> 112c - Construction Regular Operation

## Deer Trail Pit, M-1988-090

February 15, 2018 Inspection

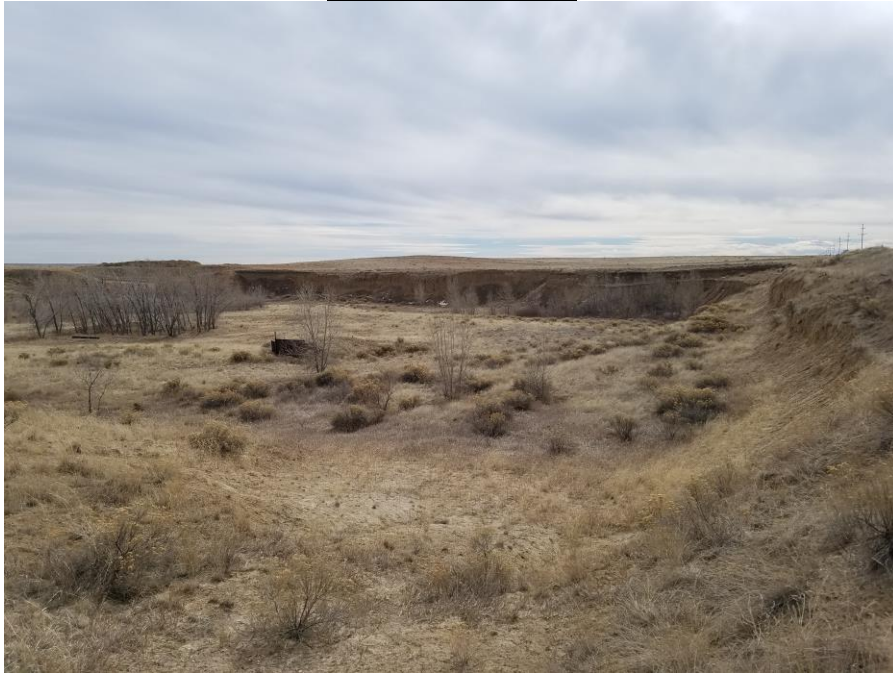
The Division will require the Operator to conduct reclamation on 6.8 acres of affected land. Mining appears to be complete in the western end of the affected area adjacent to County Road 213/Bartlett Road and the Operator must begin backfilling the highwall in this portion of the site to the final reclamation grade and conducting reclamation as prescribed in the reclamation plan. Of the 6.8 acres requiring reclamation, the western highwall area will need to be included in the reclaimed area.

**Figure 1. From the north end of the western highwall looking southeast.**

**CORRECTIVE ACTIONS:** Complete backfilling, grading, topsoiling and seeding in accordance with the approved plan on at least 6.8 acres of affected land. Mining appears to be complete within the affected area cited in this report along County Road 213/Bartlett Road and this 6.8 acres shall include this area. By the corrective action date, the Operator shall submit a written notice, photographic documentation and a map documenting the completion of reclamation.

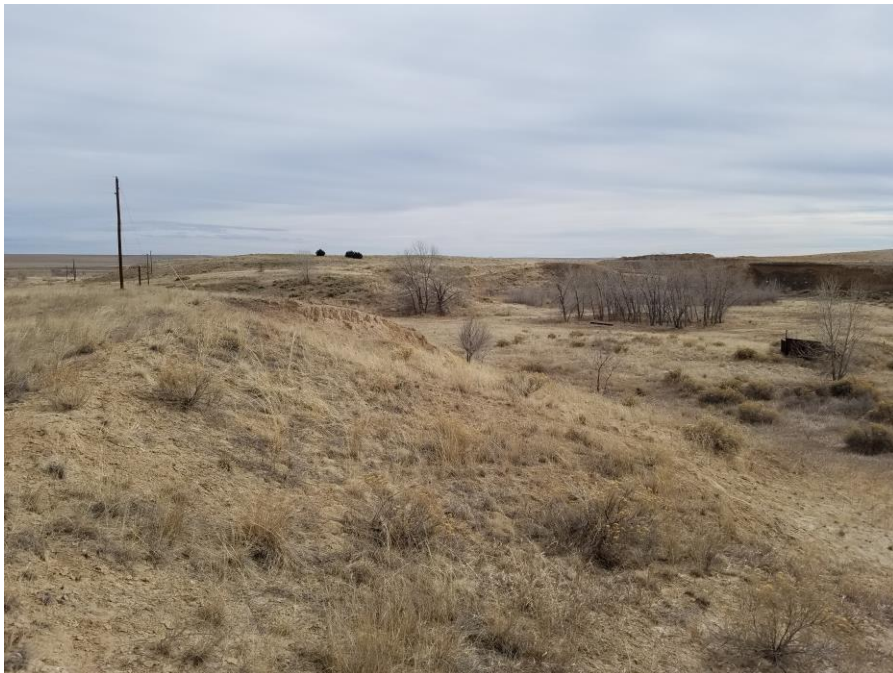
**Figure 2. From the north end of the western highwall looking east.**

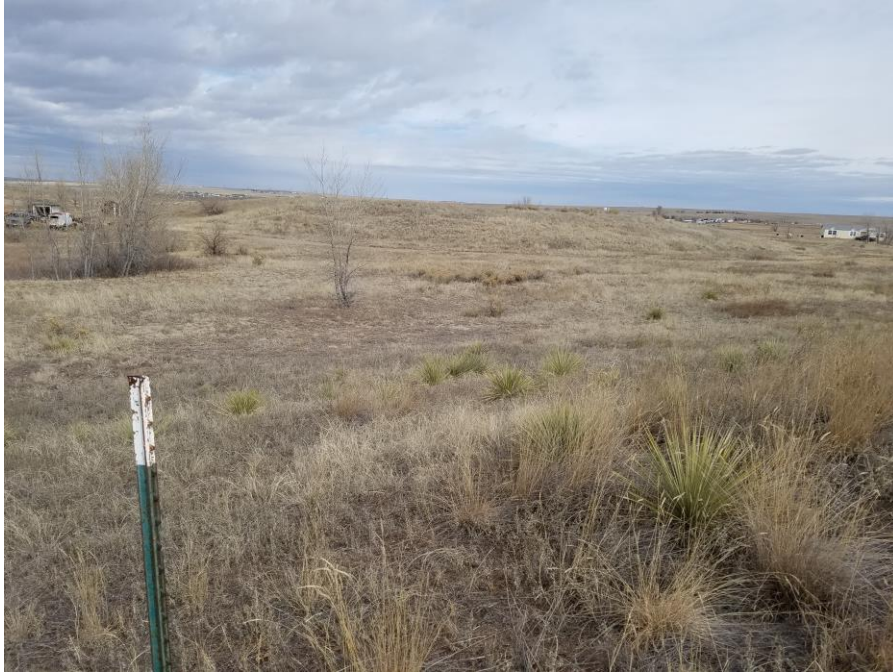
Figure 3. From the northeast corner of the former 111c area looking north.

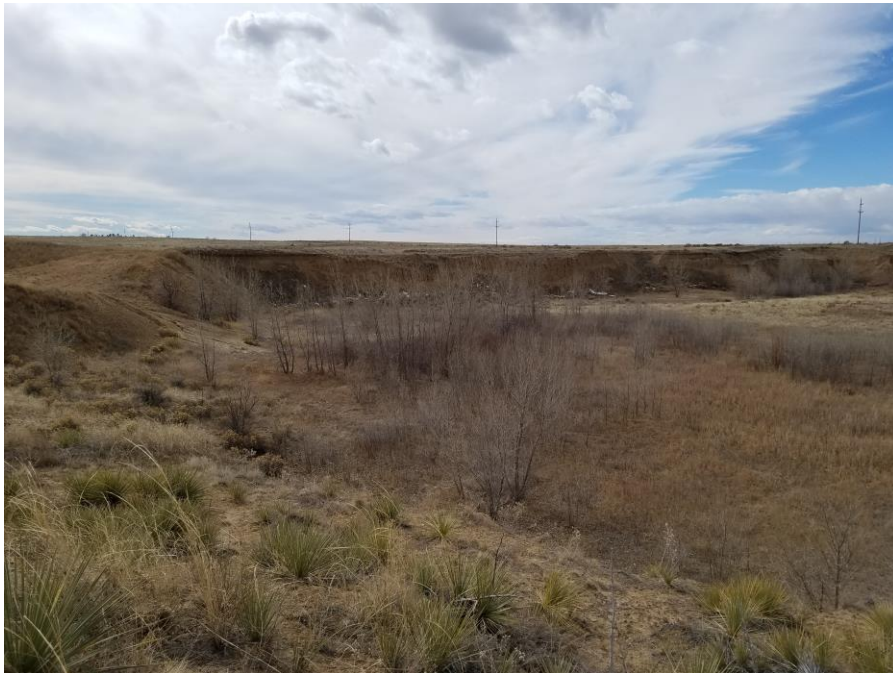
Figure 4. From the northeast end of the affected area looking southwest.

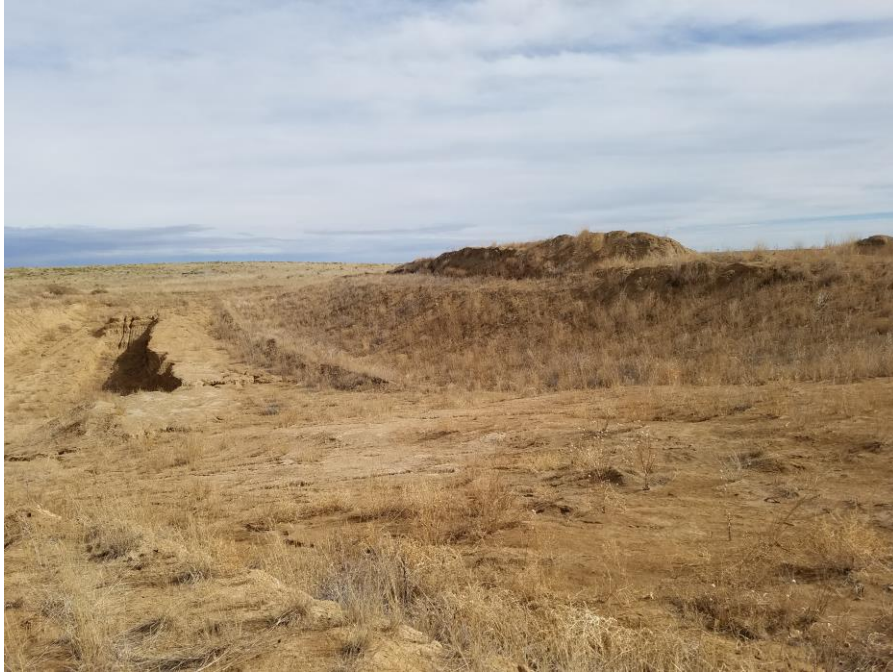
Figure 5. From the south central end of the affected area looking north at the 2015 excavation area.

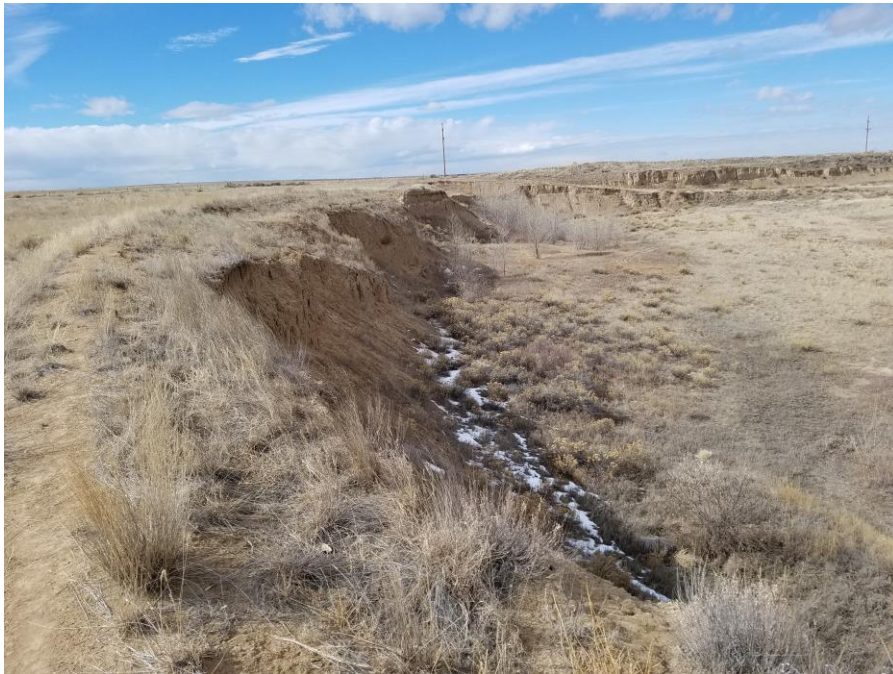
Figure 6. Southern highwall from the east end looking west.

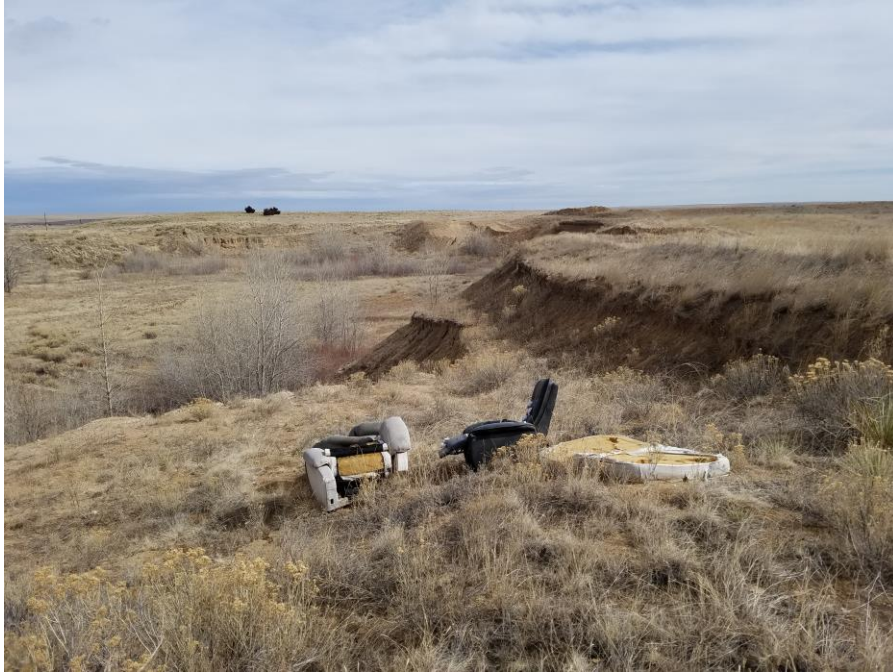
Figure 7. Southern highwall from the west end looking east.
